Contamination at Plutonium Fuel Research Facility of Oarai Research and Development Center

July 21, 2017

Japan Atomic Energy Agency

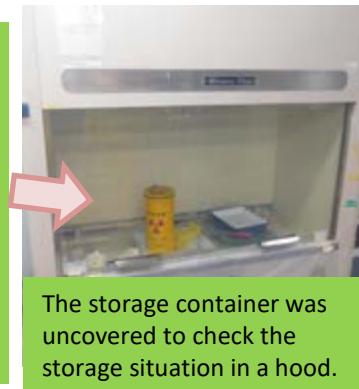
A plastic container containing nuclear fuel material is contained in two resin bags and stored in storage container

Plastic container
Resin bag (double)

Storage container (stainless)

The storage container was uncovered to check the storage situation in a hood.

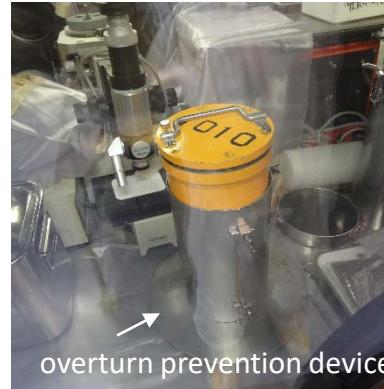
Storage of storage container in the hood

- Cleaned the floor with wipe to prevent the expansion/scattering of contamination due to walk of workers, and secured routes to the hood.
- Fix the lid of the storage container in the hood with packing tape, and installed overturn prevention device to the storage container.
- Carried the storage container out of Room No. 108, carried it in Room No. 101, and put it in the glove box in the room.

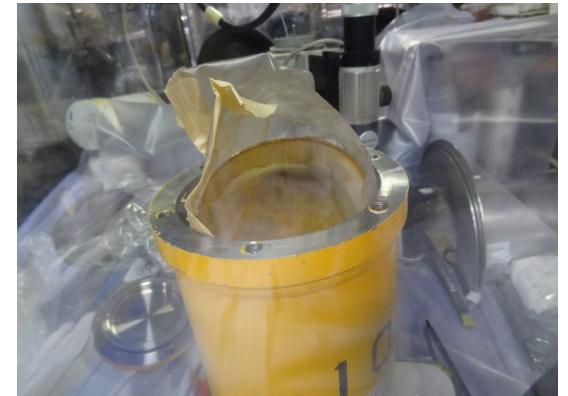
Storage of the storage container after putting it in a glove box

Storage container
(Confirmed after being put in a glove box)

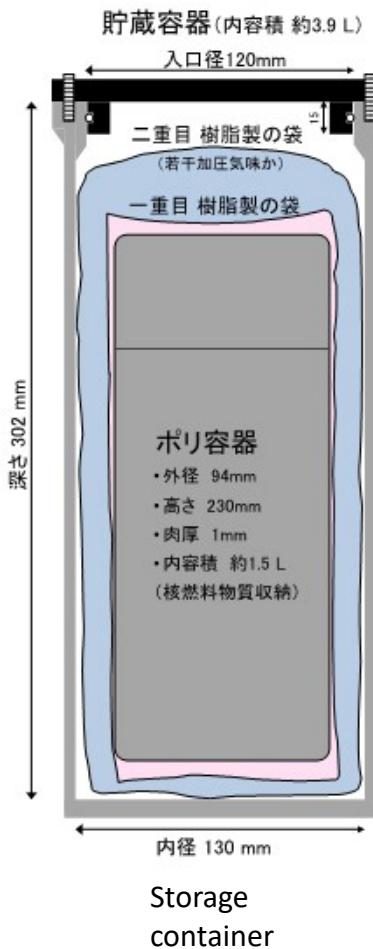
貯蔵容器梱包更新の記録	
核燃料物質貯蔵容器No. 1010	
平成 8年 7月19日	
現 状	更 新 後
バッヂ番号 W410	バッヂ番号 W410
化 学 形 M化合物	化 学 形 M化合物
物 理 形 スクラップ	物 理 形 スクラップ
総 重 量 g	総 重 量 g
Pu・ ²³⁸ U 重量 g	Pu・ ²³⁸ U 重量 g
核分裂性物質量 g	核分裂性物質量 g
NU・Th 重量 g	NU・Th 重量 g
国 籍 F、Q C、Q、U (U)	国 籍 F、Q C、Q、U (U)
備 考	備 考
梱包状態	梱包状態
内容器: ポリエチレン容器	内容器: ポリエチレン容器
内 容 器 内 の 状 態	内 容 器 内 の 状 態
1. X線回折分析試料	1. X線回折分析試料
梱包材劣化状況	梱包材劣化状況
ポリエチレン容器底部が変色、破損 内容器ビニルパックが膨張	異常なし。

Record of inspection of July 1996 when it is presumed to have checked the inside of the storage container and changed the inside container and resin bag.

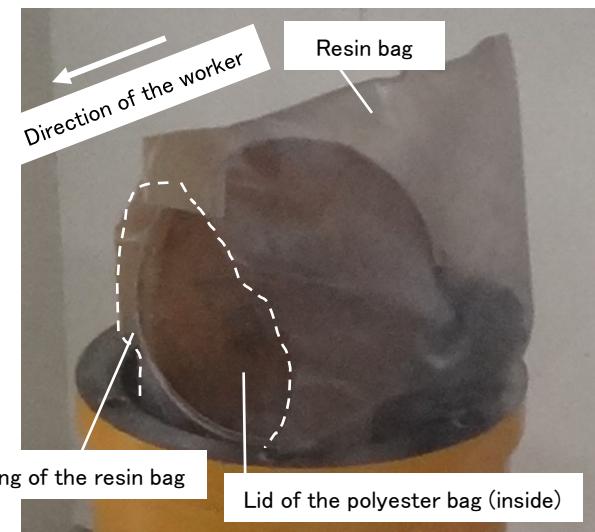
- The resin bag comes out from the top edge of the storage container, and opening of the bag is made along the side of the bag in a way to split in the vertical direction. The opening made by the burst faces the direction of the worker, and it is correspond with the statement of the worker.
- The cylindrical material seen in the bag is a lid of the polyester container, which is according to the worker upside down. The side visible is the inside of the lid.
- Black material is visible inside the bag, right to the lid. Nuclear fuel material inside the polyester container is likely to have come out at the time of the burst.

Enlarged photo taken by the worker at the time of the burst of the resin bag

(The side of the bag was partially damaged in a way to split in the vertical direction)

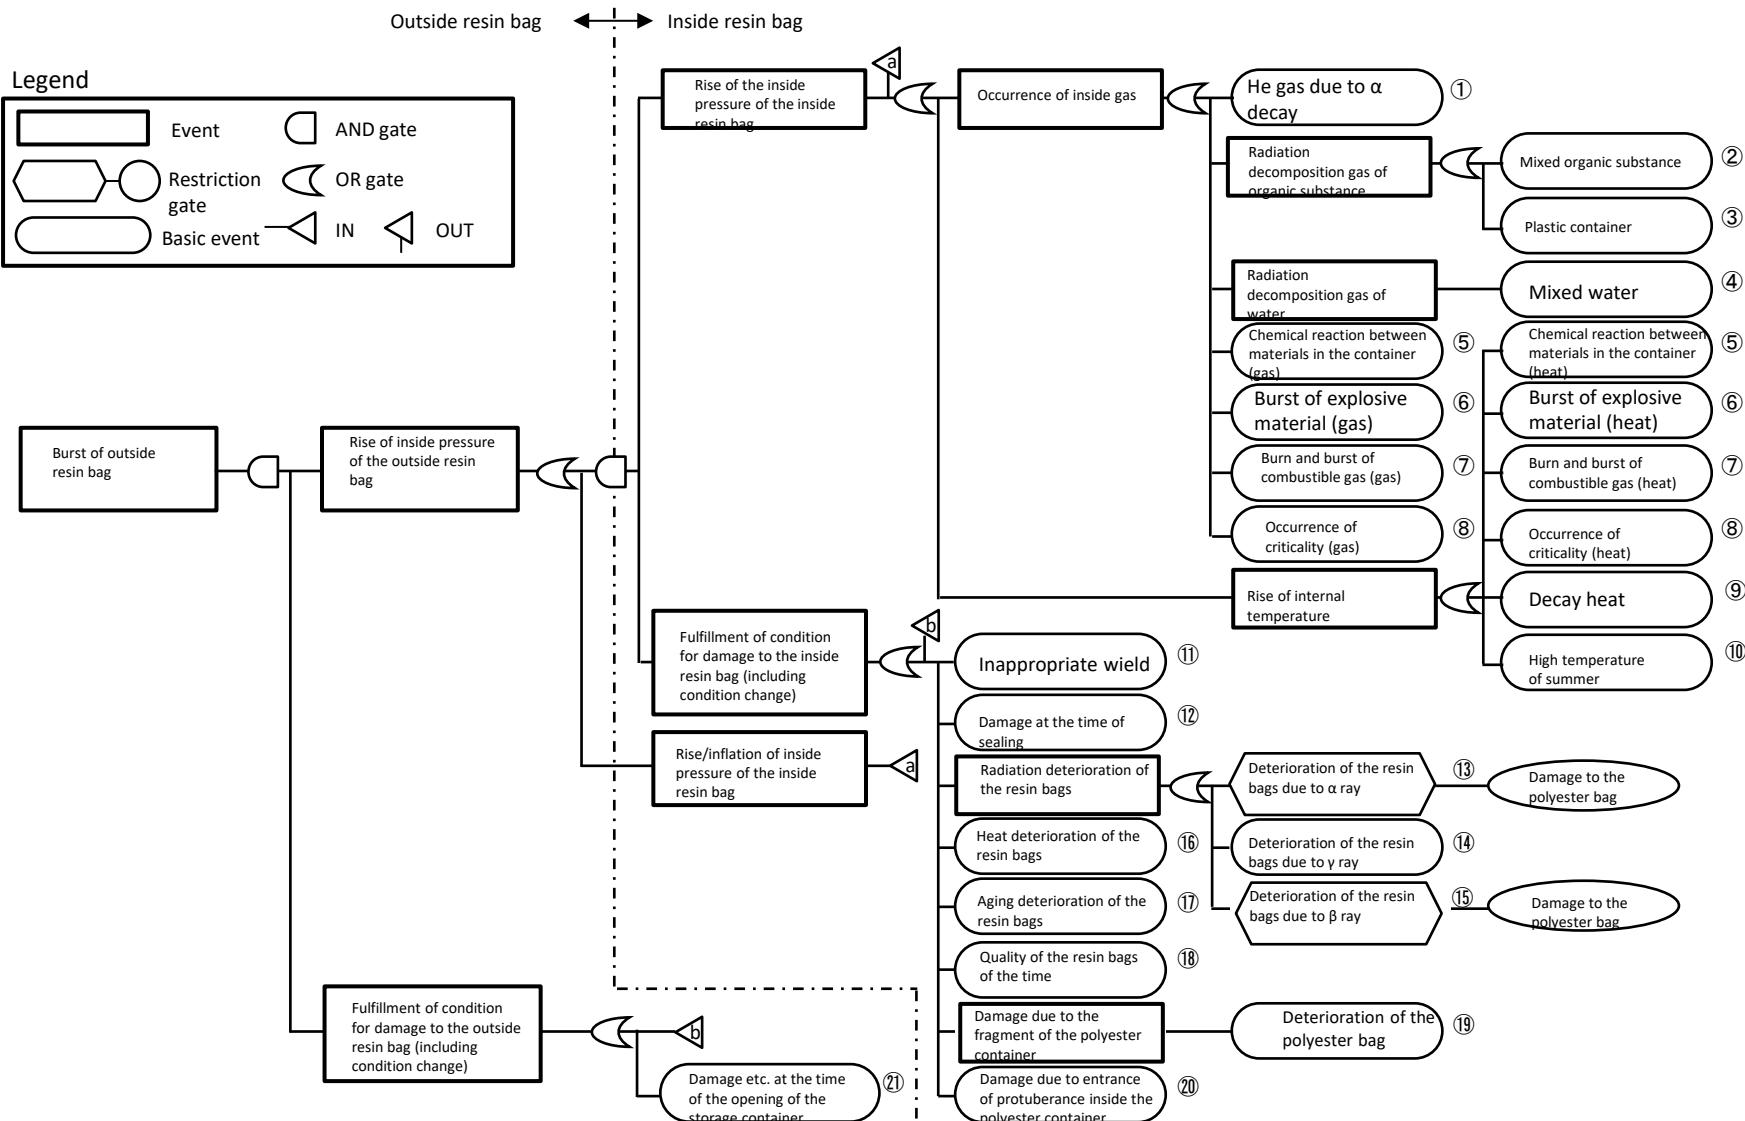
①～⑧: Factors relating to “internal gas occurrence”, ⑤～⑩: Factors relating to “internal temperature increase”, ⑪～⑯: Factors relating to “fulfillment of condition for damage to the inside resin bag (including condition change)”

- Due to fault tree analysis, cause for the burst of the resin bags was presumed to be the combination of three basic factors: mixed organic substance, polyester container and mixed water.
- Due to the above three factors or one factor, gas was generated, and during the 21 years of period, the inside pressure increase exceeded the outside pressure causing burst of the resin bags, but the bags did not burst due to the binding force of the storage container. Due to the opening of the lid of the storage container, the binding power was lost and the balance between the inside and outside pressure of the resin bags was lost, and the parts that were not fixed by the container, lid, etc. were presumed to have split open under the influence of the decrease of intensity and flexibility of the resin bags attributable to irradiation.

- Remove epoxy resin etc. that generate a large amount of gas by heat process of samples before storage.
- Store powder type nuclear material in metallic containers.
- With regard to nuclear fuel materials stored in polyester containers, estimate in advance the period of time causing inflation and change in color, and take measures in appropriate interval such as visual inspection and replacement.
