プルトニウム研究1棟105号室排気第11系統ダクト配管落下

使-01~3 プルトニウム研究1棟102号室排気第4系統ギャラリ破損

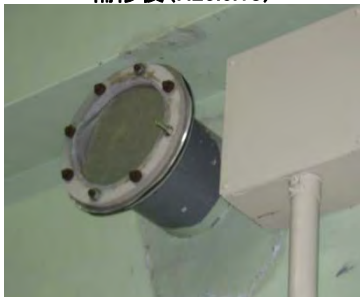
補修後(H23.5.18)

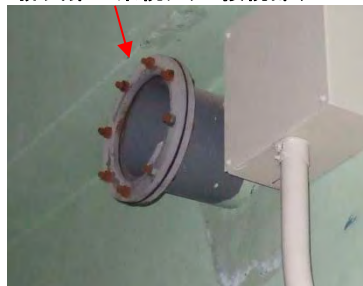
排気第11系統ダクト接続部(H23.3.11)

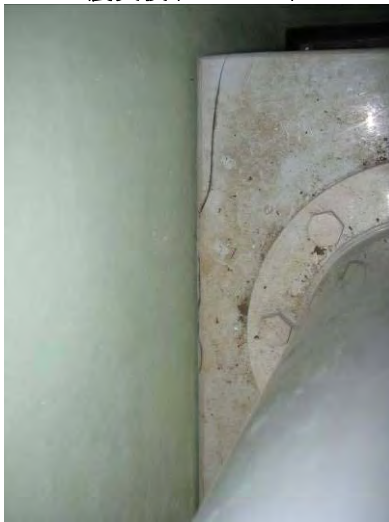
震災後(H23.5.16)

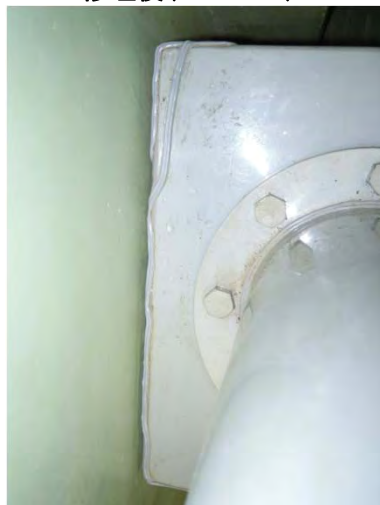
修理後(H24.8.16)

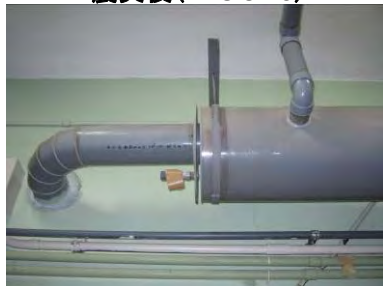
使-01~4 プルトニウム研究1棟104号室排気第4系統吸込ギャリ亀裂

震災後(H23.5.16)

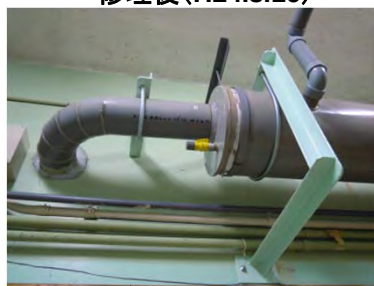
修理後(H24.8.16)

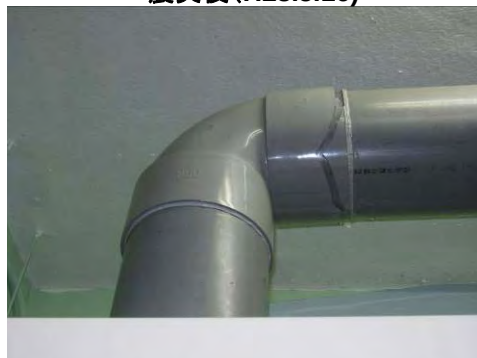
プルトニウム研究1棟106号室排気第11系統ダクト破損

震災後(H23.5.16)

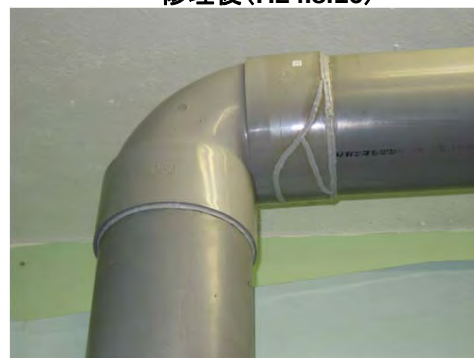
修理後(H24.8.16)

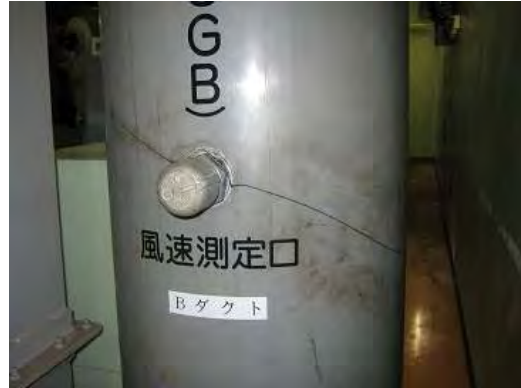
202号室 排気第8系統ダクト亀裂

震災後(H23.4.11)

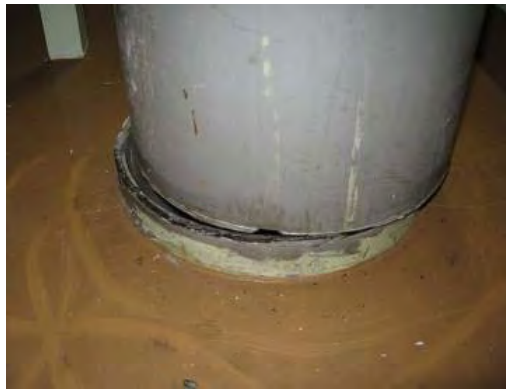
震災後(H23.4.11)

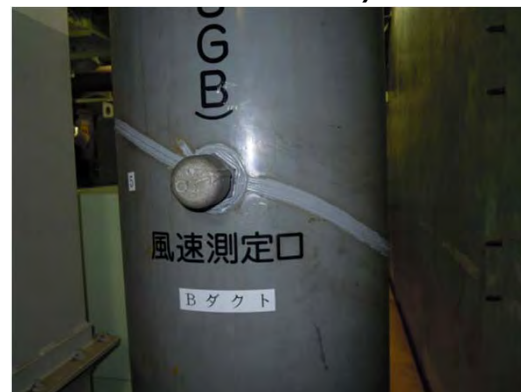
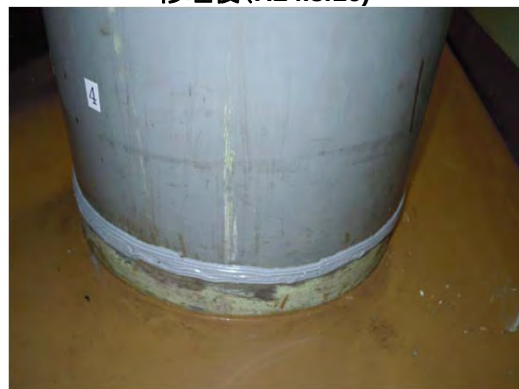
修理後(H24.8.16)

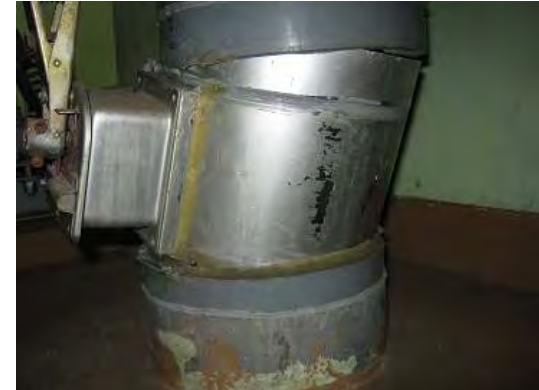
202号室 排気第9系統防火ダンパのずれ

震災後(H23.4.11)

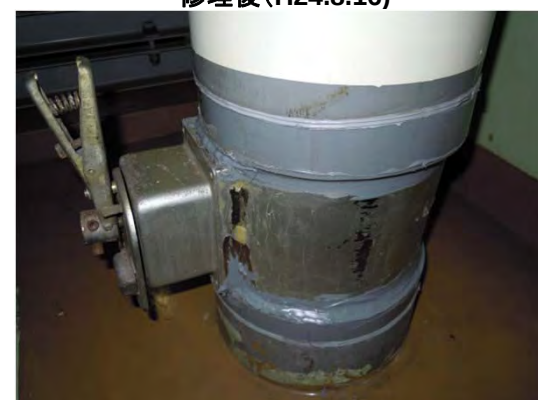
修理後(H24.8.16)
