## Radioactive contamination at Plutonium Fuel Research Facility (PFRF) in Oarai Research and Development Center (Follow-up 4)

Japan Atomic Energy Agency

Below is the situation after the press release issued on June 13 of the radioactive contamination at Plutonium Fuel Research Facility (PFRF) occurred on June 6 (Tue), 2017. (Added information is underlined.)

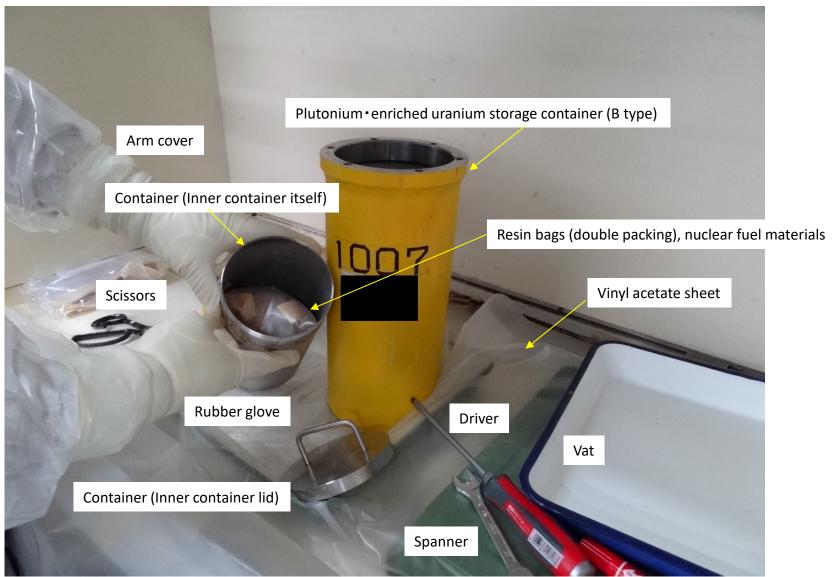
Spanner and driver used to open the storage container.

The vat and scissors were not used for this work.
Instead of using a bat, the inner floor of the hood is cured with the vinyl acetate sheet.

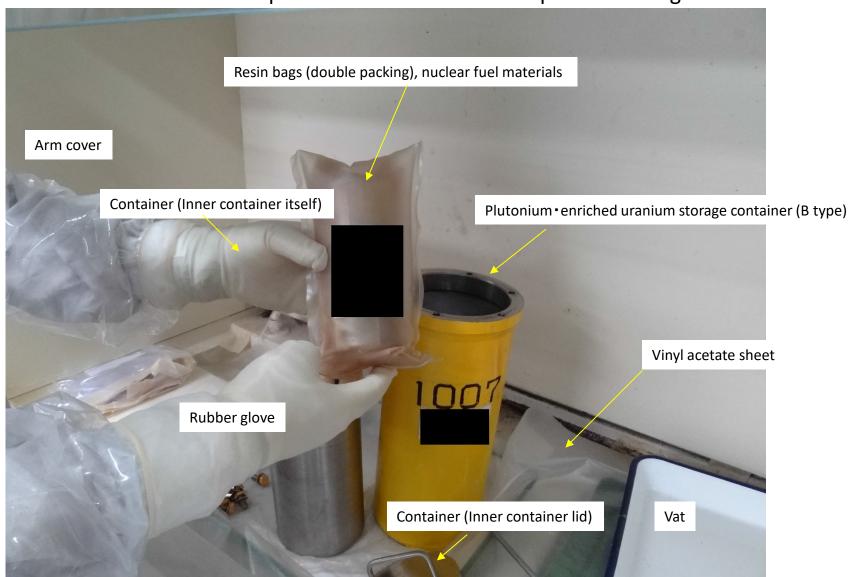
Spanner and driver used to open the storage container.

The vat and scissors were not used for this work.
Instead of using a bat, the inner floor of the hood is cured with the vinyl acetate sheet.

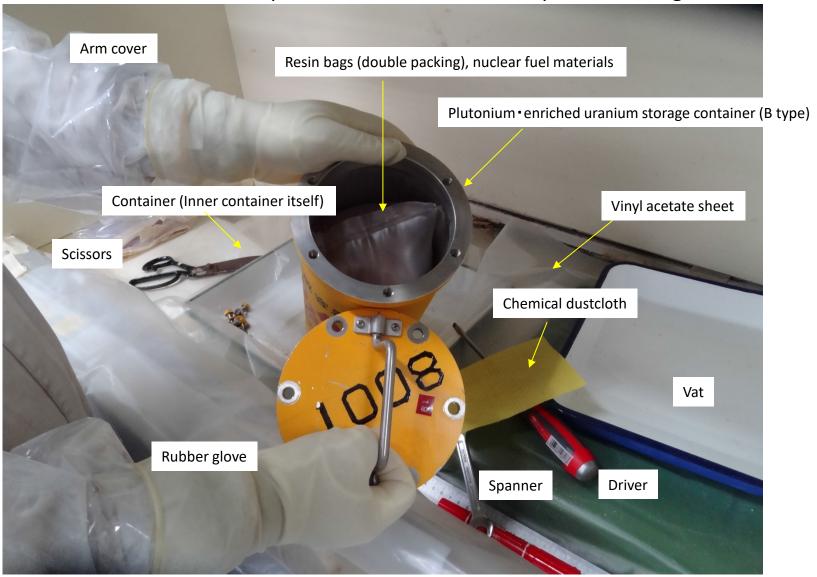
Spanner and driver used to open the storage container.

The vat and scissors were not used for this work.
Instead of using a bat, the inner floor of the hood is cured with the vinyl acetate sheet.

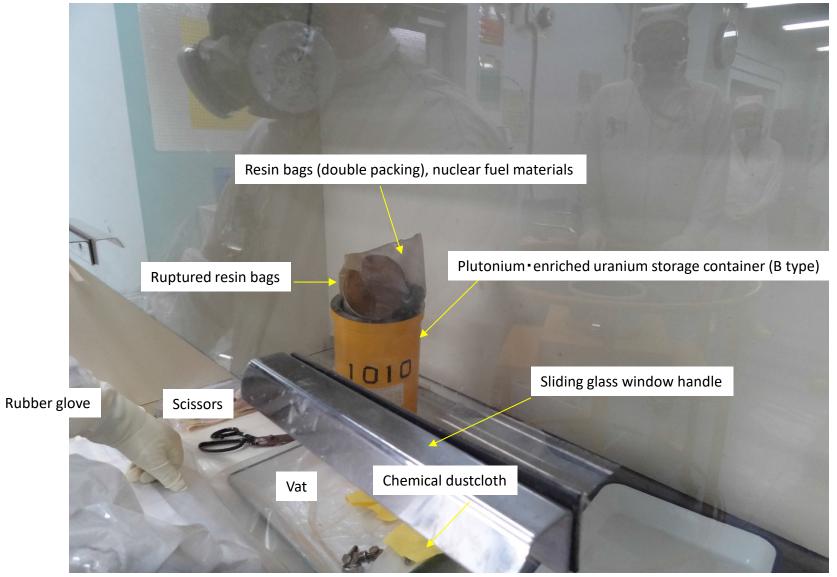
Spanner and driver used to open the storage container.

The vat and scissors were not used for this work.
Instead of using a bat, the inner floor of the hood is cured with the vinyl acetate sheet.

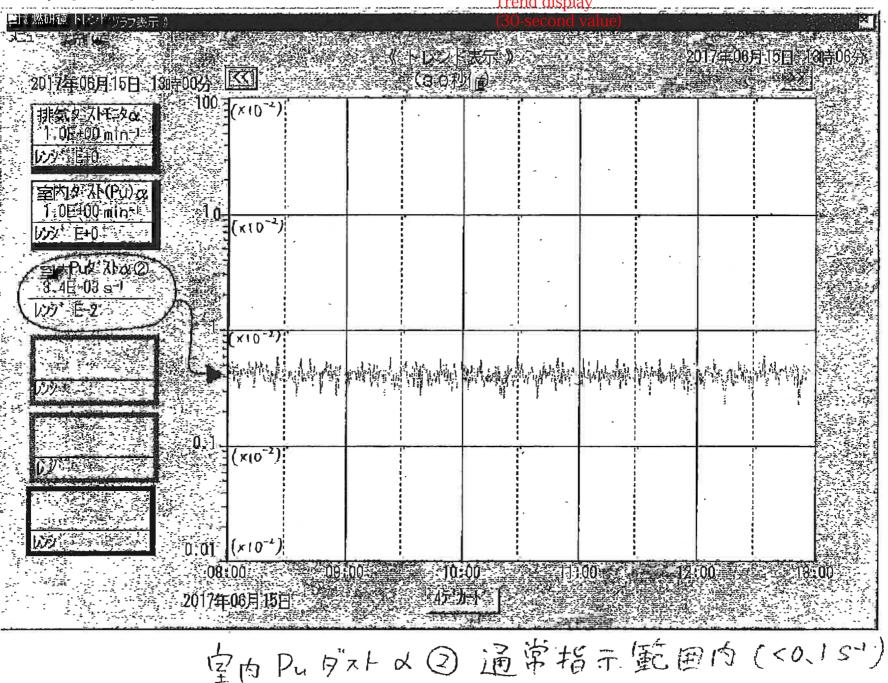
PFRF Trend Graphic Display

Room Pu dust monitor  $\alpha$  ② indicated value within the range of normal. (<0.1 s<sup>-1</sup>)
