Report on the contamination at Plutonium Fuel Research Facility

Report on failure, etc. of a nuclear facility

| Title | Contamination at Plutonium Fuel Research Facility (PFRF) |

Contamination at Plutonium Fuel Research Facility

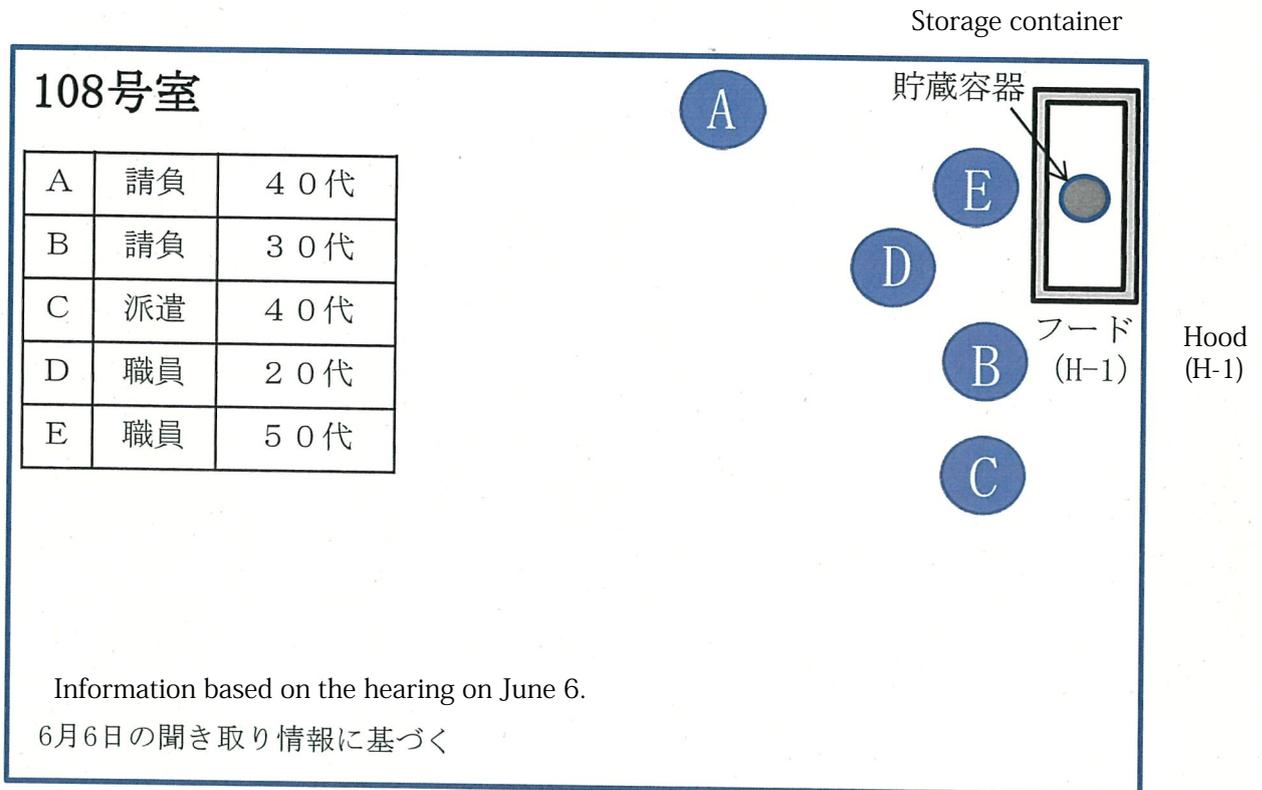
Fig.6 Location of the five workers in Room No. 108 at the incident occurrence

Around 11:15, June 6, 2017, in the hood (H-1) (Fig. 5) of an analyzing room in PFRF (in a controlled area) (hereinafter “Room No. 108” Fig. 4), resin bags encapsulating a container of nuclear fuel materials that the storage container contained burst during the inspection work of the storage container. As a result of a contamination check conducted in the Room No. 108 using surface contamination test meter of α -ray, all the five workers were confirmed to be contaminated. The location of the five workers (Worker A ~E) when the event occurred is indicated in Fig. 6.

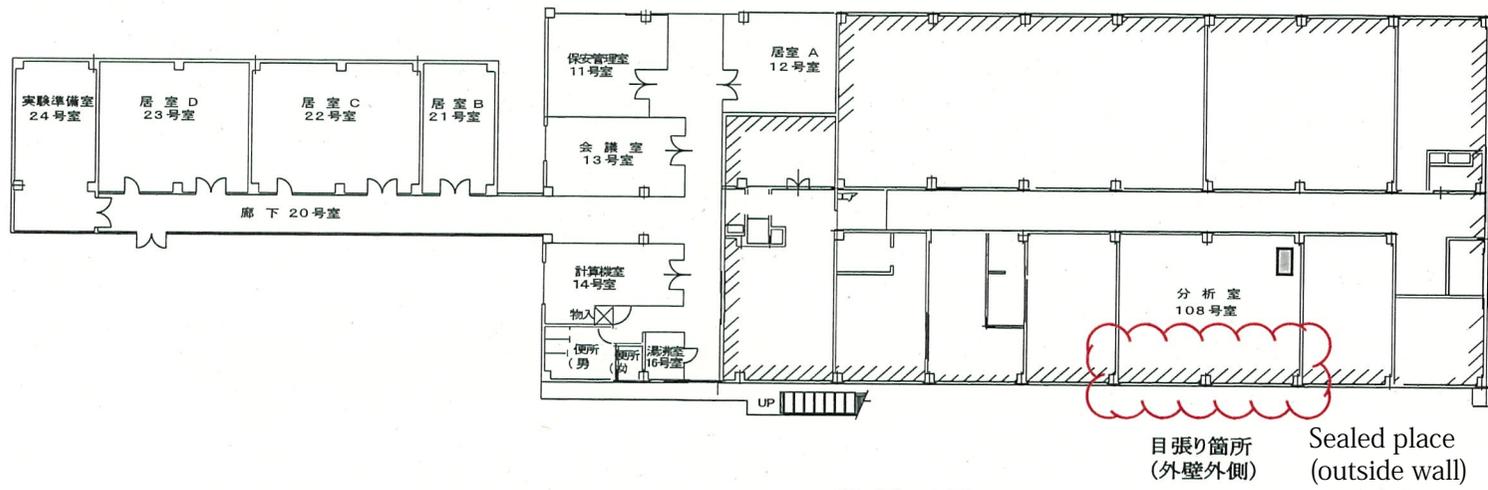
Fig.8 Sealed place

After the occurrence of the event, in order to prevent the expansion of the contamination, a greenhouse¹ (Fig. 7) was set at the entrance of the Room No. 108 to the side of the corridor and the gaps at the emergency exit of the Room No. 108 to outside of the building were sealed up from outside. The sealed place is shown in Fig. 8.

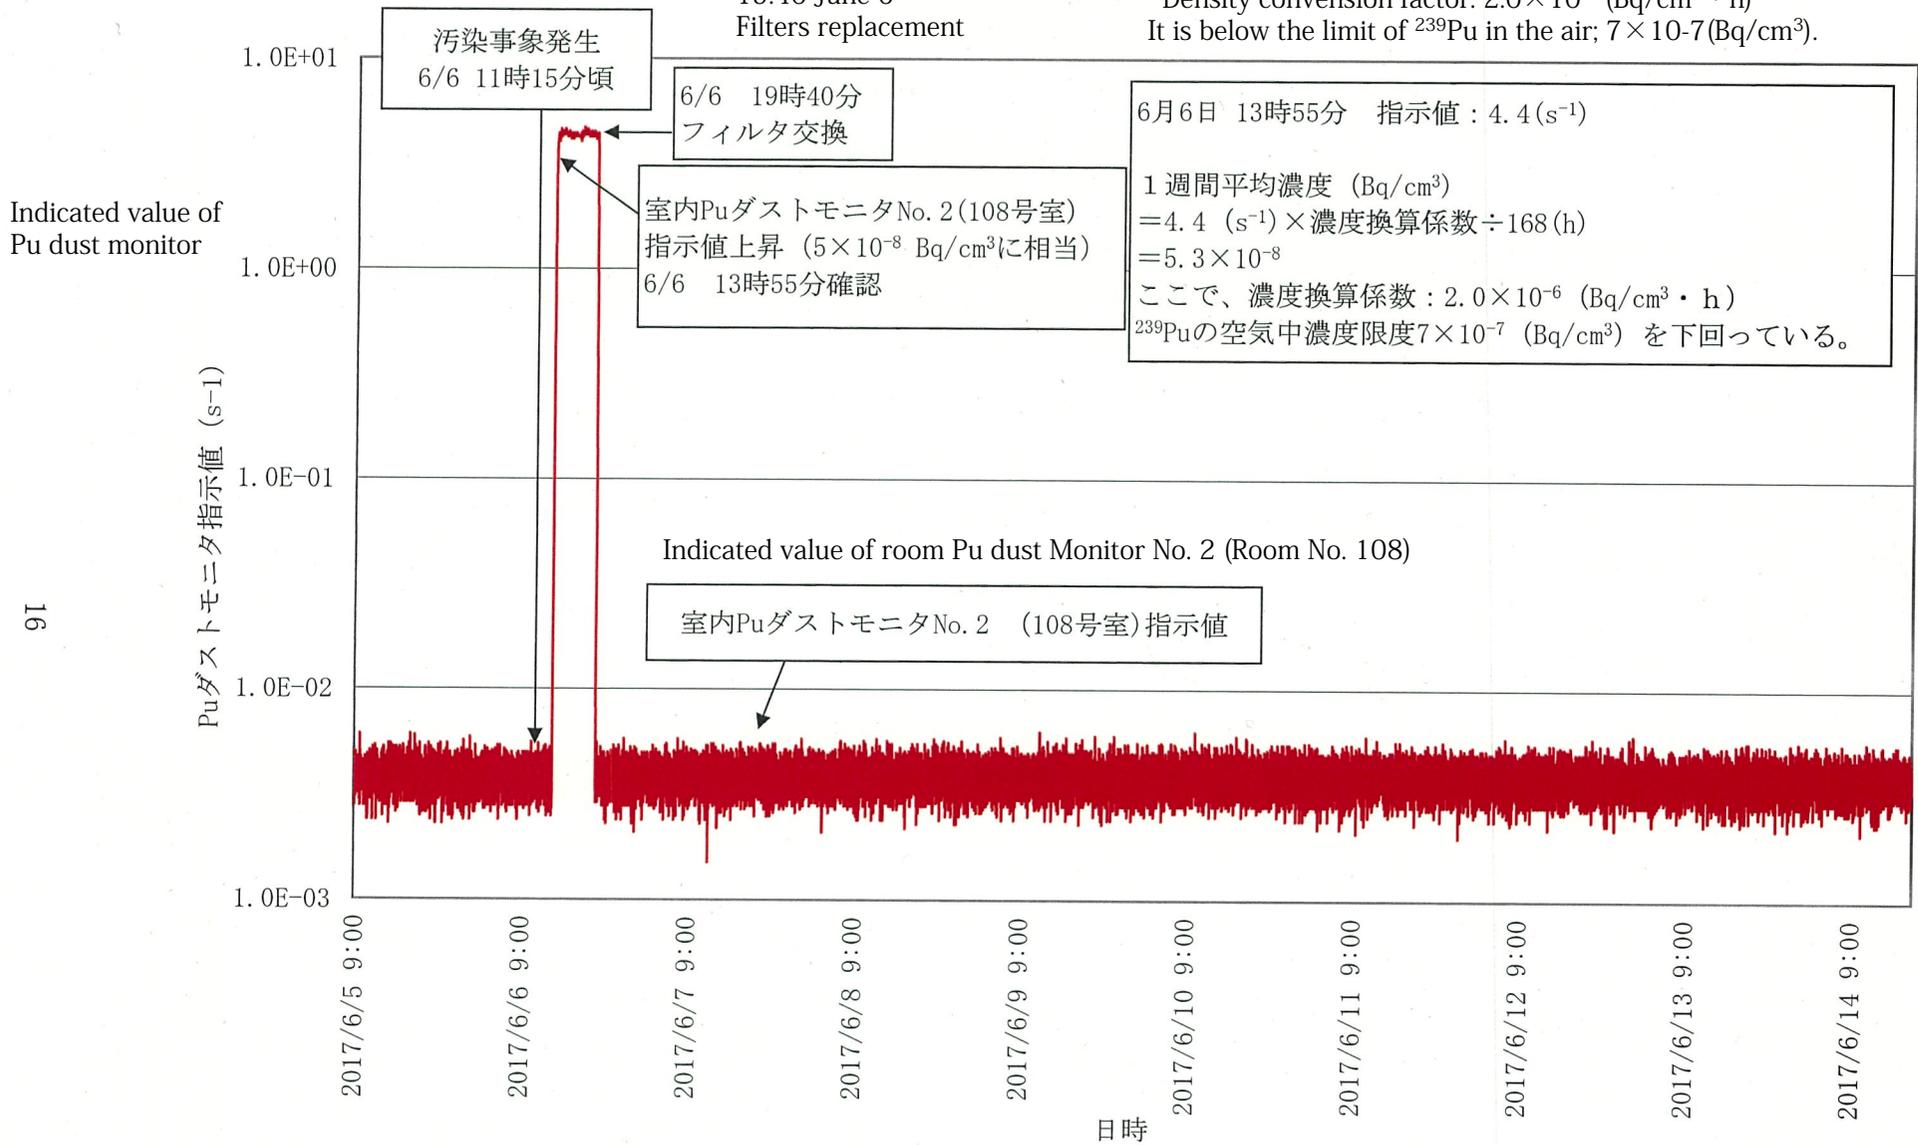
Fig.11 Indicated value trend of room Pu dust monitor No.2 (Room No. 108) at PFRF

The values indicated by the monitoring posts and the ventilation dust monitor of PFRF stayed unchanged before and after the occurrence of the event. The trend of the values indicated by the monitoring post nearest to PFRF (P-2) and the ventilation dust monitor of PFRF is shown in Fig. 9 and 10. With regard to the concentration of radioactive materials in the air of the site of occurrence, the value indicated by the dust monitor No.2 (inside the Room No. 108) (hereinafter “Pu dust monitor”) at the time of the occurrence of the event was within the normal fluctuation range. At 13:55, June 6, 2017, the value indicated by the monitor rose to 5×10^{-8} Bq/cm³ (average concentration of one week)², but there was no rise in the value subsequently. This value is lower by one digit than the air concentration limit of Pu-239 designated by the law (7×10^{-7} Bq/cm³). As a result of replacement of the dust filter of the Pu duct monitor, decline of the value to within the normal fluctuation range was confirmed. Since then the value has been within the normal fluctuation range. the trend of the values indicated by the Pu dust monitor is shown in Fig. 11.

| Date | Time | Event |
|---|---|---|
| | 20:04 | After the replacement of dust collection filters of the "Pu dust monitor No.2 (Room No. 108), the value was confirmed to be within the normal range (Since then the value remain unchanged). Ventilation dust monitor: within the normal range |

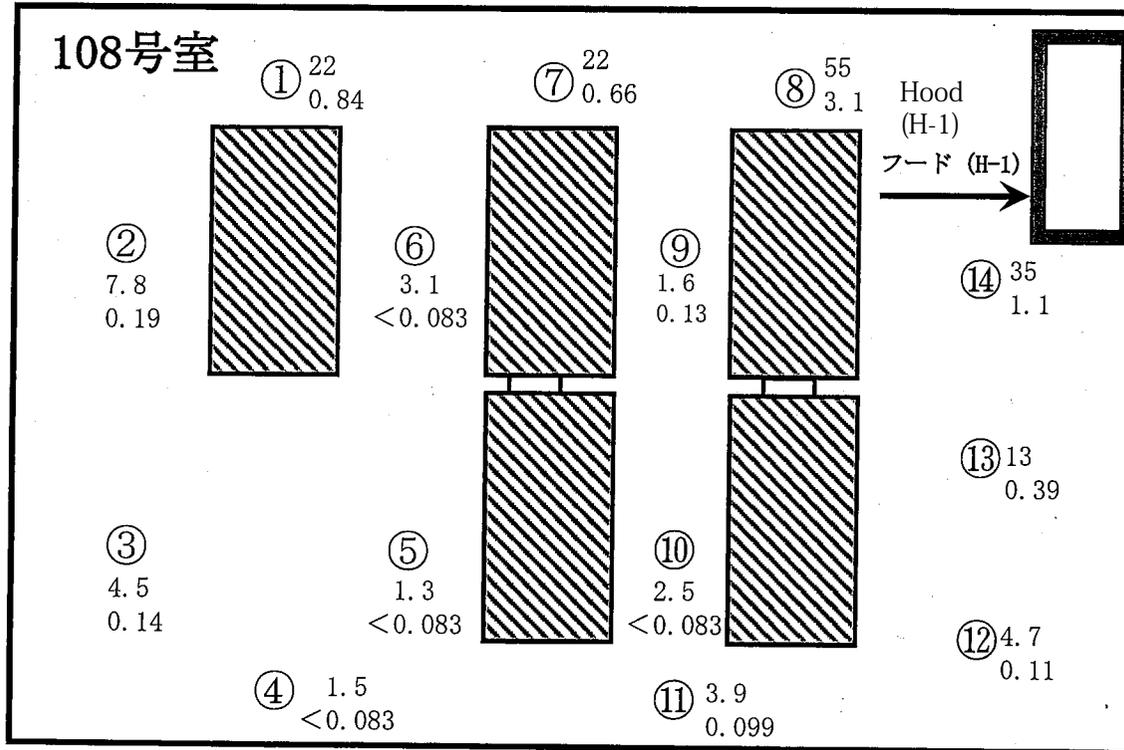
Fig. 12 Measurement results of surface density

With regard to the surface concentration of the Room No. 108, levels of contamination of 55 Bq/cm² (α ray) and 3.1 Bq/cm² (β (γ) ray) at a maximum were confirmed at 18:55 by the measurement of the floor conducted June 7, 2017. It was confirmed that there is no contamination in the corridor in front of the Room No. 108, which is in a controlled area, and the outside of the emergency exit of the Room No. 108, which is exterior of the building.

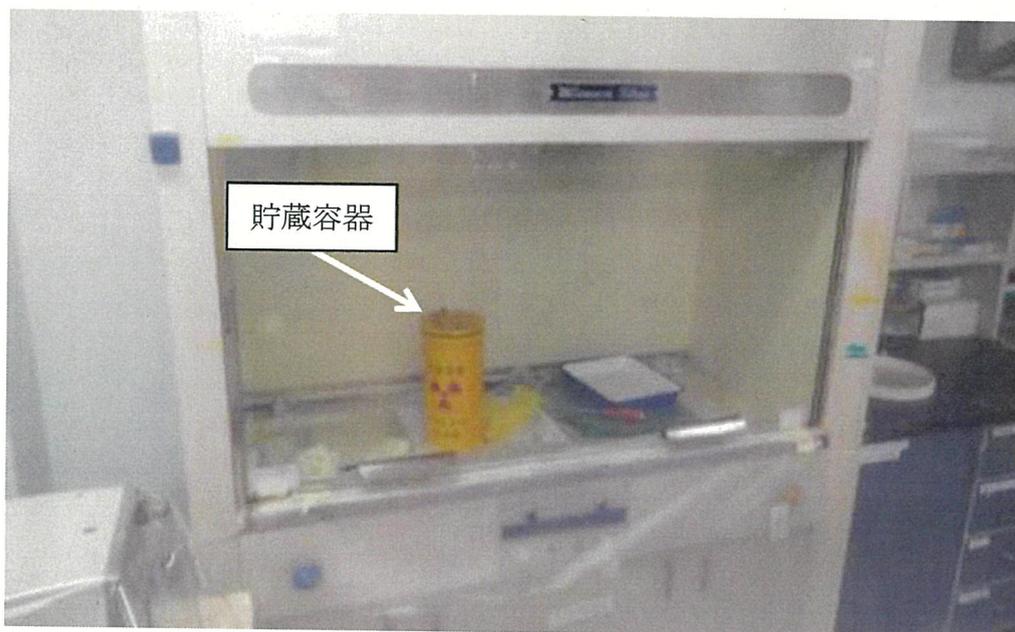
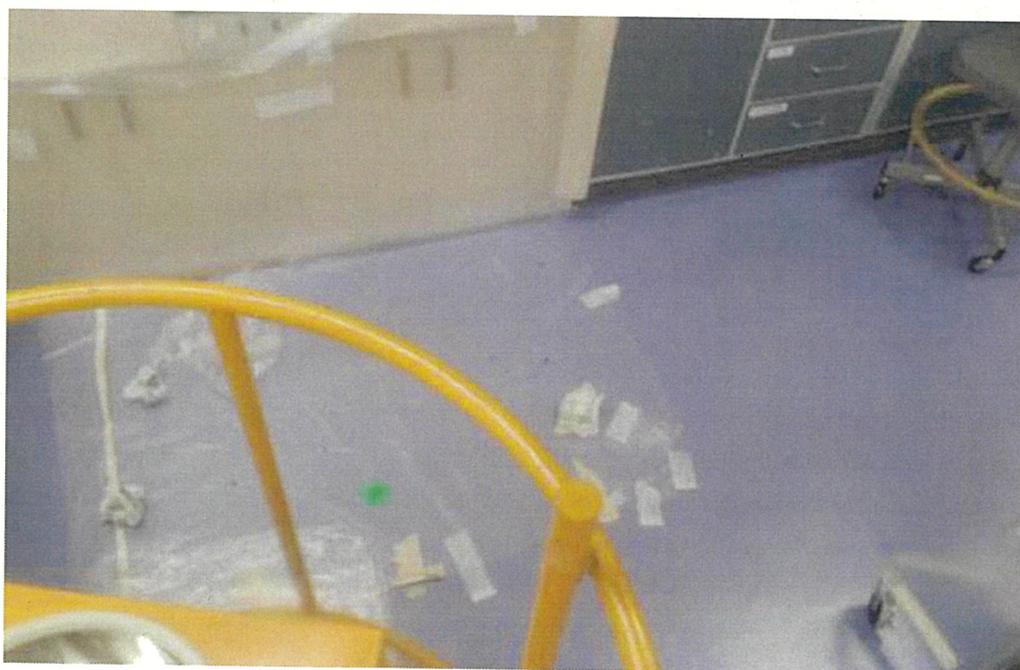
Fig. 16 Situation around the hood (H-1) after the incident occurrence

Photos of the hood (H-1) after the occurrence of the event (taken on June 7, 2017) are shown in Fig. 16. Particles assumed to have scattered from the storage container were confirmed on the floor in front of the hood (H-1). Currently, the storage container is covered with a lid and placed in the hood (H-1) shut with sliding glass doors. The storage container is monitored with TV camera through the glass doors of the hood (H-1). (Fig. 17)

フード内
Inside the hood

フード前床
Floor in front of the hood

For the restoration of the Room No. 108, which is the site of the accident, transfer of the storage container and the inside nuclear fuel materials, recovery of the scattered particles etc., detailed inspection on the state of contamination of the hood (H-1) and inside of the Room No. 108, and gradual decontamination are planned to be conducted. All the work concerning the restoration of the Room No. 108 will be carried out paying sufficient attention to safety and recording the situation of contamination etc.

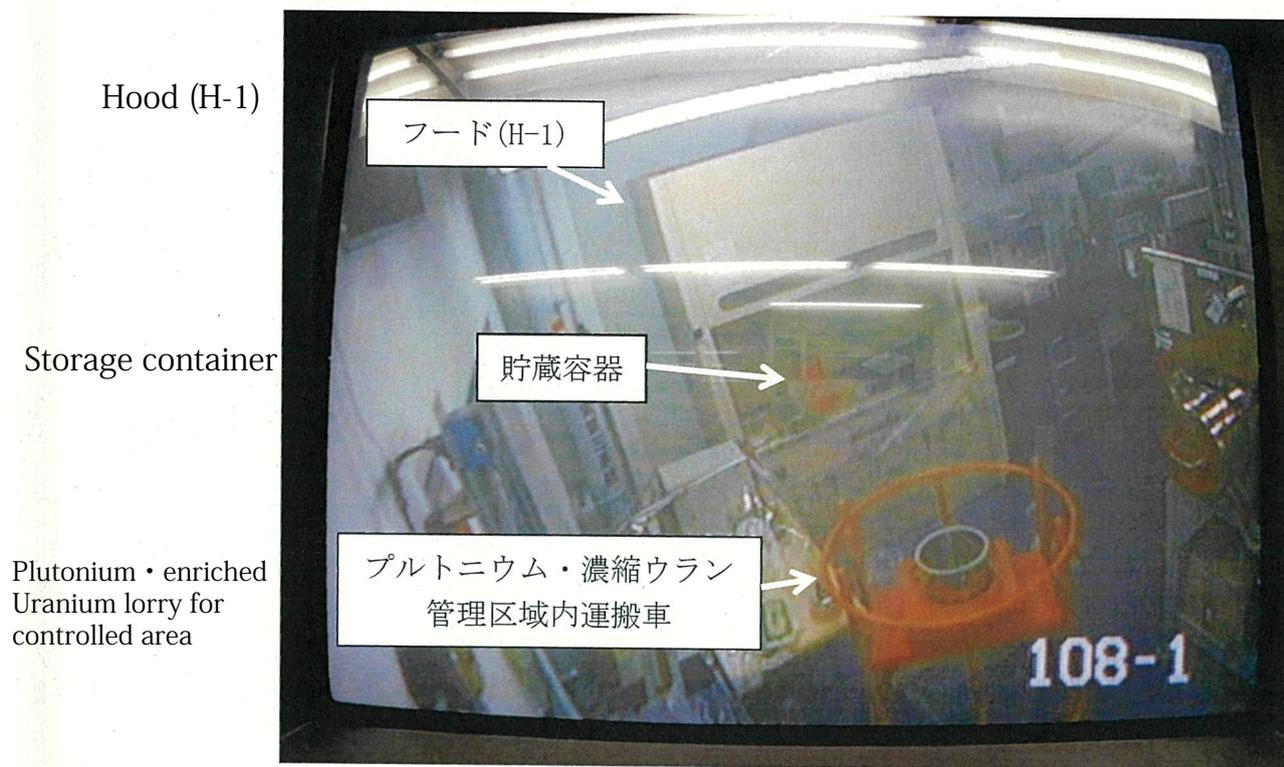
Fig. 17 Continuous monitoring of the storage container by TV camera

As mentioned in 4.2 (2), the storage container is now covered with lid and placed in the hood (H-1) shut with sliding glass doors. The storage container is being monitored through the glass doors of the hood (H-1) by TV camera. Entry to the Room No. 108 is continuously restricted, a greenhouse was set at the entrance of the room to the side of the corridor, and the gaps at the emergency exit from the room to the outside of the building were sealed up. Thus measures have been taken to prevent the expansion of contamination. The ventilation system of PFRF continuously operates as ever after the occurrence of the event to keep the normal negative pressure in the controlled area. The fluctuation of the values indicated by the ventilation dust monitor of PFRF and Pu dust monitor are within the normal range (Fir. 11, 12 and 13). Accordingly, no impact to the outside of the facility has been confirmed so far.
