図 4.1.1 大洗研究開発センター施設配置図

Fig.4.1.1 Facility layout of Oarai Research and Development Center

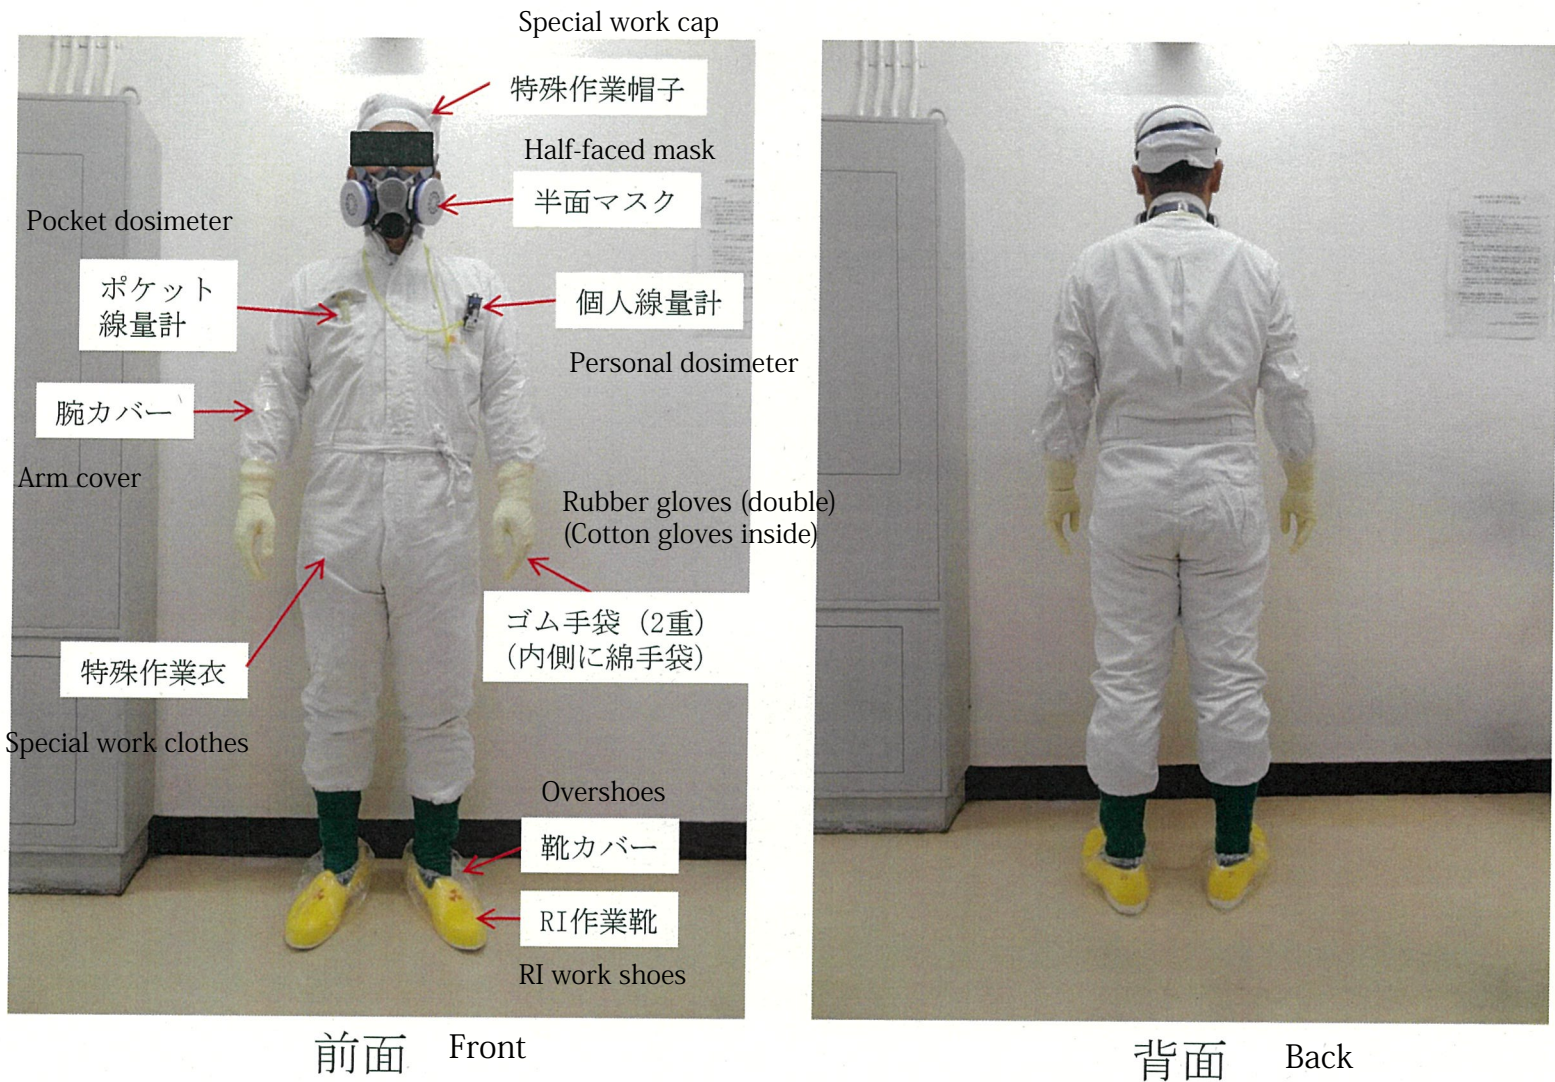
図3 事象発生時の作業員と同等の防護具を装着した状態

Fig. 4.1.5 The same protective gear which the workers put at the time of the incident occurrence

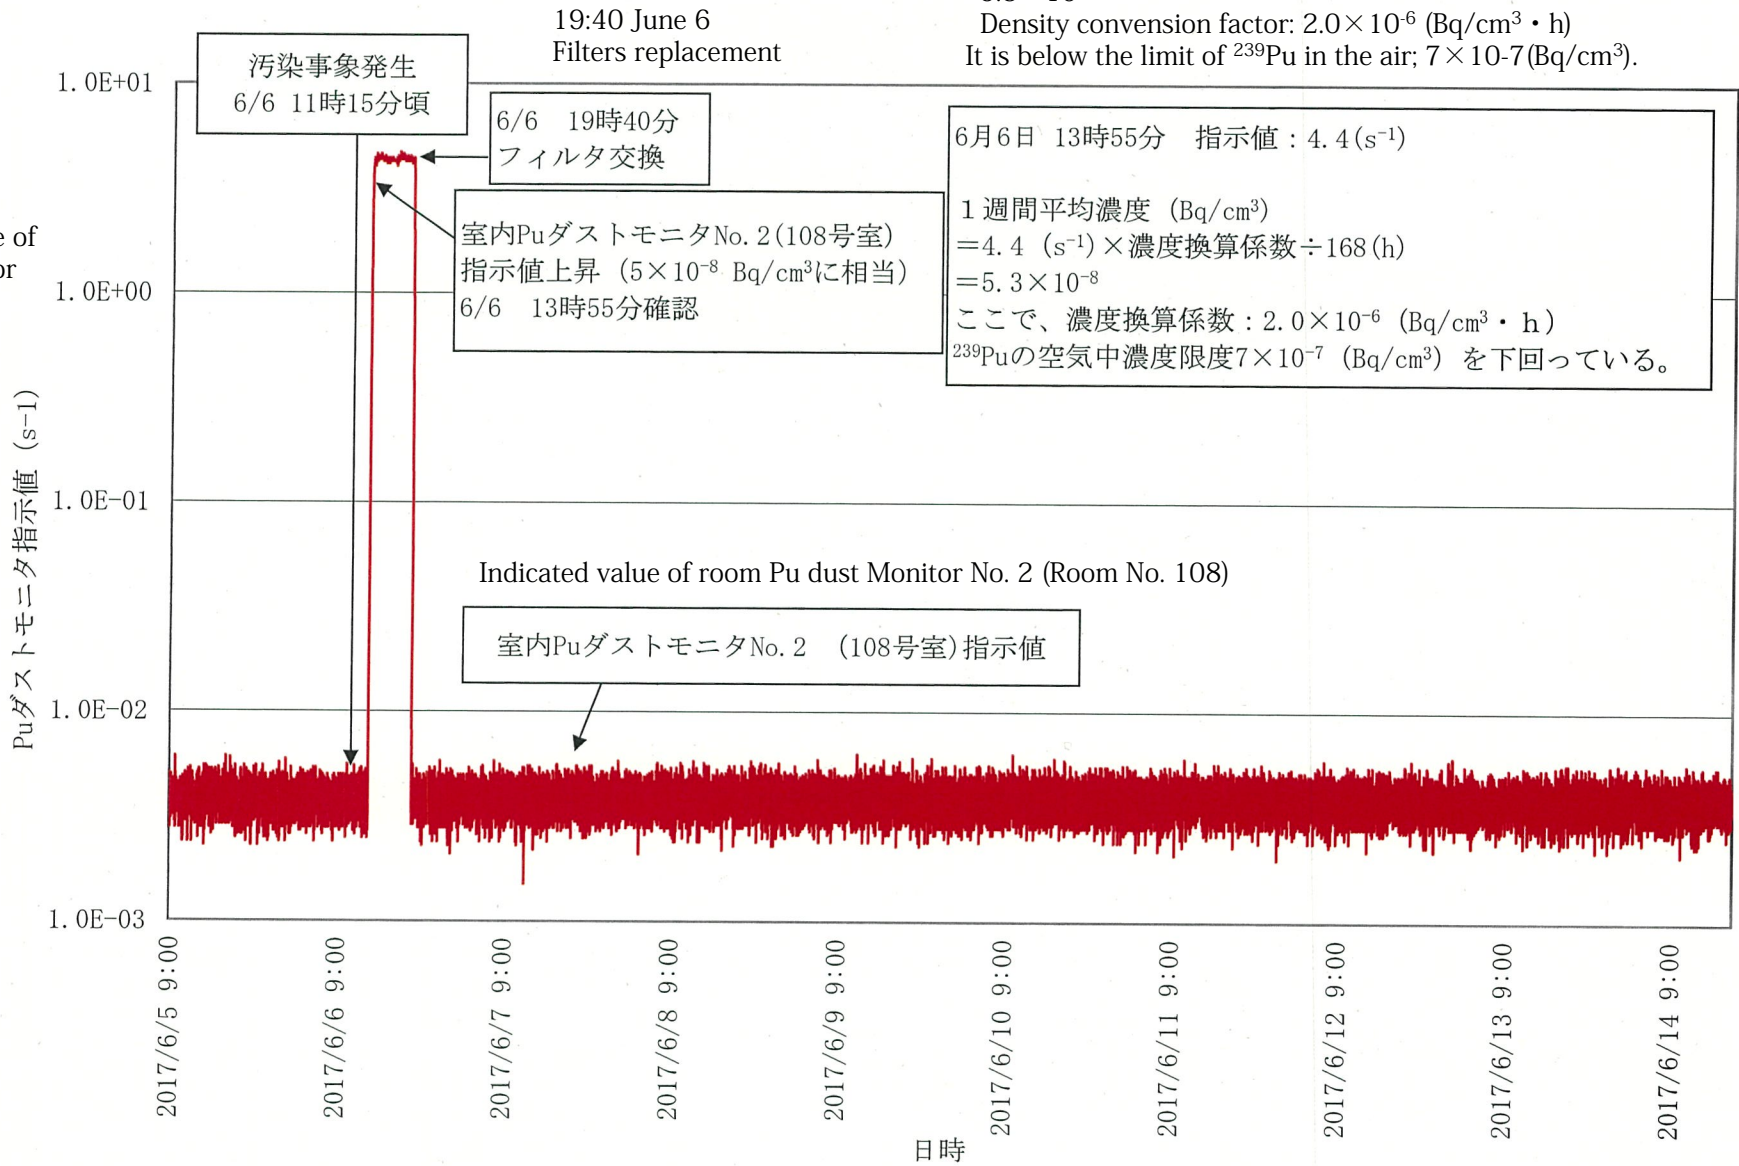
図11 燃料研究棟の室内PuダストモニタNo.2 (108号室) 指示値のトレンド

Fig.4.2.8 Indicated value trend of room Pu dust monitor No.2 (Room No. 108) at PFRF (June 5 -June 14, 2017)

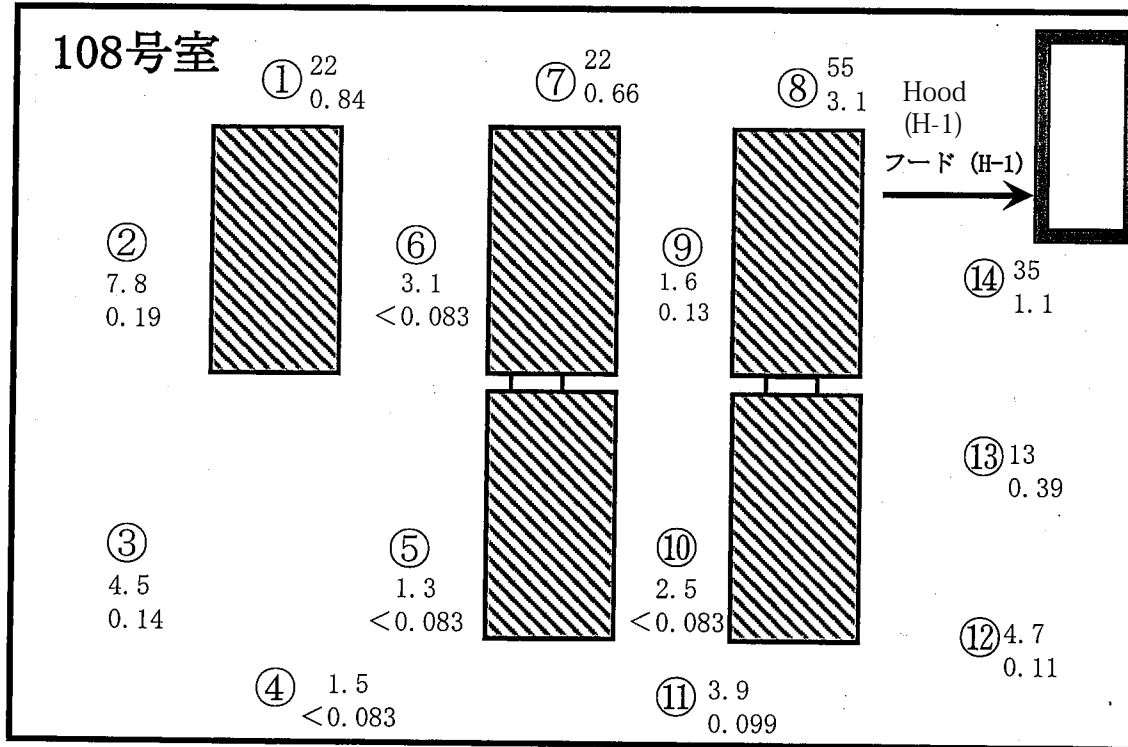
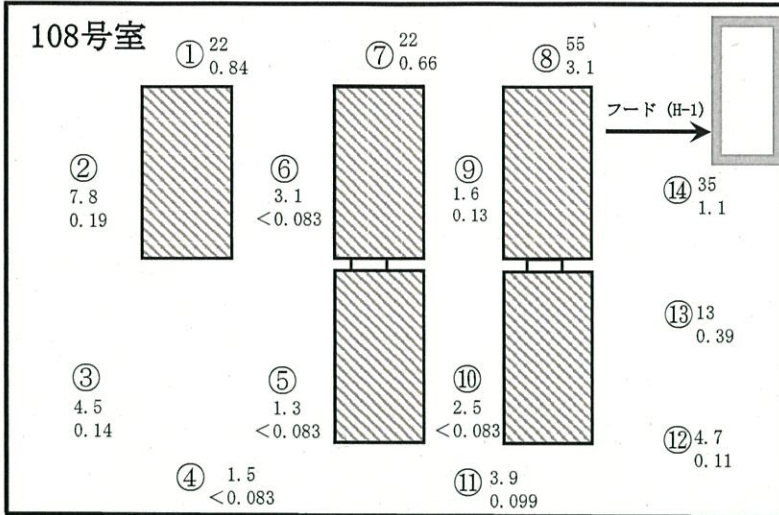
図12 表面密度測定結果

Fig. 4.2.9 Measurement results of surface density

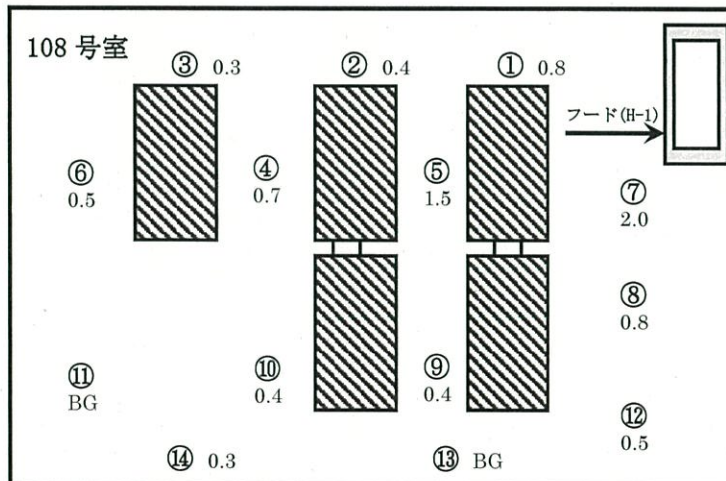
図 4.2.10 線量当量率測定記録

Fig. 4.2.10 Record of the measurement of dose equivalent

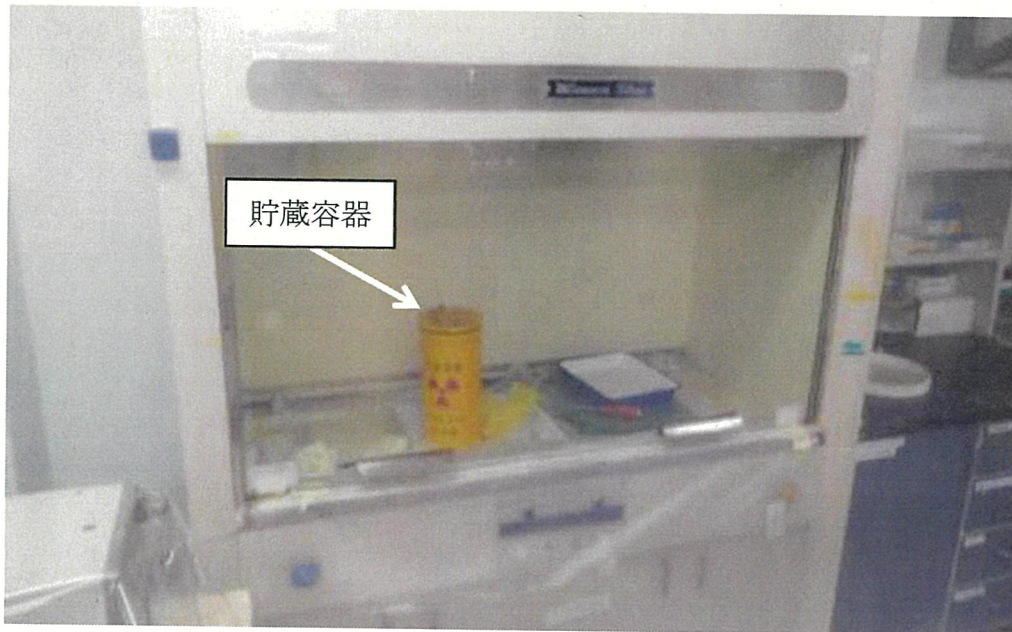
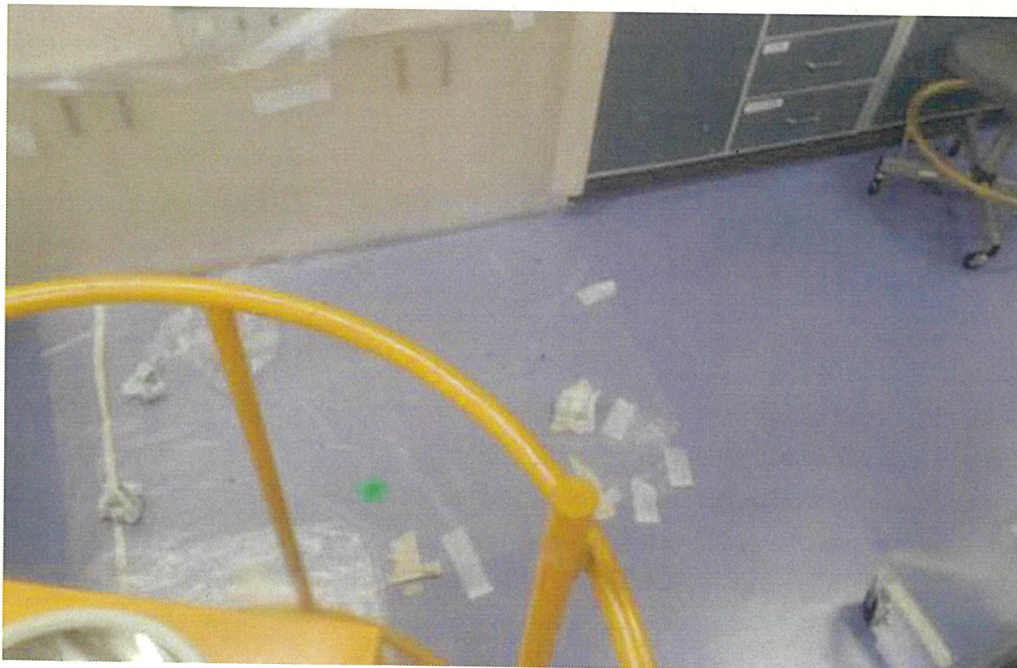
図 16 事象発生後のフード (H-1) 周辺

Fig. 4.2.14 Situation around the hood (H-1) after the incident occurrence

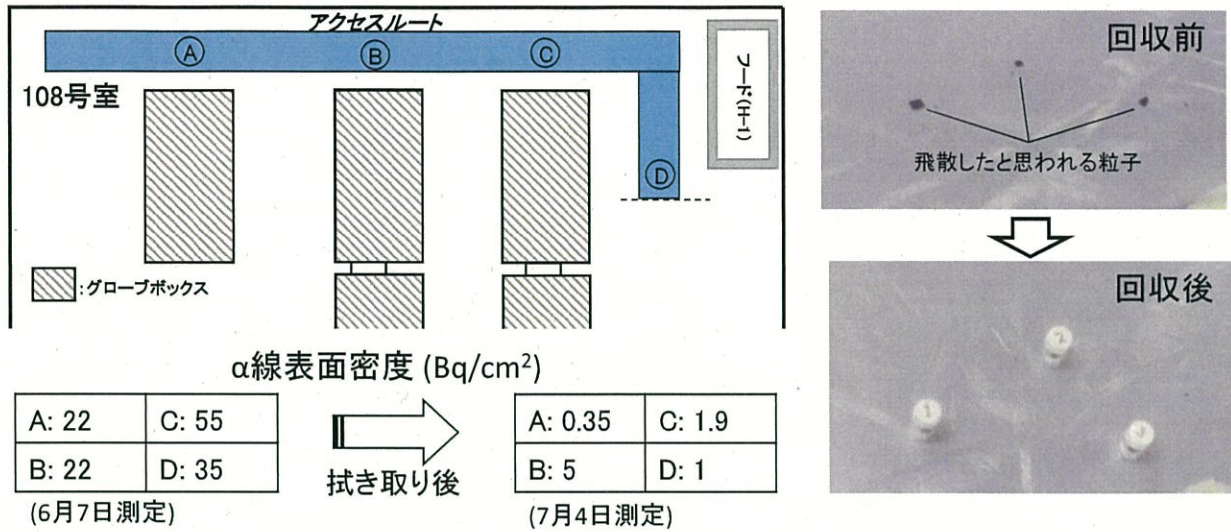
- 108号室入口からフードまでの通路について、作業員の歩行による汚染拡大・飛散防止のための床の拭き取りを実施。
- アクセスルート(床の一部)の表面密度は、床の拭き取りにより低減。
- フードから飛散したと思われる粒子については、カメラで位置情報を記録した後、位置毎にバイアル瓶の容器に回収し、金属容器に収納した。前面のビニルシートについては、折りたたんで金属容器に収納した。

図6.2.1 アクセスルート床の表面密度測定結果及び粒子回収前後の写真

フードまでのアクセスルートの確保(7月4日)

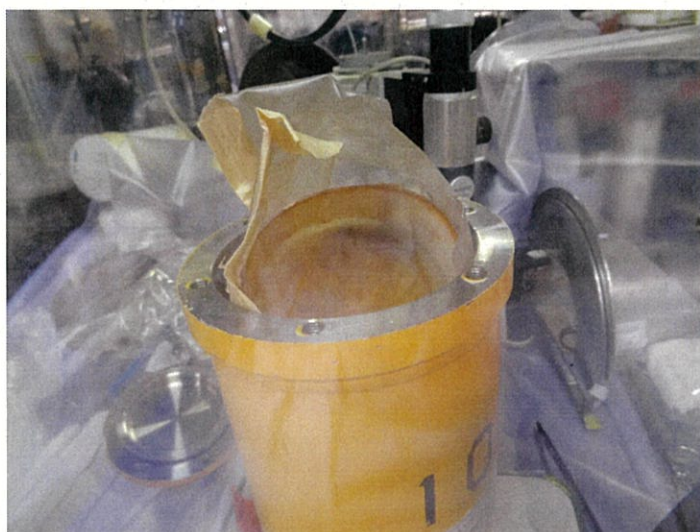
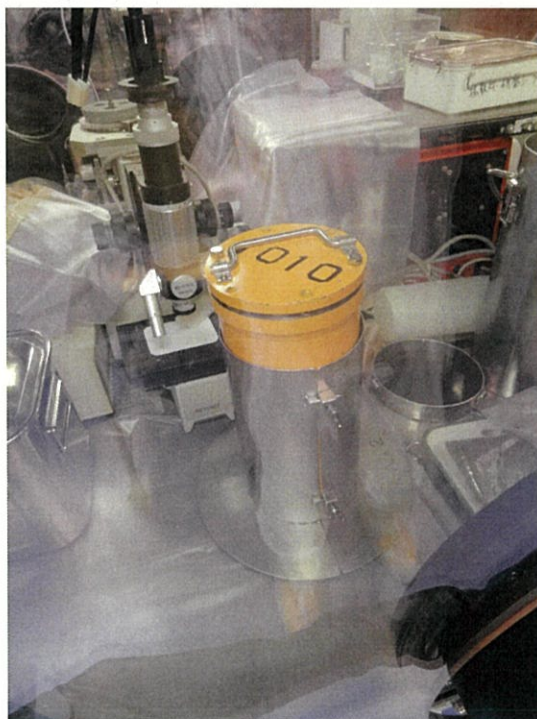
貯蔵容器の状況

グローブボックス (123-D) 搬入後の貯蔵容器の状況
(転倒防止治具取り付け後)

図 6.2.4 グローブボックス (123-D) 搬入後の貯蔵容器

Fig. 6.2.4 Storage container put in the glove box

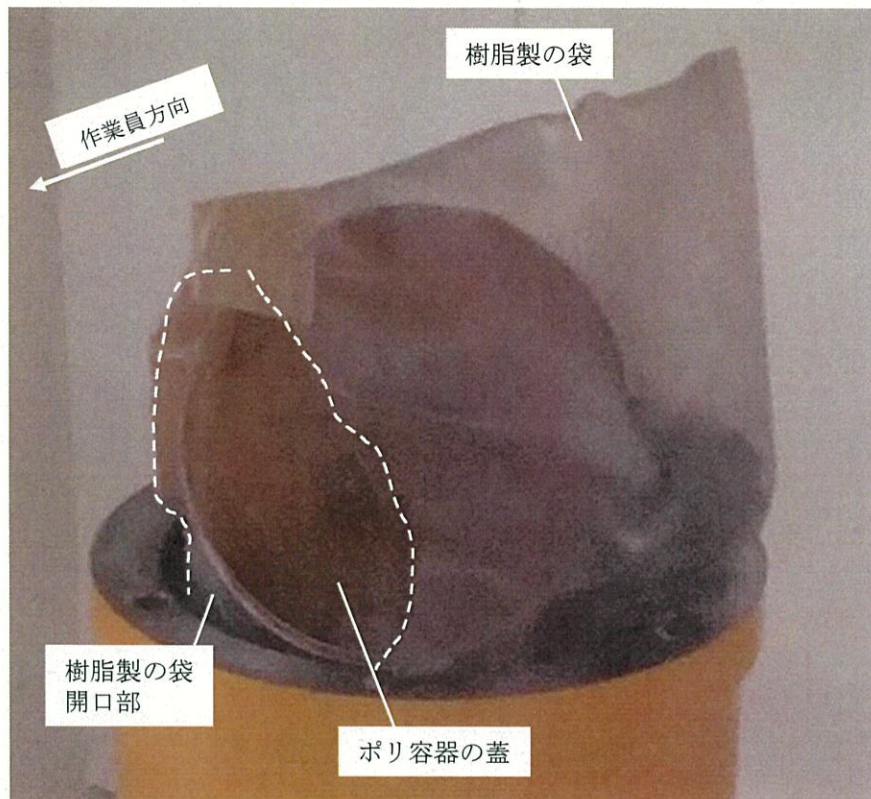
樹脂製の袋の破裂後に作業員が撮影した写真を拡大

図 6. 4. 2 樹脂製の袋の破裂後貯蔵容器上部状態

Fig. 6.4.2 Upper part of the storage container after the resin bags burst.

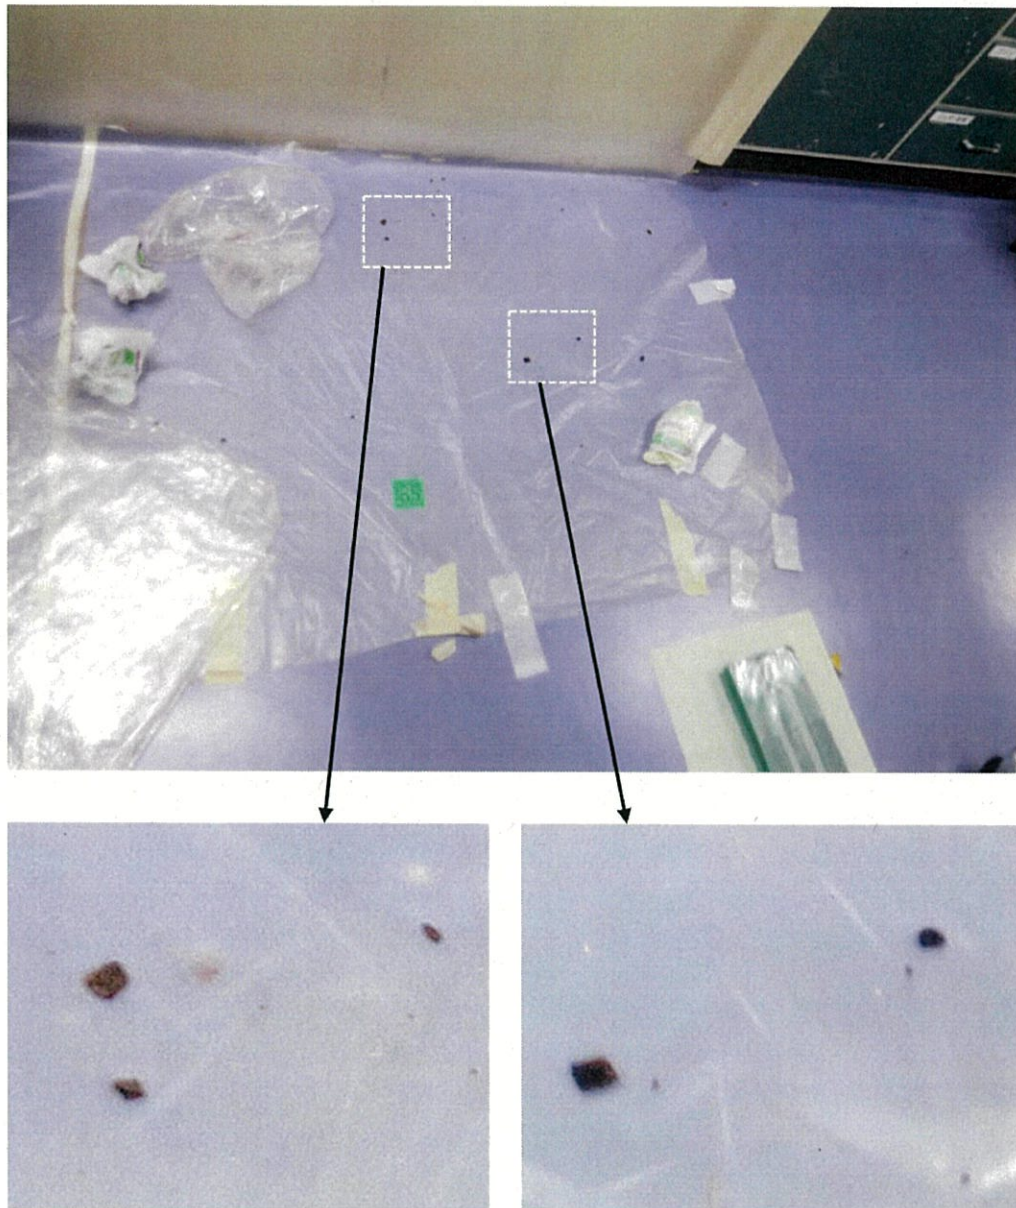
図 6.4.3 フード手前の床養生シート上に
飛散したと思われる粒子の外観

Fig. 6.4.3 Appearance of particles scattered on the curing sheet in front of the hood

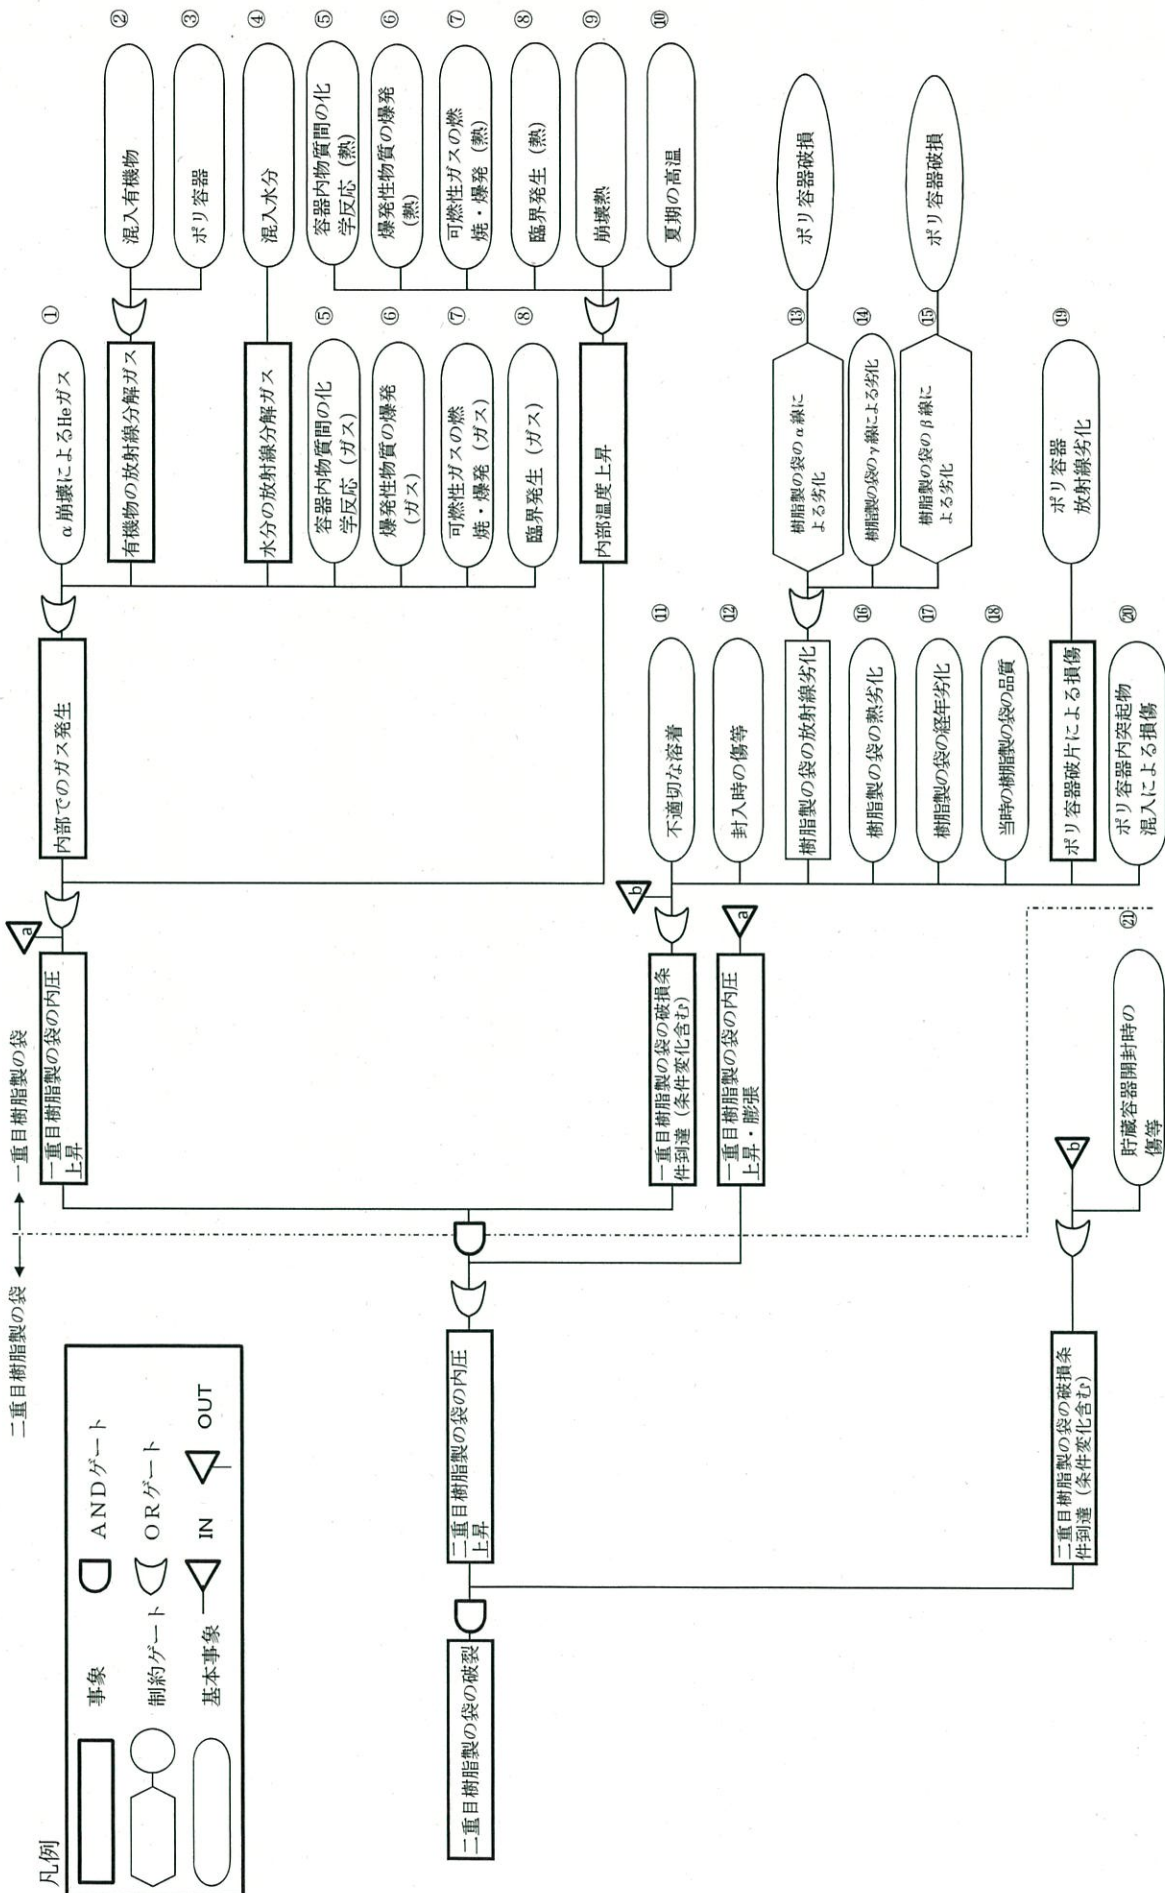
図7.1.1 樹脂製の袋の破裂要因に係るフォルトツリー図

Fig. 7.1.1 Fault tree concerning causes of the burst of the resin bags
