# Contamination at Plutonium Fuel Research Facility of Oarai Research and Development Center

# September 29, 2017 Japan Atomic Energy Agency

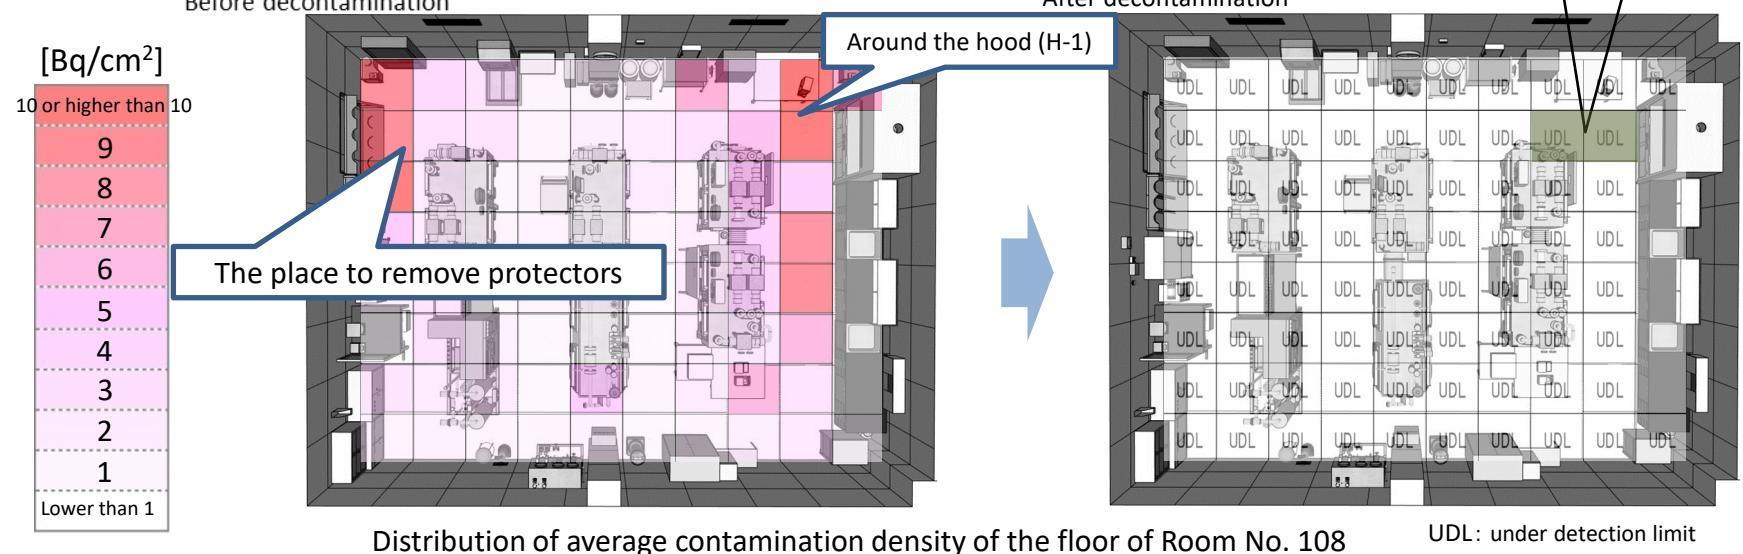
- > Confirmed contamination with high density around the hood (H-1) and the place to remove protectors.
- > Decontaminated with wet waste cloth etc. Fixed the remaining contamination with adhesive tape (right photo) and cured with plastic sheets.

- (5) Contamination test and decontamination of the walls, ceiling, glove box, etc. of Room No. 108
- Contamination test and decontamination are currently being conducted (entrance restriction to Room No. 108 will be lifted by the middle of October) Before decontamination

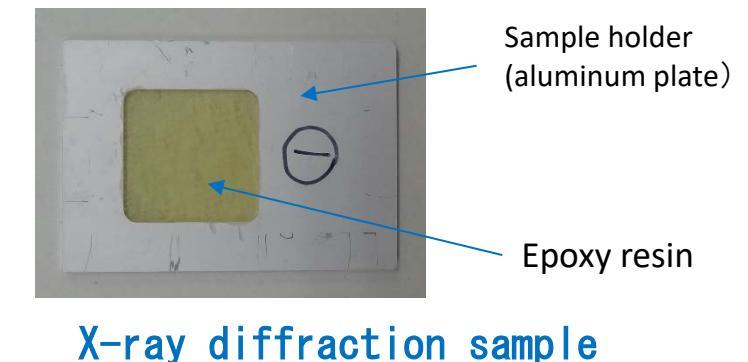
- This nuclear fuel material (resin solidified material) was put in the storage container in October 1991 in a state contained in a polyester container and then in double resin bags.

- When the lid of the storage container was opened in July 1996, inflation of the bag and damage to the bottom of the polyester container were confirmed, and therefore the packaging was redone. Since then, no document on inspection of the inside of the storage container was found until June 2017.

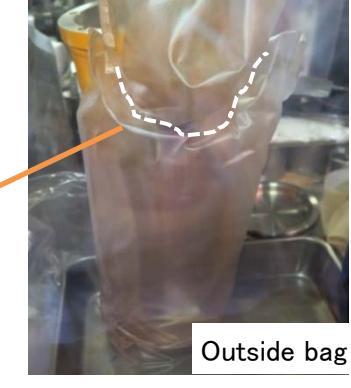
**E**Small fragments

- Interior surface of the storage container (A)
  - No entrance of foreign substances. O-ring of the lid has cracks.
- Resin bags **B**  $\geq$ 
  - The inside resin bag which is longer than the outside resin bag protruded from the outside resin bag.
  - The inside resin bag was cracked longitudinally along the side welded part.
- Polyester container **©**  $\geq$ 
  - Change in color and embrittlement. No damage.
  - The lid and the container body were fixed with paper tape, which was broken at the boundary.
- $\geq$ Contents of the polyester container (D)
  - Samples used for X-ray diffraction measurement (resin solidified material) was contained, filling the container up to 2/3 of its height.
  - Some kept almost complete shape and others were broken pieces.
  - Small fragments (E) and powders were observed at the bottom.

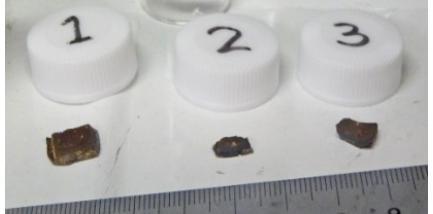
(F)Scattered material collected from the floor in front of the hood

**D**Containing situation inside

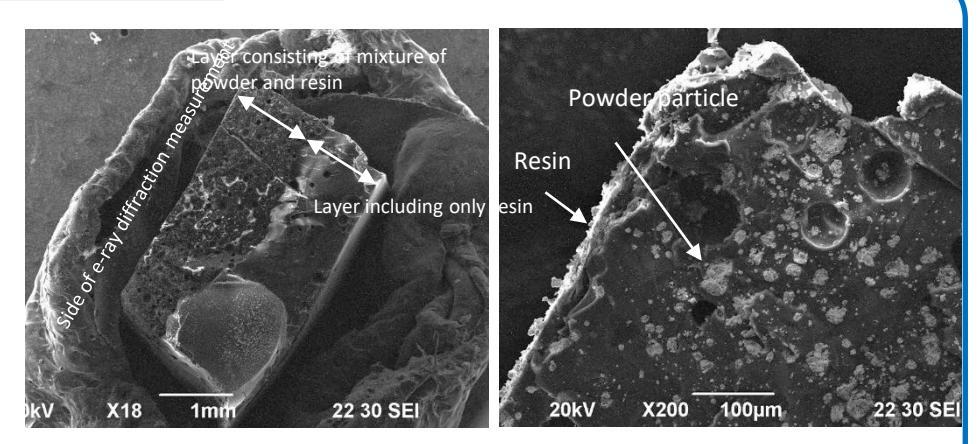
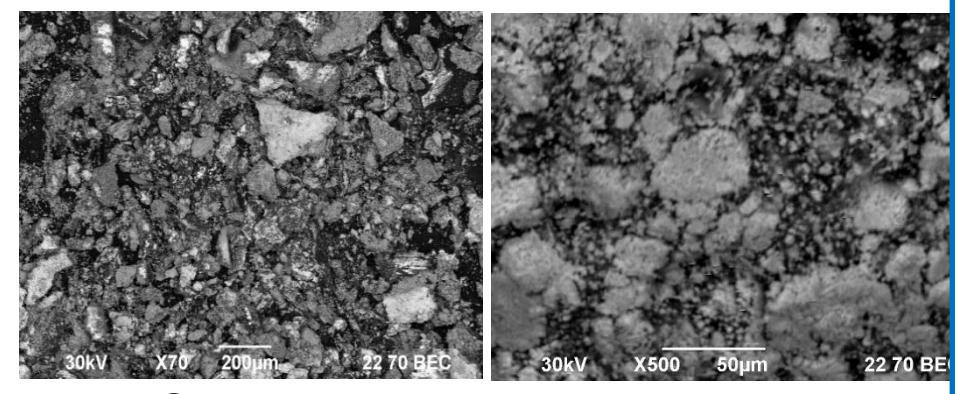
- Resin fixed material G
  - Resin fixed materials were observed and analyzed with an electron microscope and x-ray elemental analysis, dividing them in three levels of low, middle and high (range of 10  $\sim$  220µSv/h).
  - The cross-section shows two layers: a layer consisting of the mixture of resin and powder and a layer including resin only.
  - The size of the scattered powder particles spans from several micro meters to more than 50  $\mu m$  (20  $\mu m$  on average in the right image).
  - Low dose equivalent rate sample is almost only U.
- Screened powder component (H)
  - The size of the powder particles expand from 1  $\mu m$  to 300  $\mu m.$

- The ratio U/(U+Pu) is 0.8±0.1 at most analysis points.
- By X-ray diffraction, carbide was confirmed in addition to oxide.
- The powder components were presumed to be small elements breaking away from the resin fixed material, instead of resin fixed material treated with oxide heating, as the screened powders included resin and carbide.
- Scattered material
  - Powder particles were dispersed as well as resin fixed materials, and they were confirmed to be the pieces of the resin fixed materials.

- (H) Observation image of powder component (left: low magnification, right: high magnification)
- Other
  - Detected metal elements other than U and Pu are small amount of Ni added in the process of research, rare-earth Sm, etc.

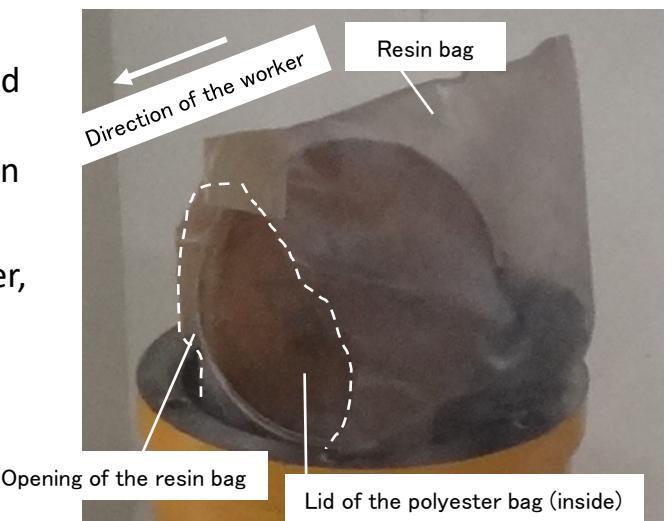
(2) Photo of the storage container taken by a worker

- The resin bag comes out from the top edge of the storage container, and opening of the bag is made along the side of the bag in a way to split in the vertical direction. The opening made by the burst faces the direction of the worker, and it is correspond with the statement of the worker.
- The cylindrical material seen in the bag is a lid of the polyester container, which is according to the worker upside down. The side visible is the inside of the lid.

Enlarged photo taken by the worker at the time of the burst of the resin bag

(The side of the bag was partially damaged in a way to split in the vertical direction)

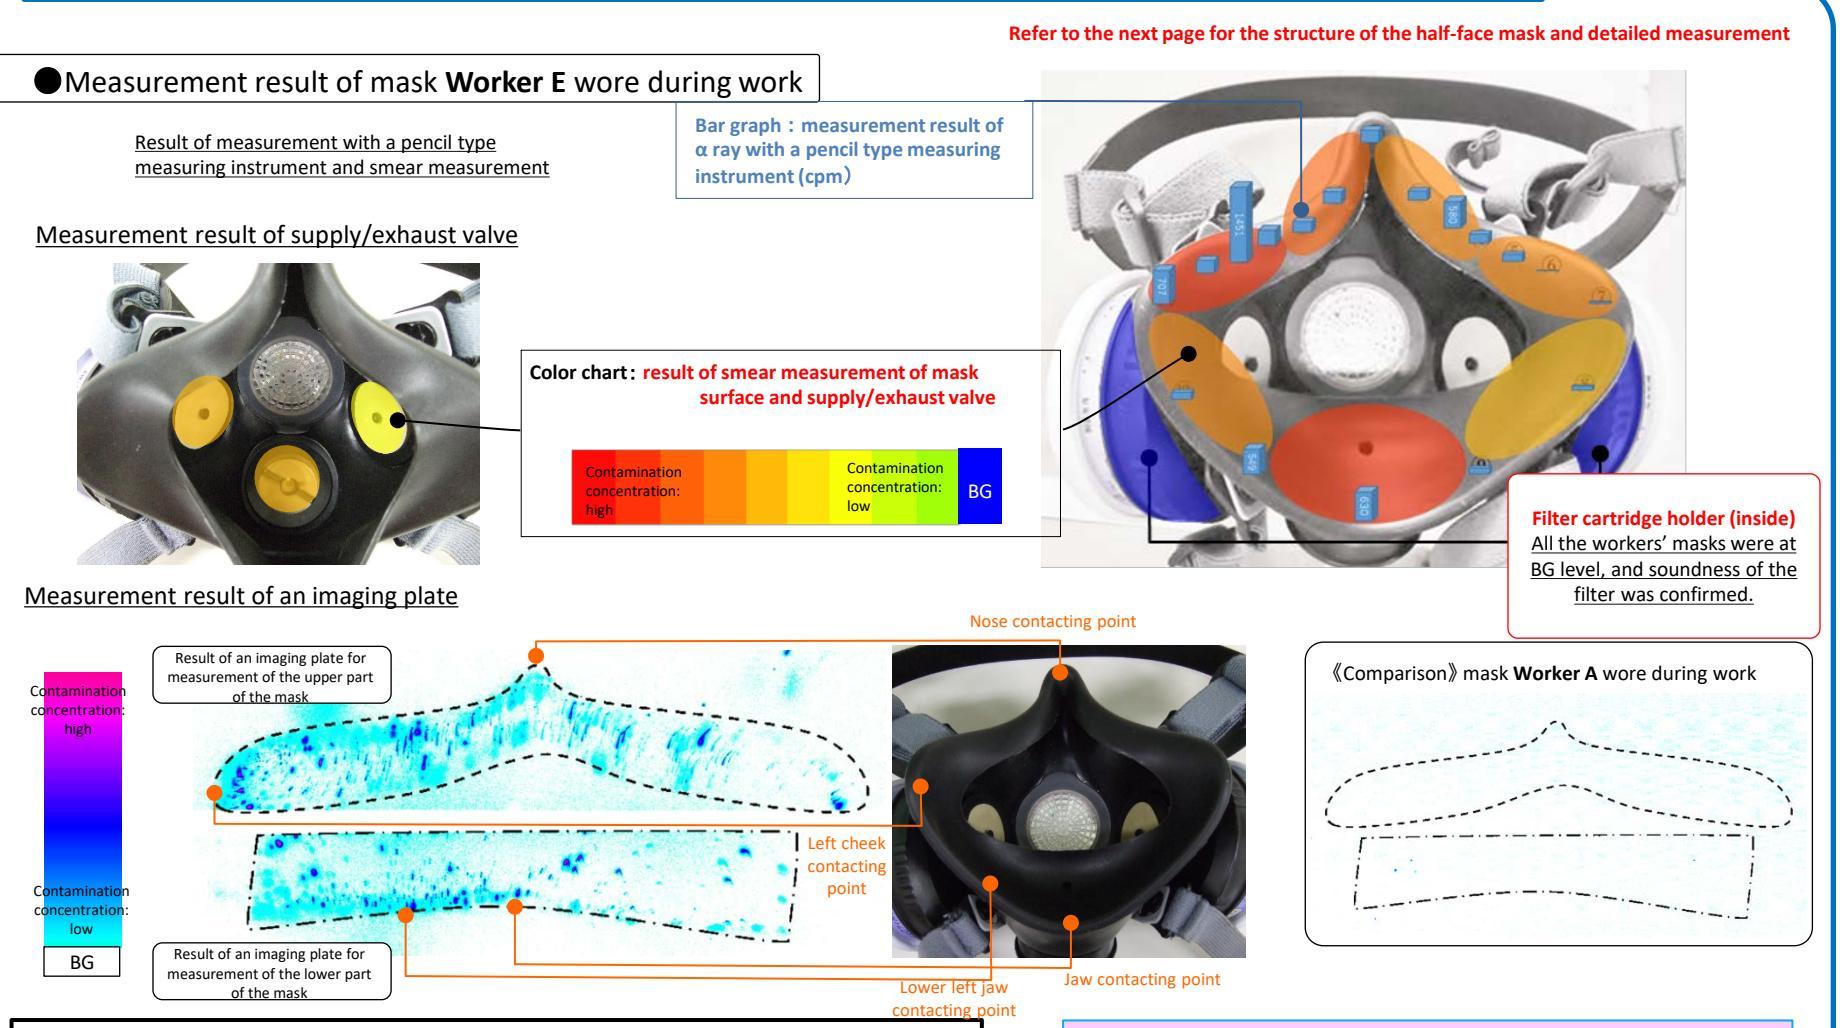
# Measurement and analysis of half-face mask for investigating probable causes

From the surface of the half-face mask Worker E was wearing during the work, highly concentrated contamination was detected at the points where the left cheek bone and lower left jaw contact. Also, the entire surface was widely contaminated, and intrusion into the inside of the half-face mask was confirmed of the contamination that had entered the face contacting points.

Based on the interview with the workers and analyzation of the factors, it is presumed that Pu particles the workers got contact with at the time of the burst and contamination that had adhered to the face entered the gaps between the mask body and the face, and thus internal exposure was caused.

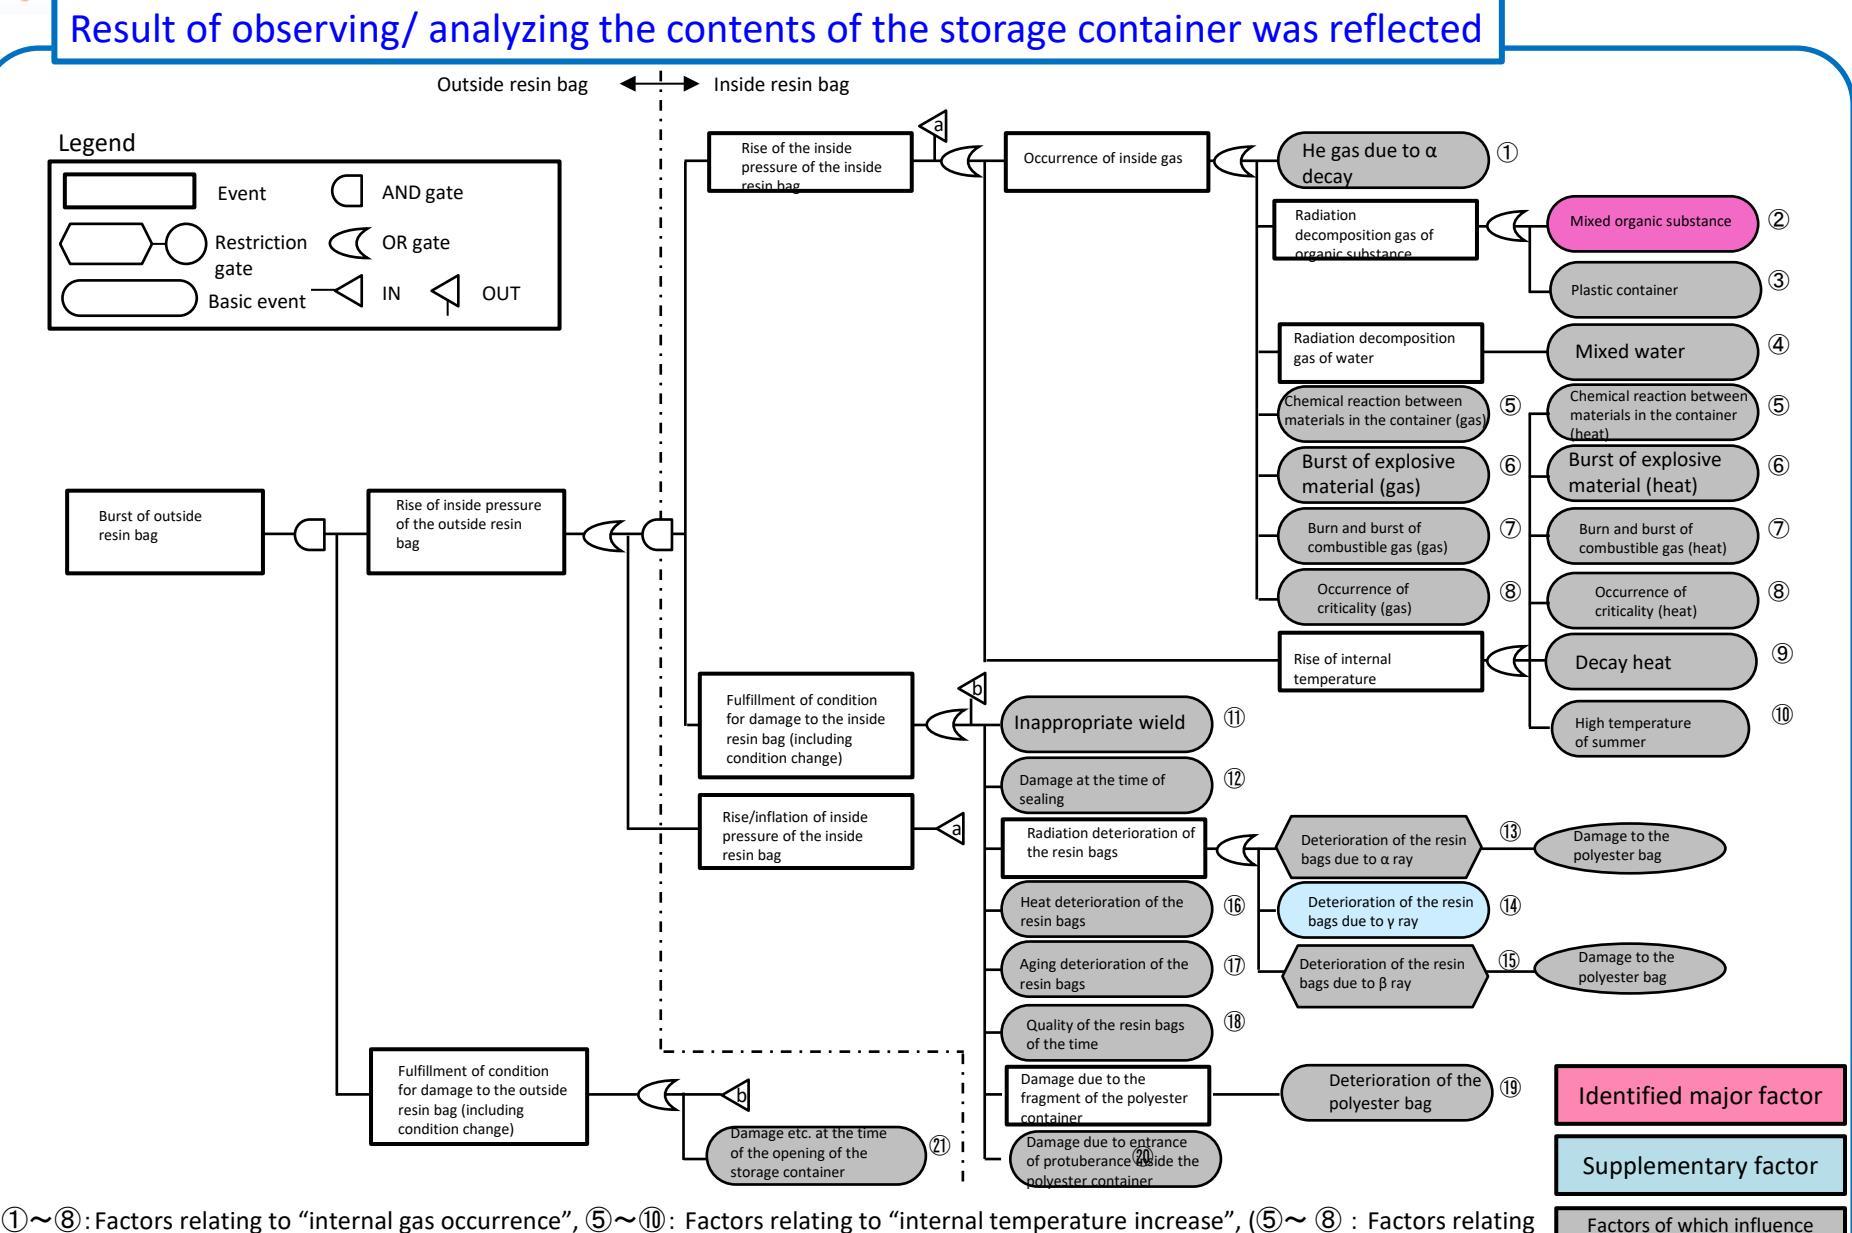
# Cause for the burst of the resin bags(1) fault tree

$(1 \sim 8)$ : Factors relating to "internal gas occurrence",  $(5 \sim 1)$ : Factors relating to "internal temperature increase",  $(5 \sim 8)$ : Factors relating to "internal gas occurrence" and "internal temperature increase"),  $(1 \sim 2)$ : Factors relating to "fulfillment of condition for damage to the inside resin bag (including condition change"

were evaluated as low

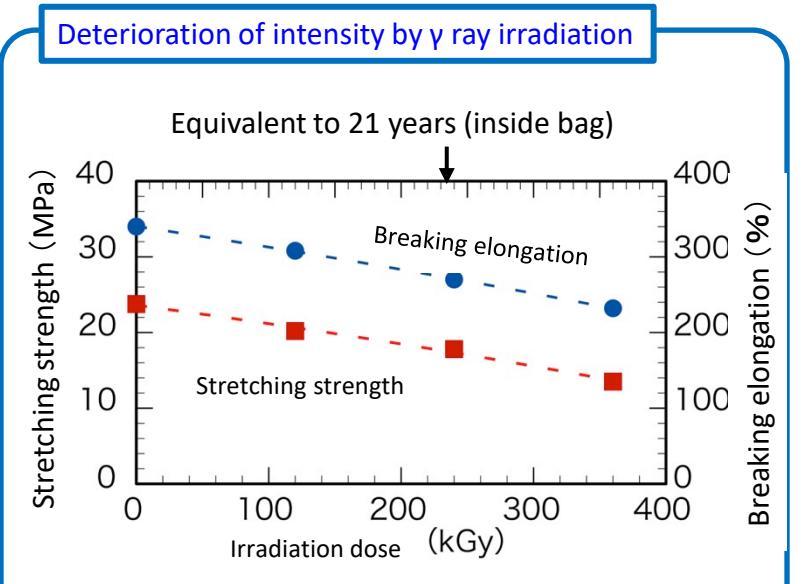
• Stretching strength and breaking elongation of the resin bag deteriorates almost in proportion to the amount of irradiation dose.

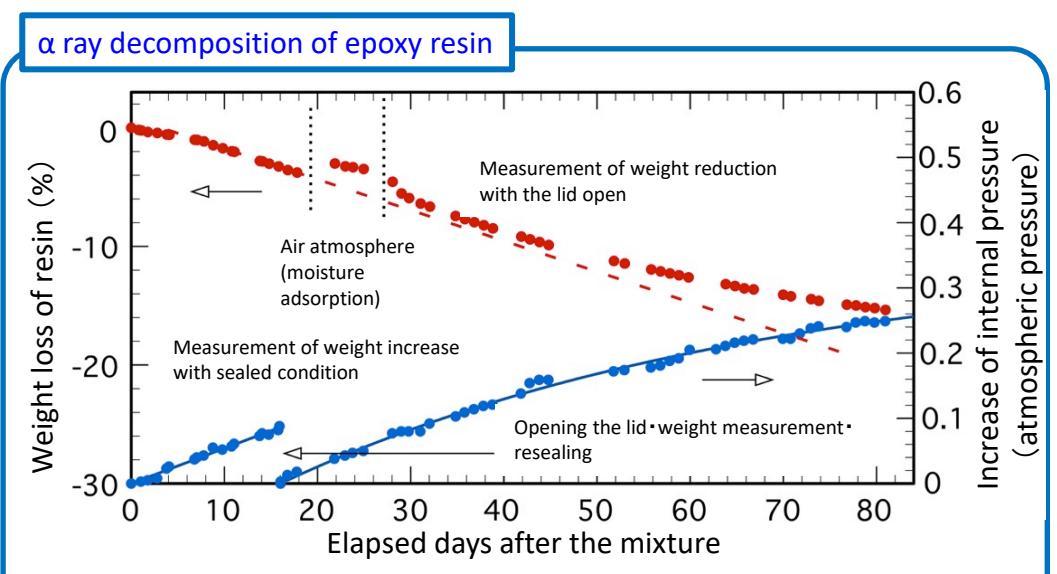
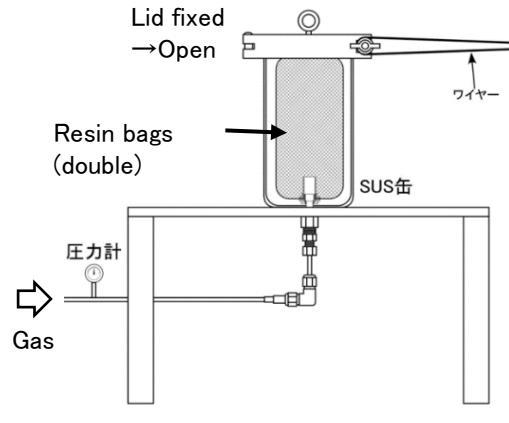
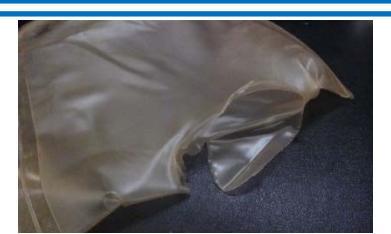
Fig. 1 Outline of the test (top: outside ba

- In the test, pressure was applied to double resin bags contained in a metal container, and then the lid was opened. The process of burst and damage was observed. (Fig. 1)
- The damaged state of the resin bags deteriorated by γ ray irradiation was reproduced with the internal pressure at 2.5 atmospheric pressure or higher. (Fig. 2: Internal pressure was applied at 4 atmospheric pressure. The outside bag has opening at the top and the inside bag has one at the welded part.)

As a result of solidifying the mixture of Curium (Cm) with short half-life and epoxy resin and testing, the weight of the solidified mixture decreased due to α ray decomposition and gas was generated. The gas generation slowed down as the decomposition of resin proceeded. The result was reflected in the evaluation of generated amount of gas during storage period.

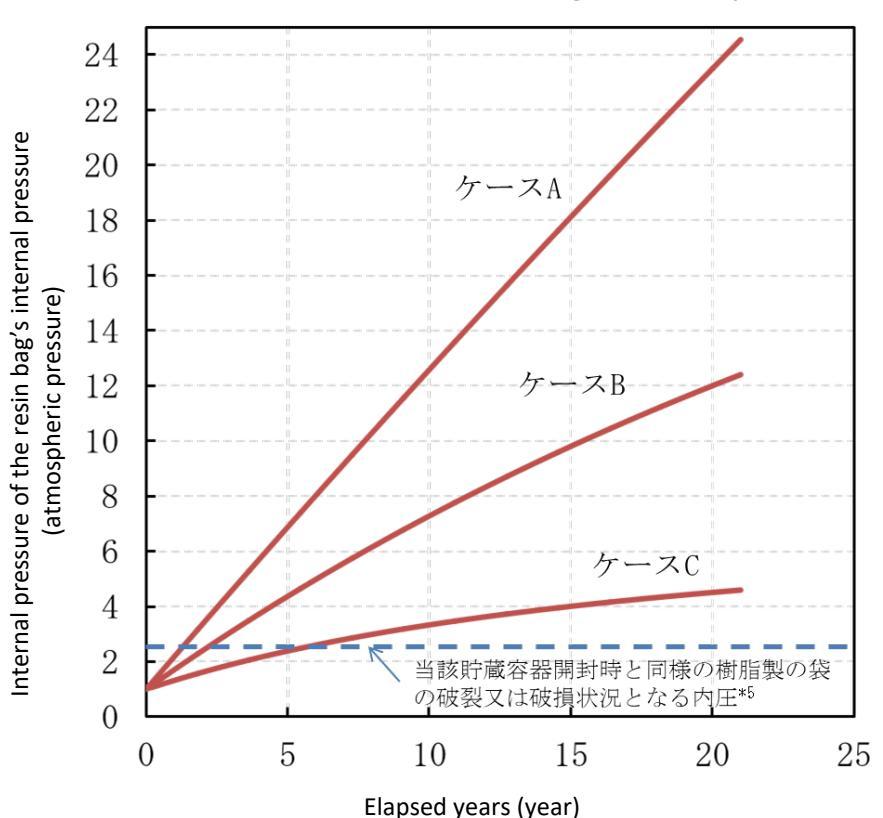
• While evaluation values vary widely depending on the calculation condition, due to the generated gas, the internal pressure exceeds the breaking pressure of the resin bags (within the range of pressure that can break the bags)

- \*5 In the burst test, the internal pressure that causes burst of or damage to a resin bag in the similar condition with the one in the storage container when it was opened was 2.5 atmospheric pressure or higher. It is considered that there is a margin of error due to similar condition etc., and burst is considered to occur at 2.5 atmospheric pressure or higher. This burst pressure is equivalent to the condition which simulates the deterioration of the bag through γ ray irradiation for 21 years.

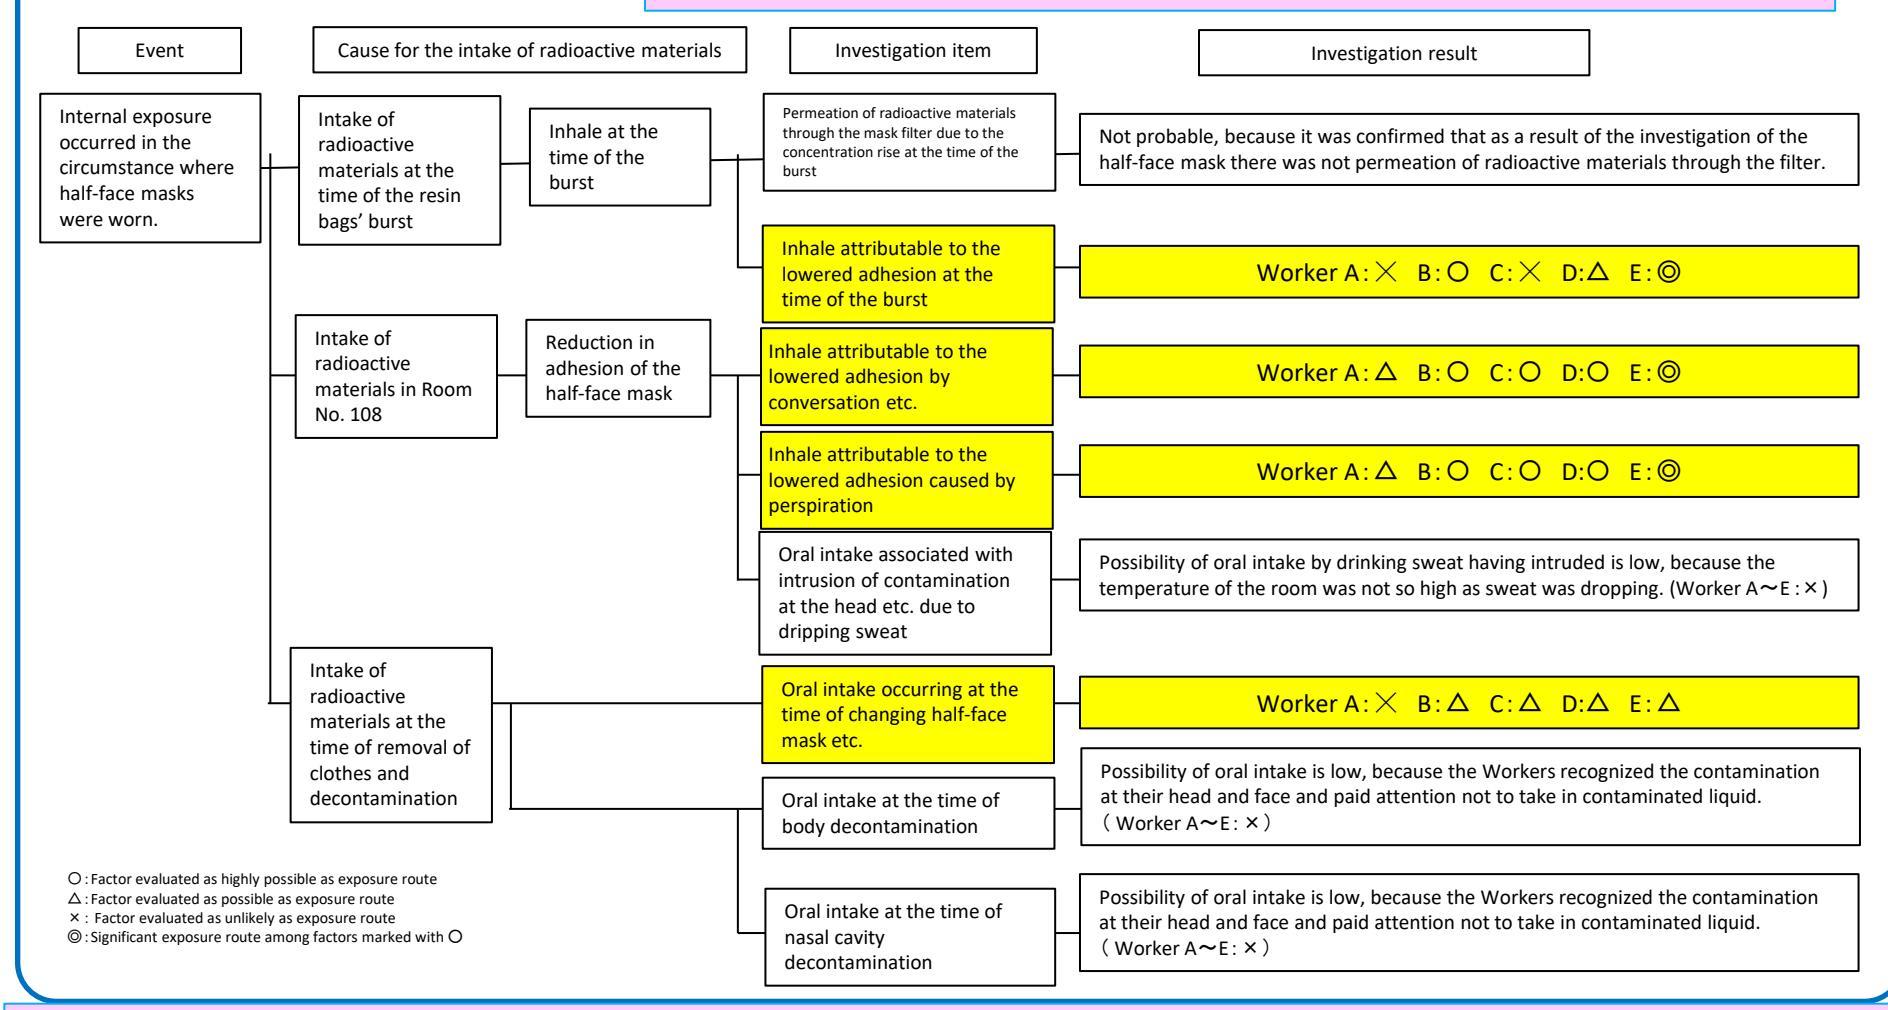
Factors were identified with respect to each of the stages where exposure was suspected, and based on the result of interview, investigation of contamination situation, etc. possibility was determined.

• It is highly possible that due to the reduction in adhesion of half-face mask caused by the burst of the bags, conversation, perspiration, etc., radioactive materials such as Pu that had adhered to the face etc. entered inside the mask through the part of the mask contacting with the face, and thus they took in radioactive materials by inhale.

• It is possible that the Workers took in radioactive materials such as Pu that had adhered to the head and face when changing the half-face mask at the time of removal of clothes.
