Radioactive contamination at Plutonium Fuel Research Facility (PFRF) in Oarai Research and Development Center (Follow-up)

Japan Atomic Energy Agency

Radiation exposure to workers at Plutonium Fuel Research Facility (PFRF) (Chronology)

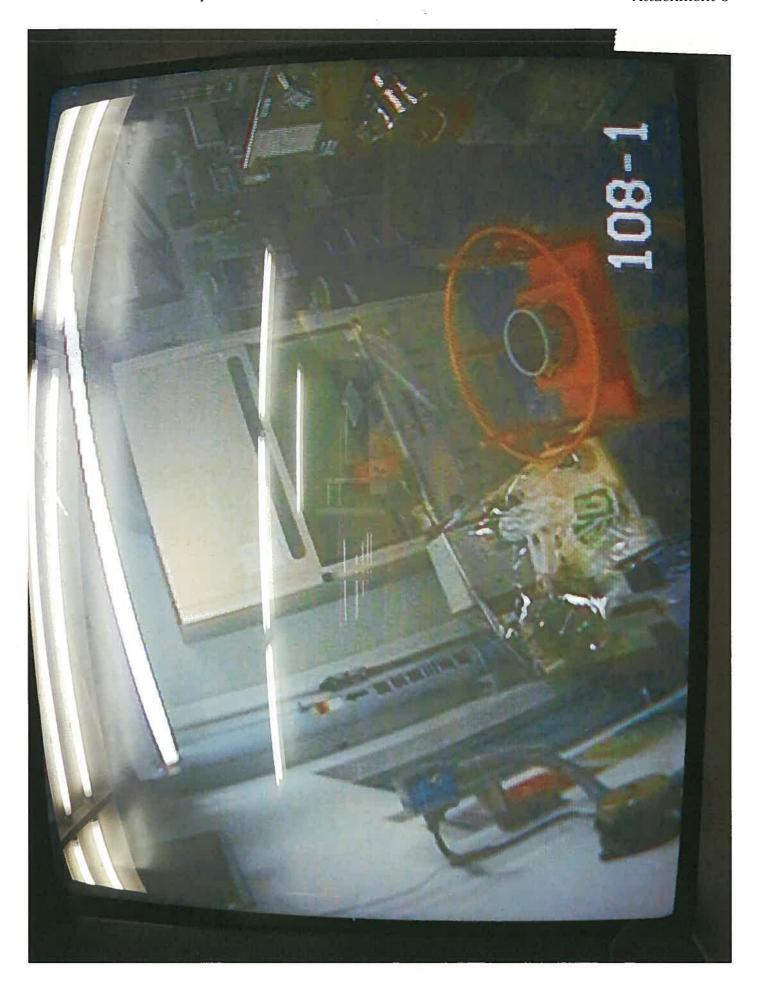
The storage container (Attachment 5) with a lid covered is set still in the hood, being monitored continuously by TV camera. (Attachment 6)

Continuous monitoring of the storage container by TV camera

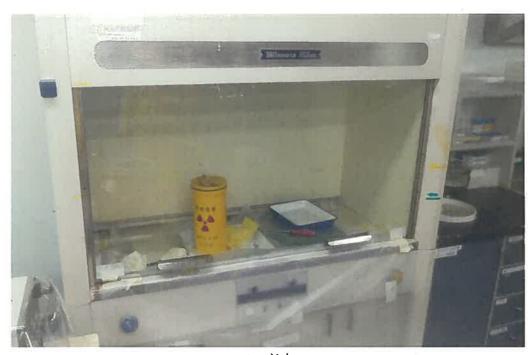
フード内 Inside the hood

汚染事象発生後のフード (H-1) 周辺写真

Photos showing the situation around the hood after the occurrence of the contamination accident

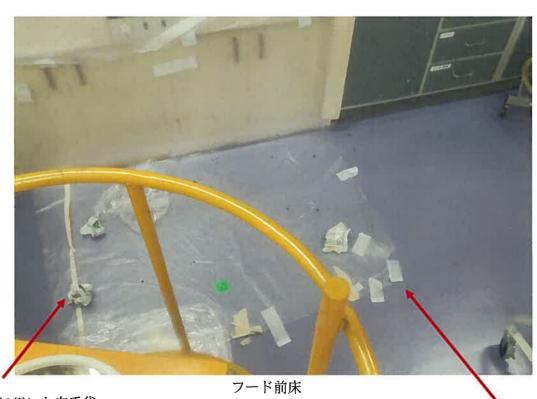
作業時に用いた布手袋 Gloves used during the work

アード前床 Floor in front of the hood

養生を固定するためのテープ Tape used to fix the curing sheet

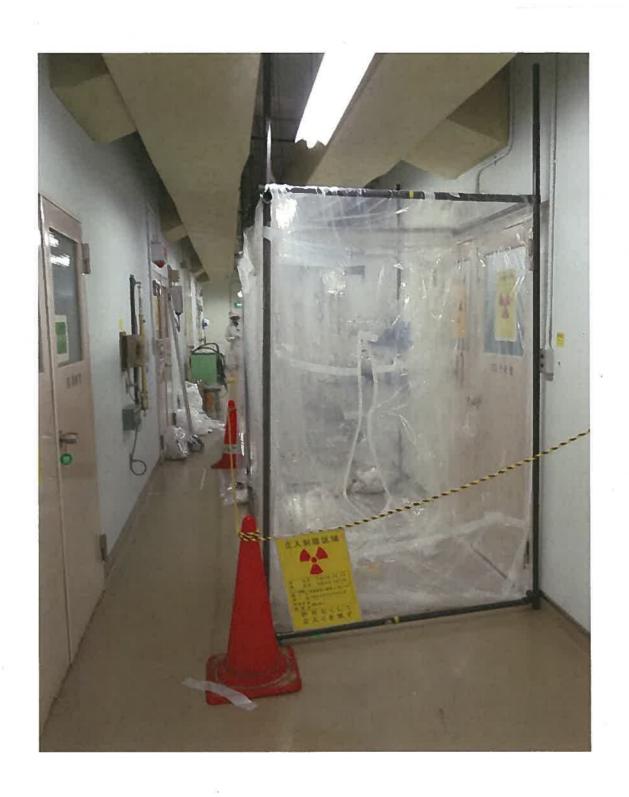
グリーンハウス Greenhouse

Decontamination of the greenhouse (Attachment 10) is completed, methods to collect scattered matters are under review.

- 10:43: FAX (the 4th report, the 7th in total) was sent. \rightarrow 11:20 FAX acceptance was confirmed.
- 16:40: Clearance and decontamination in the greenhouse was completed.
