Contamination at Plutonium Fuel Research Facility of Oarai Research and Development Center

July 21, 2017

Japan Atomic Energy Agency

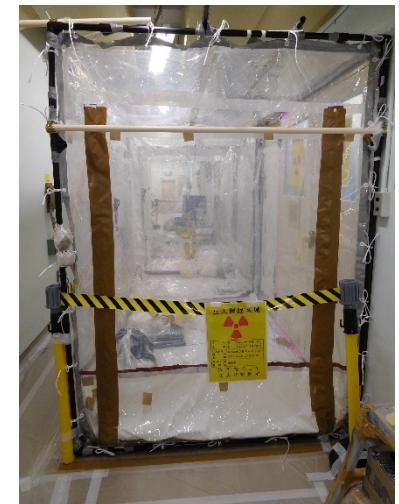
Replaced greenhouse

- Replaced the makeshift greenhouse which was set immediately after the accident with the one added reinforcement from the standpoint of contamination control.
- Contamination test/decontamination of the hood and Room No. 108 will be carried out.
