## Radioactive contamination at Plutonium Fuel Research Facility (PFRF) in Oarai Research and Development Center (Follow-up 4)

Japan Atomic Energy Agency

Below is the situation after the press release issued on June 13 of the radioactive contamination at Plutonium Fuel Research Facility (PFRF) occurred on June 6 (Tue), 2017. (Added information is underlined.)

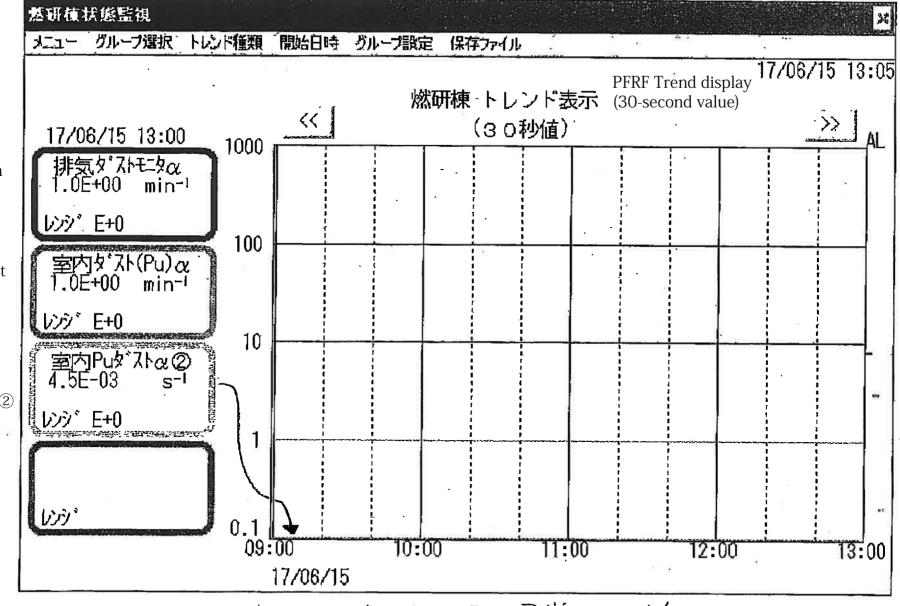
PFRF Situation Monitor

室内 R ガスト 人 ② 通常指示範回内(<0.15-1)

Room Pu dust monitor a② indicated value within the range of normal. (0.1 s-1) → 系従軸 レンジをもり替え → 別 添 ② → Vertical axis range switched.→Attachment②
