Report on the contamination at Plutonium Fuel Research Facility

Report on failure, etc. of a nuclear facility

| Title | Contamination at Plutonium Fuel Research Facility (PFRF) |

Contamination at Plutonium Fuel Research Facility

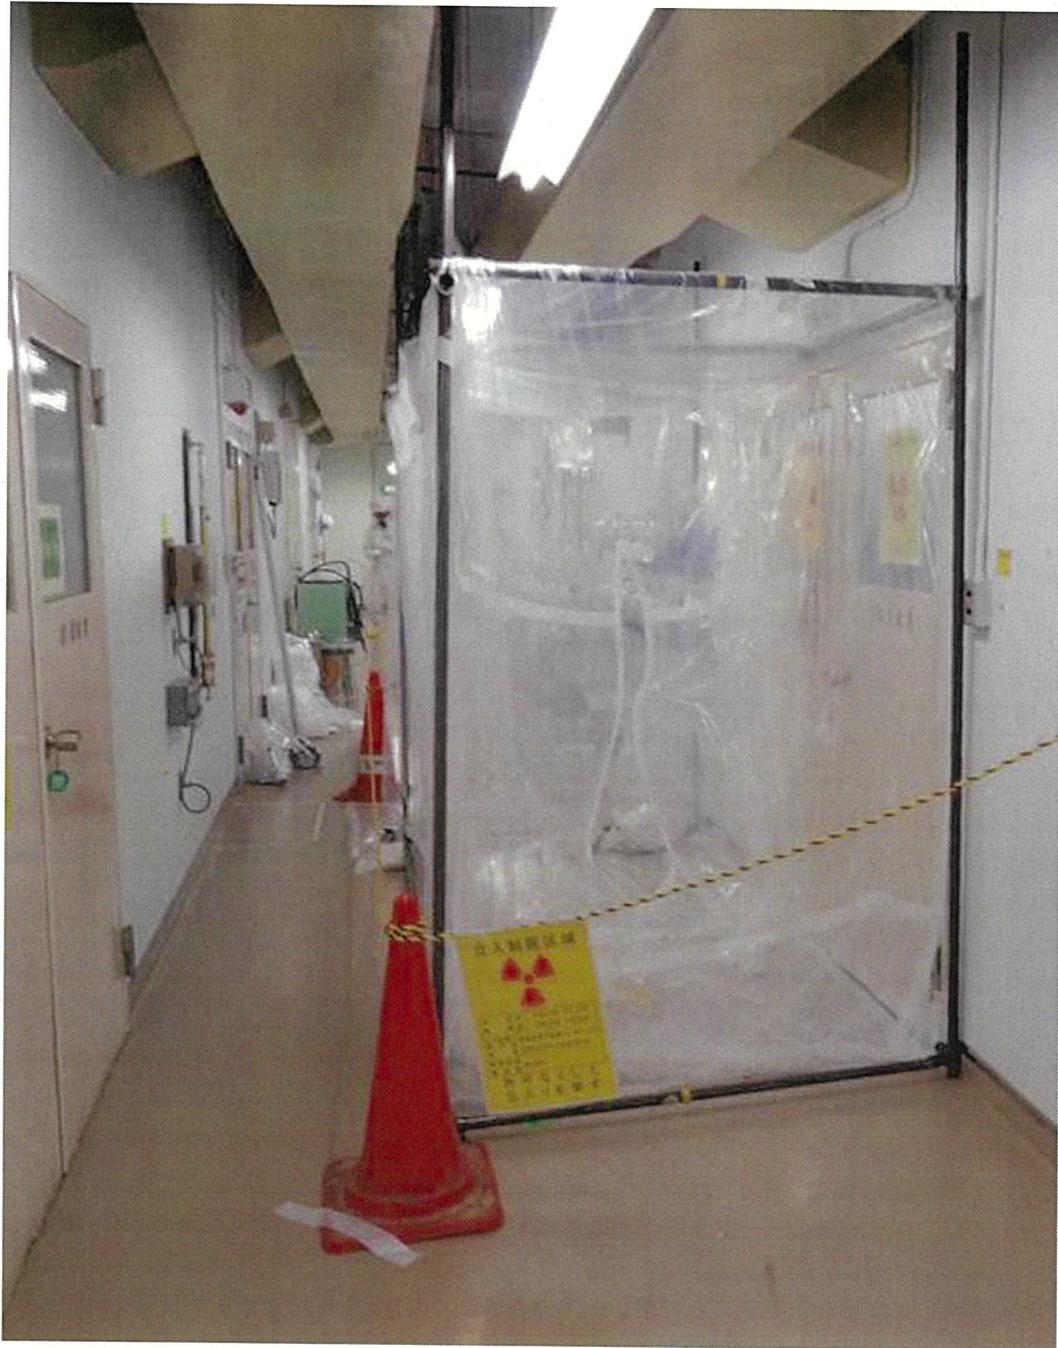
Fig.7 Greenhouse

After the occurrence of the event, in order to prevent the expansion of the contamination, a greenhouse¹ (Fig. 7) was set at the entrance of the Room No. 108 to the side of the corridor and the gaps at the emergency exit of the Room No. 108 to outside of the building were sealed up from outside. The sealed place is shown in Fig. 8.

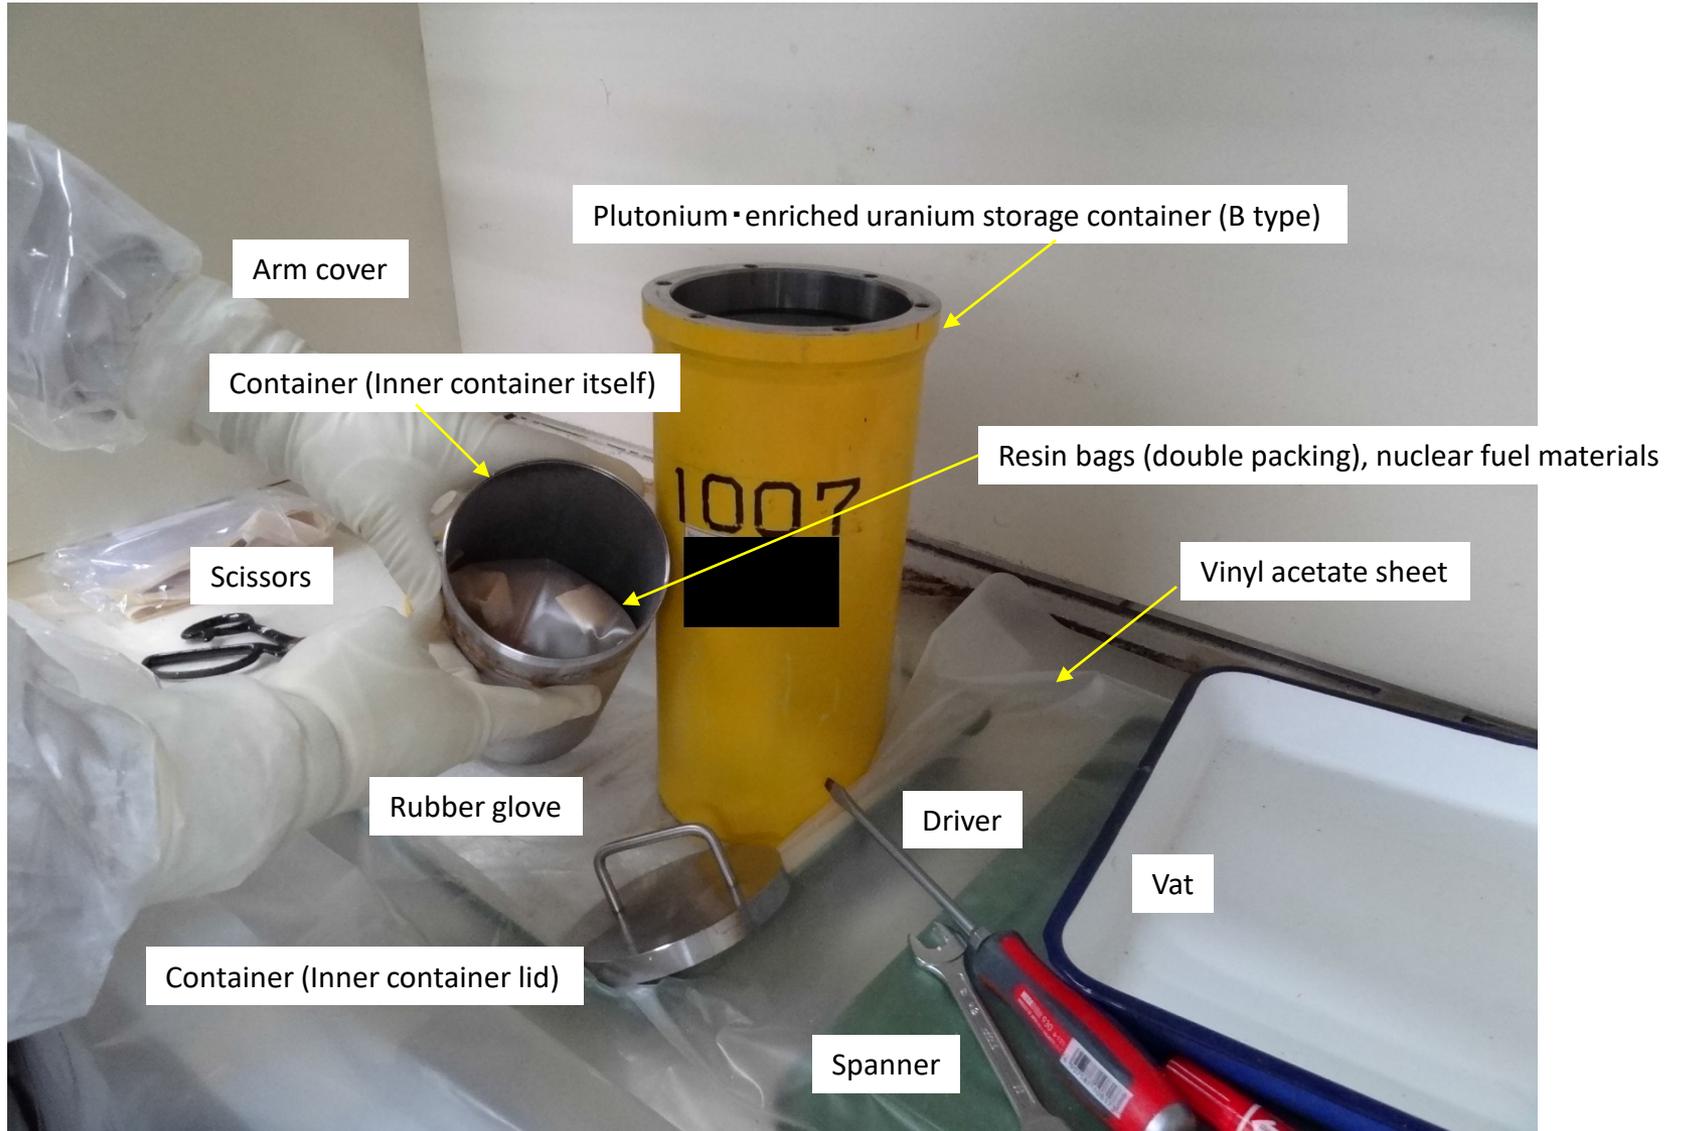
There is an inner Container in storage container.

Spanner and driver were used to open the storage container.

The vat and scissors were not used for this work.
Instead of using a bat, the inner floor of the hood is cured with the vinyl acetate sheet.

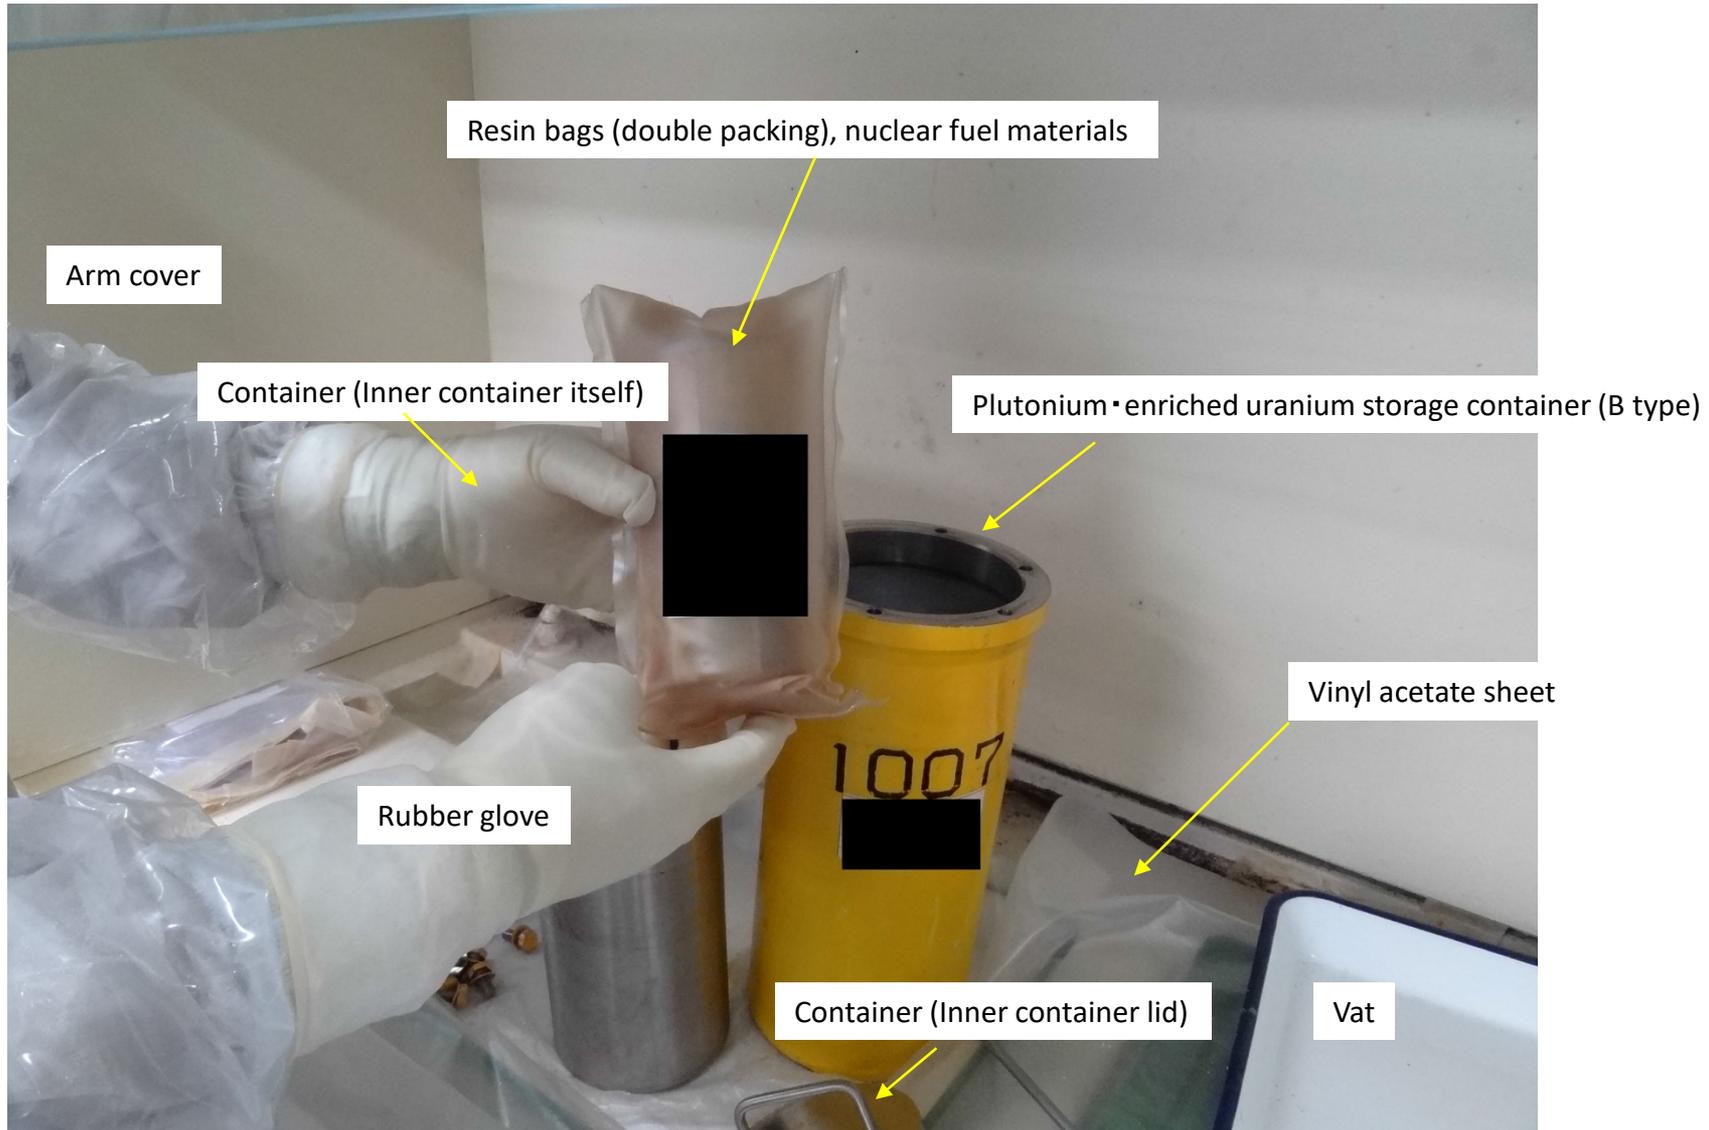
There is an inner Container in storage container.

Spanner and driver were used to open the storage container.

The vat and scissors were not used for this work.
Instead of using a bat, the inner floor of the hood is cured with the vinyl acetate sheet.

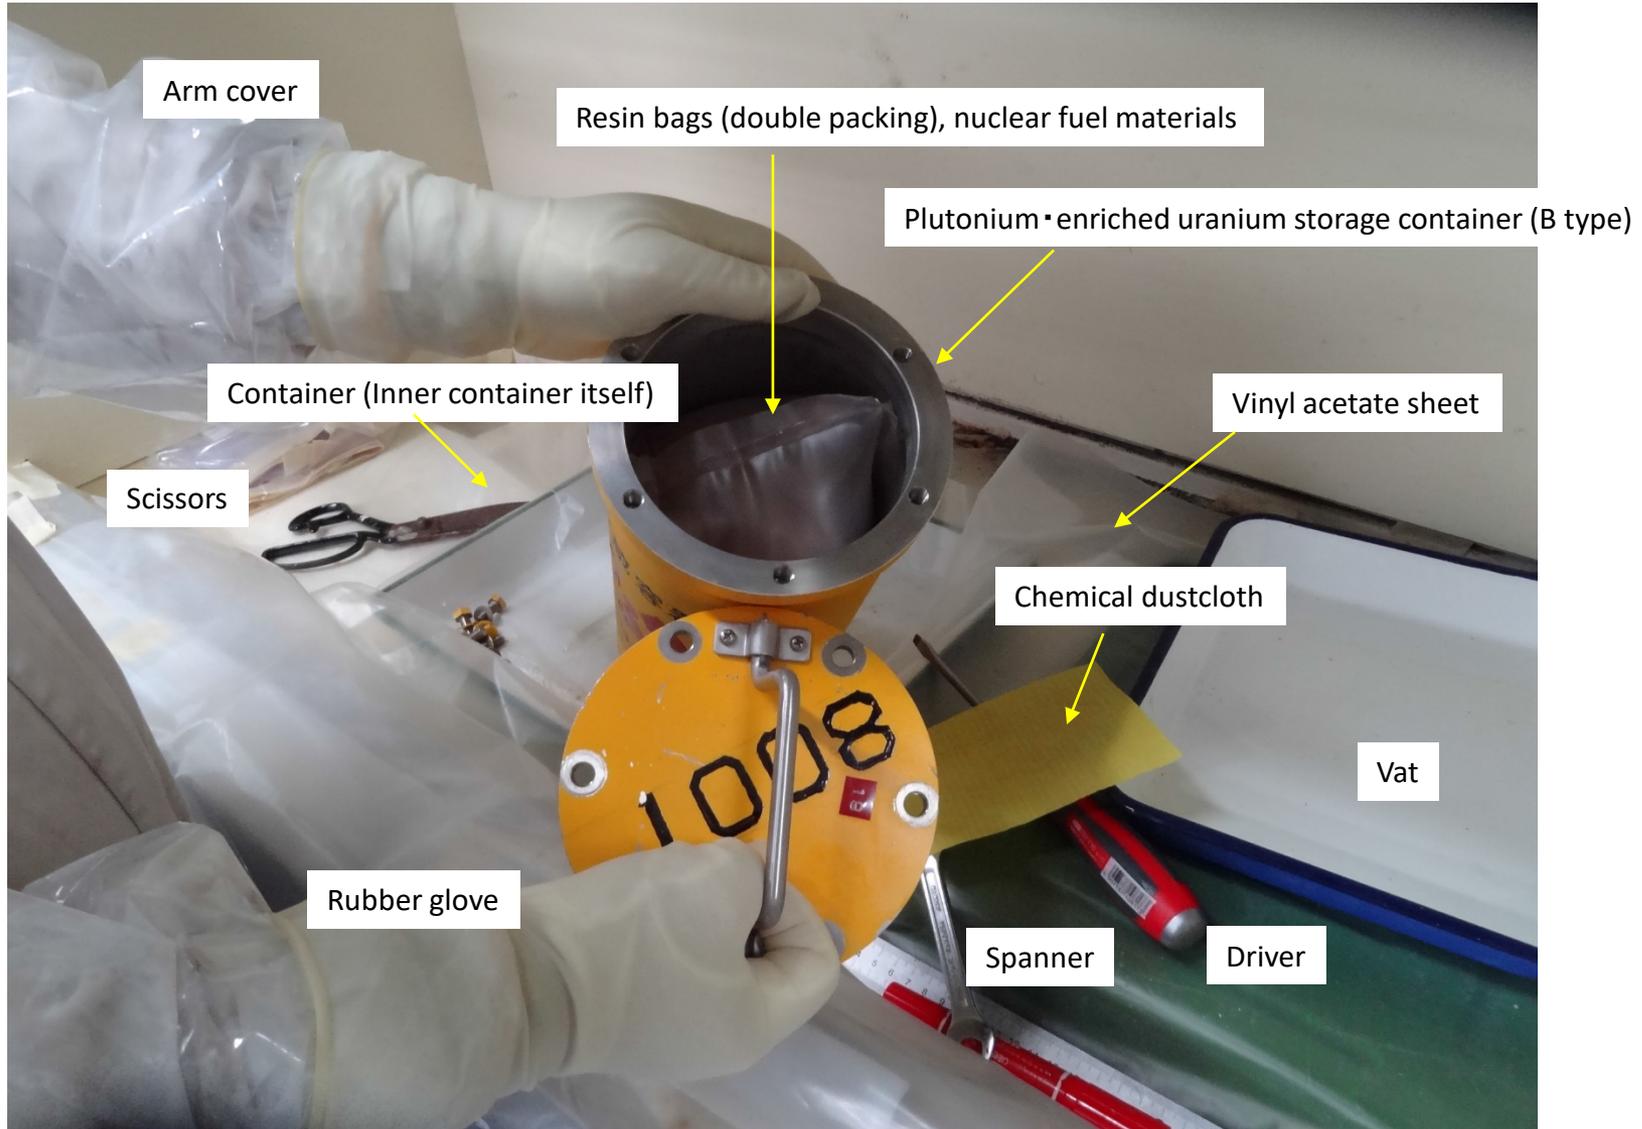
There is an inner Container in storage container.

Spanner and driver were used to open the storage container.

The vat and scissors were not used for this work.
Instead of using a bat, the inner floor of the hood is cured with the vinyl acetate sheet.

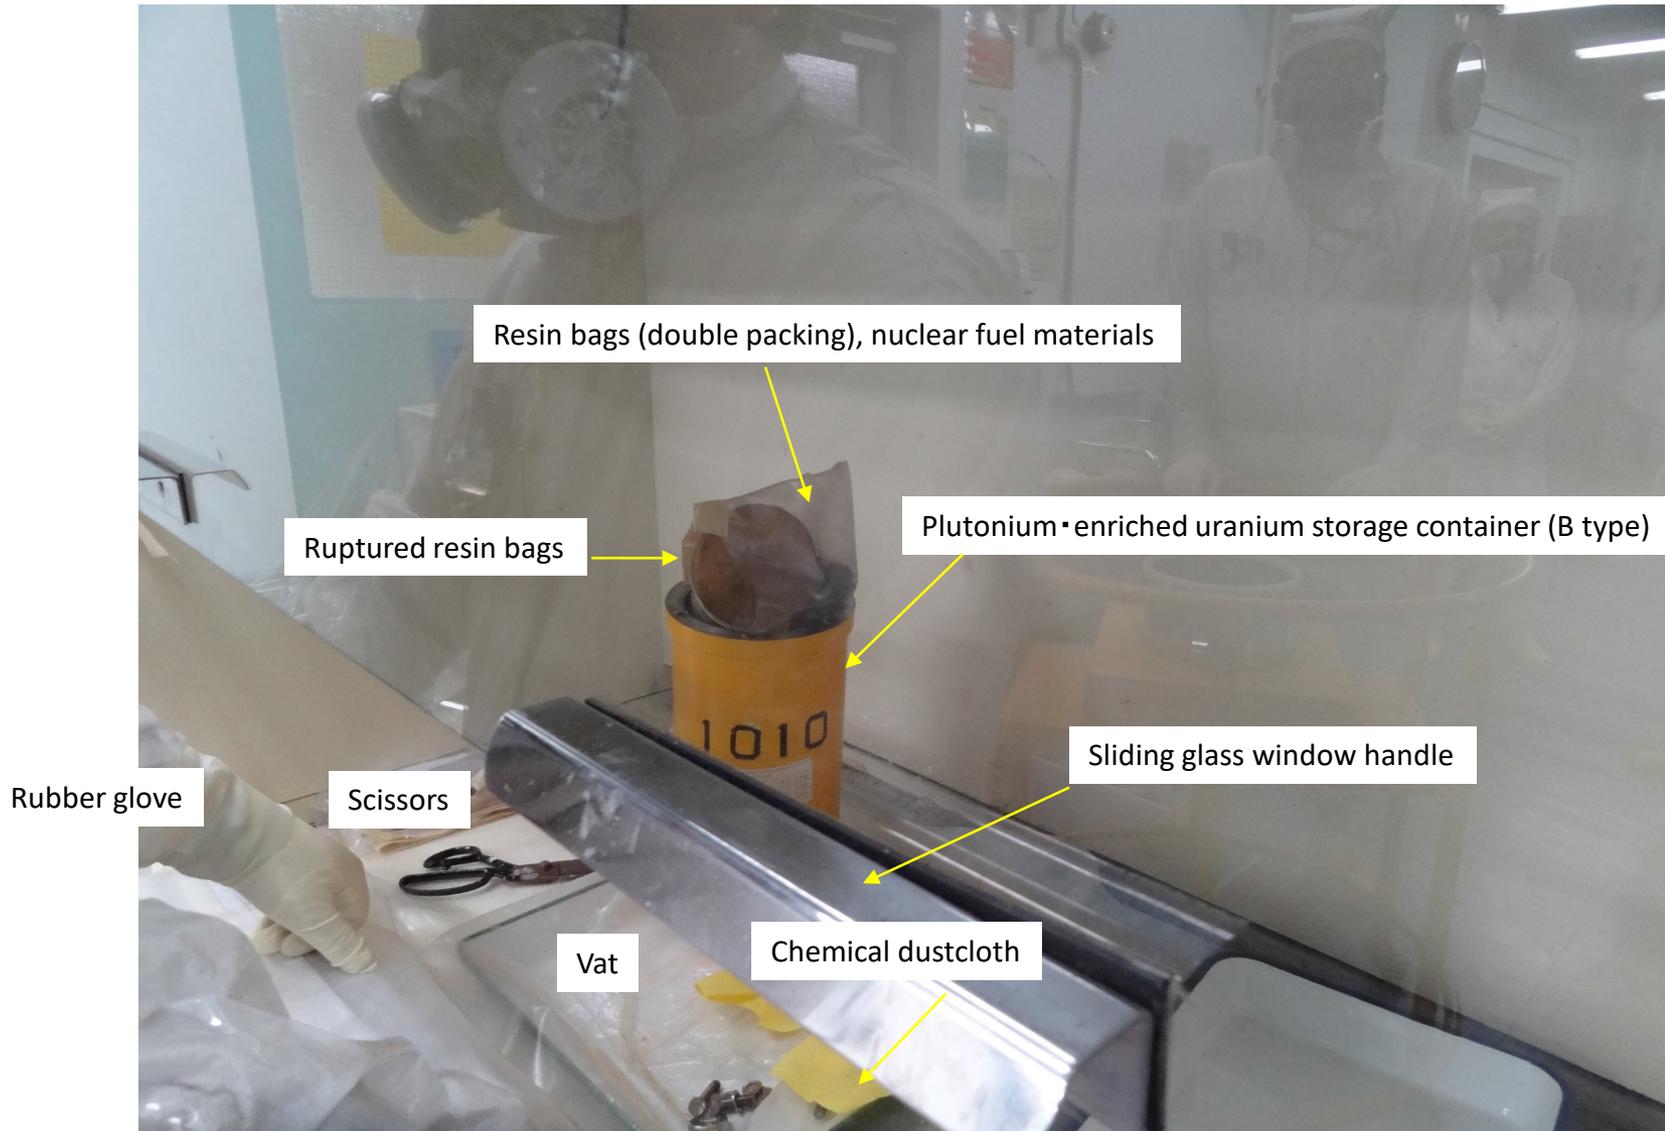
There is an inner Container in storage container.

Spanner and driver were used to open the storage container.

The vat and scissors were not used for this work.

Instead of using a bat, the inner floor of the hood is cured with the vinyl acetate sheet.
