図 4.1.1 大洗研究開発センター施設配置図

Fig.4.1.1 Facility layout of Oarai Research and Development Center

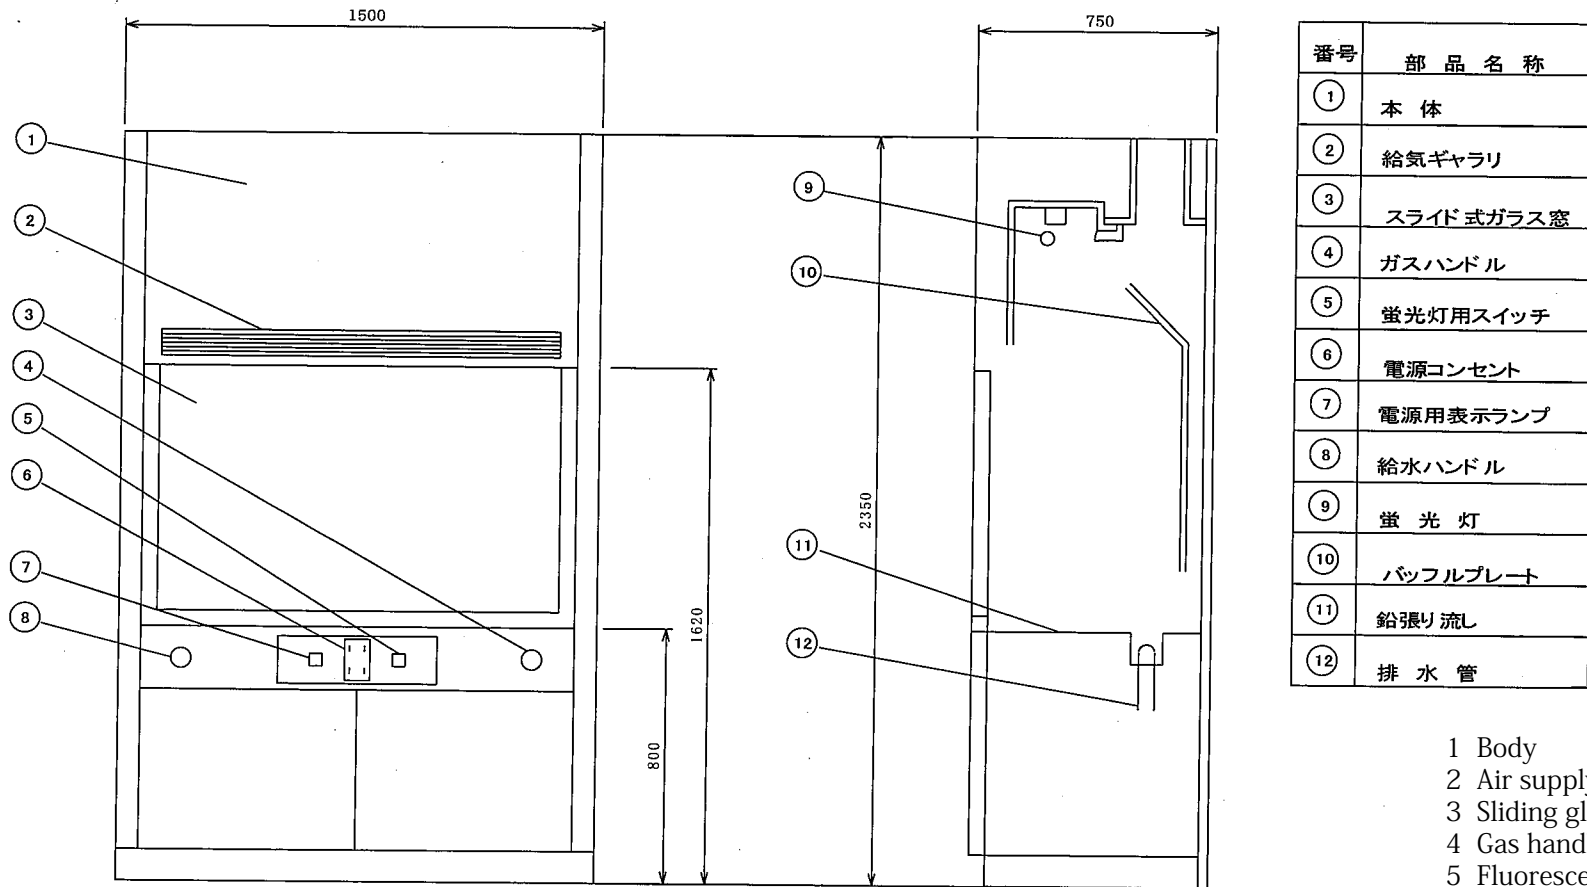
Fig.4.2.2 Outline of hood (H-1)

図5 フード (H-1) 概略図

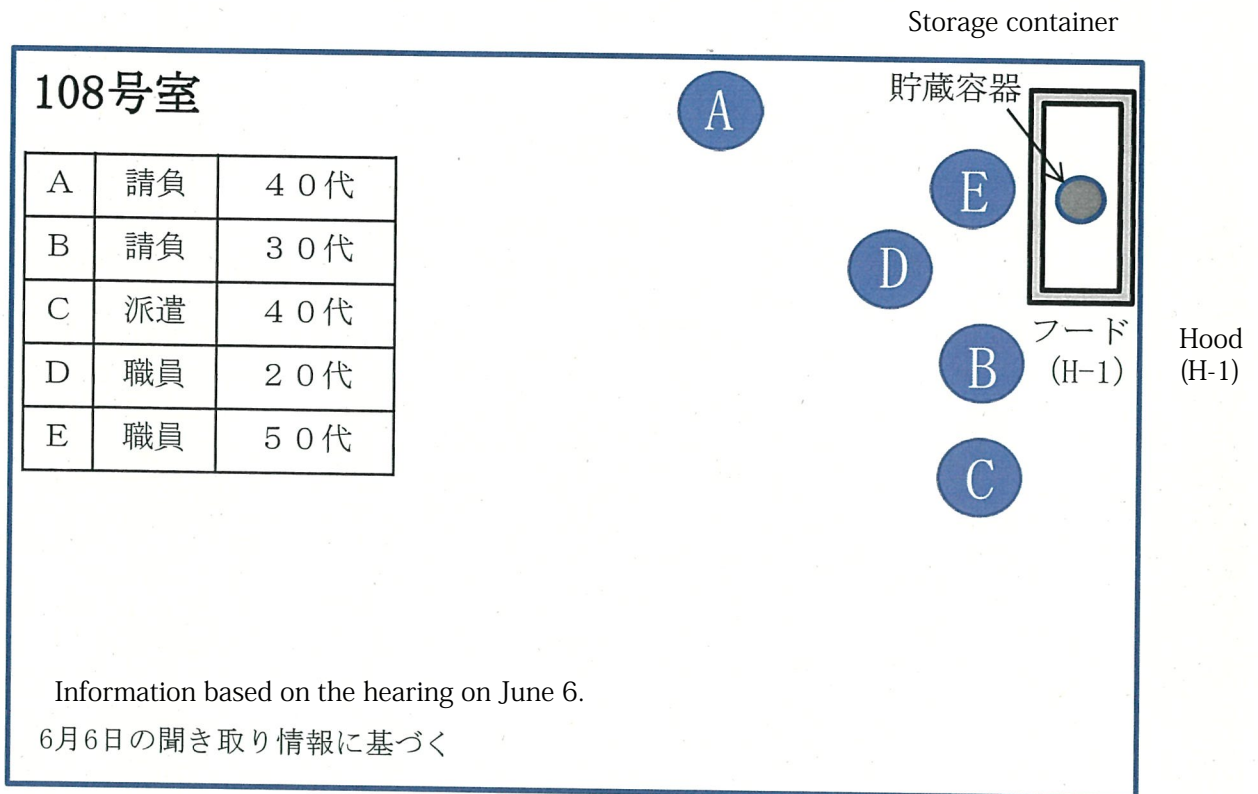
Fig.4.2.3 Location of the five workers in Room No. 108 at the incident occurrence

図6 108号室における事象発生時の作業員5名の位置関係

A	Contract-based worker	40's
B	Contract-based worker	30's
C	Temporary-worker	40's
D	JAEA staff member	20's
E	JAEA staff member	50's

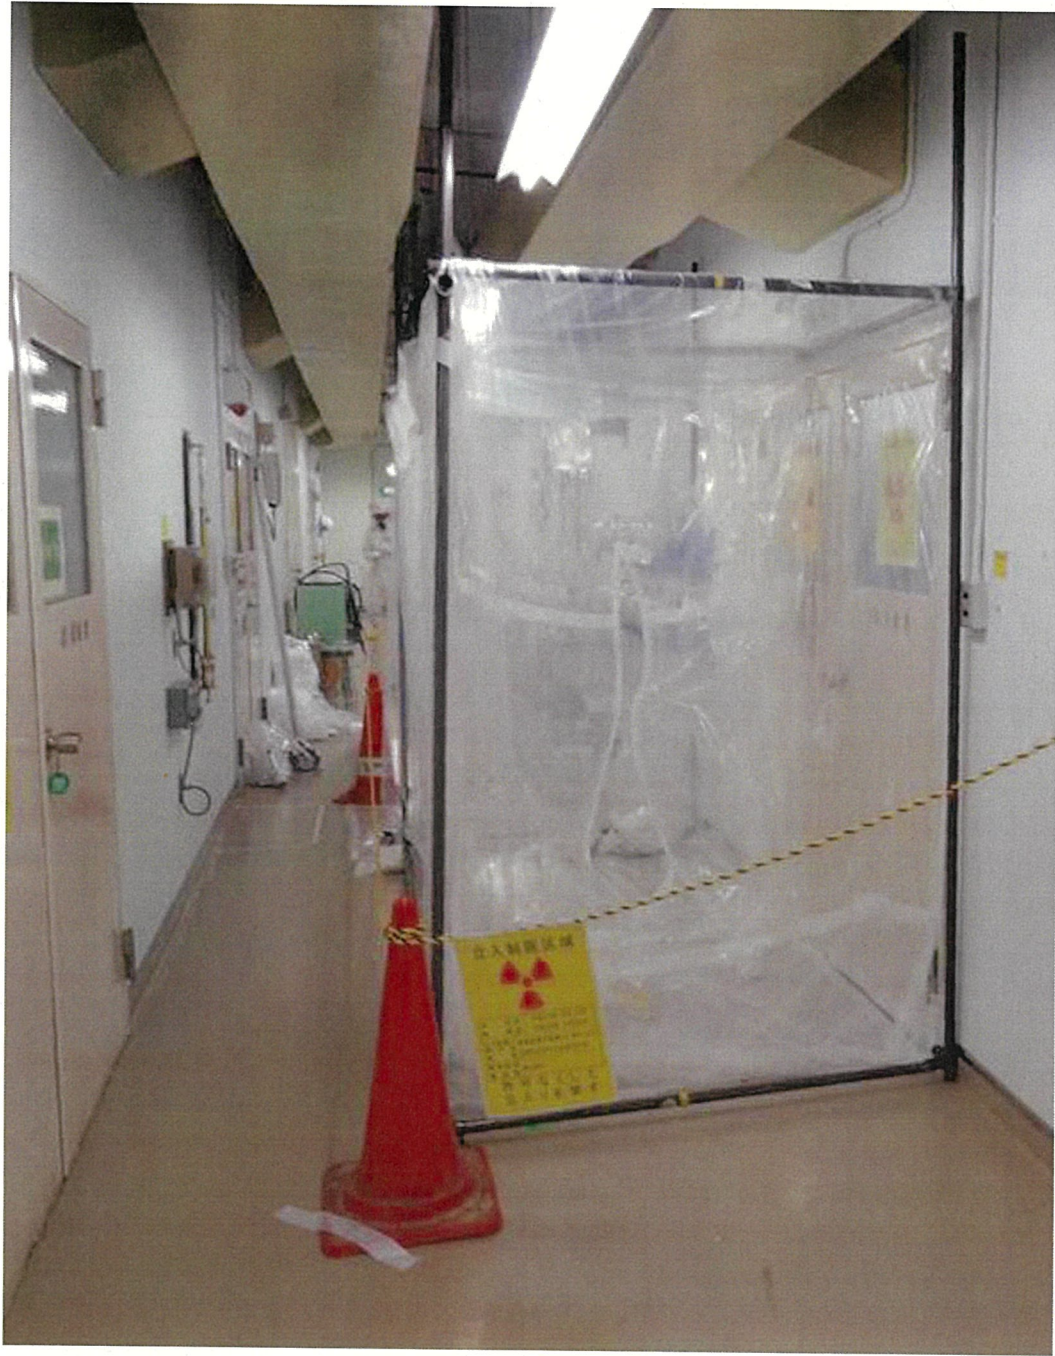
Fig.4.2.4 Greenhouse

図7 グリーンハウス

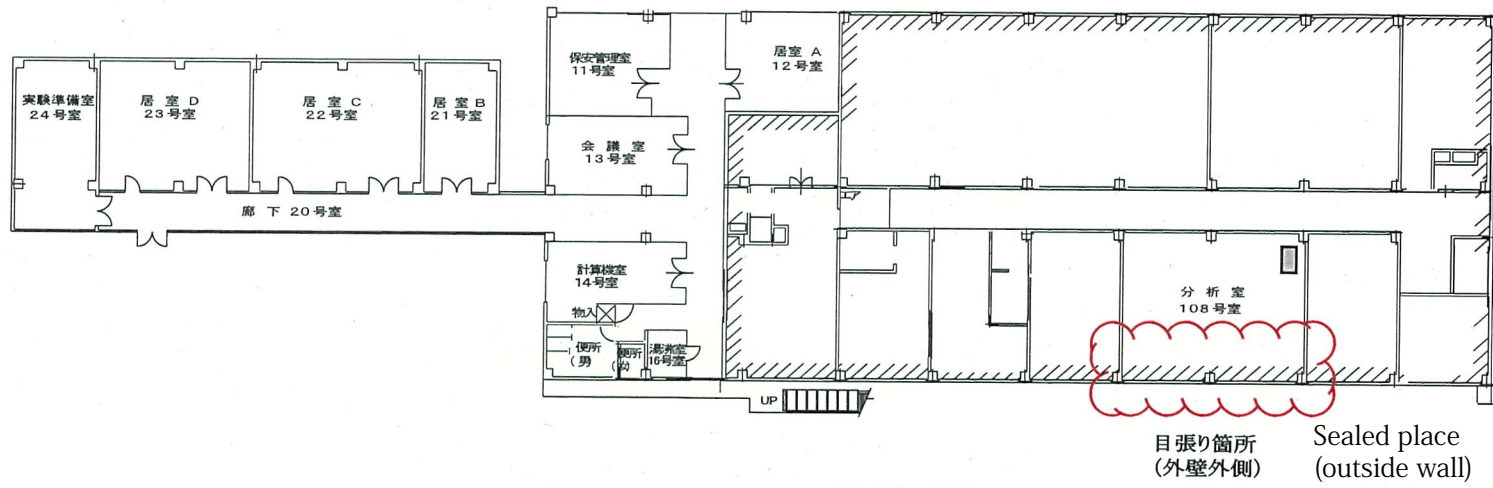
Fig.4.2.5 Sealed place

目張り箇所 (外壁外側) Sealed place (outside wall)

図8 目張り箇所

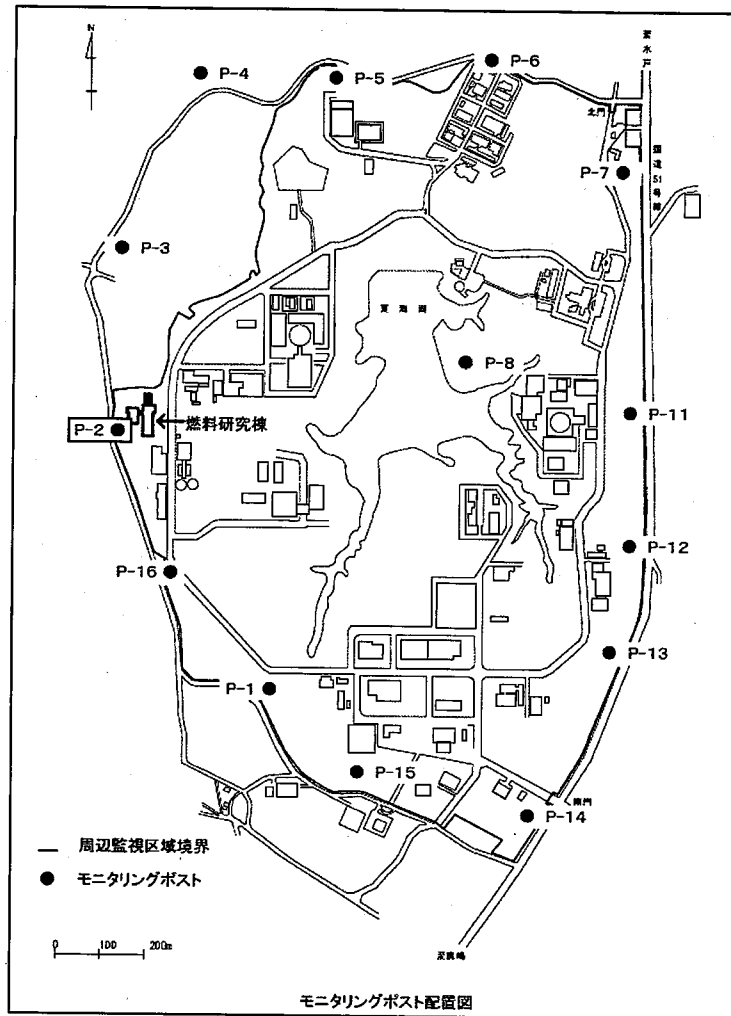
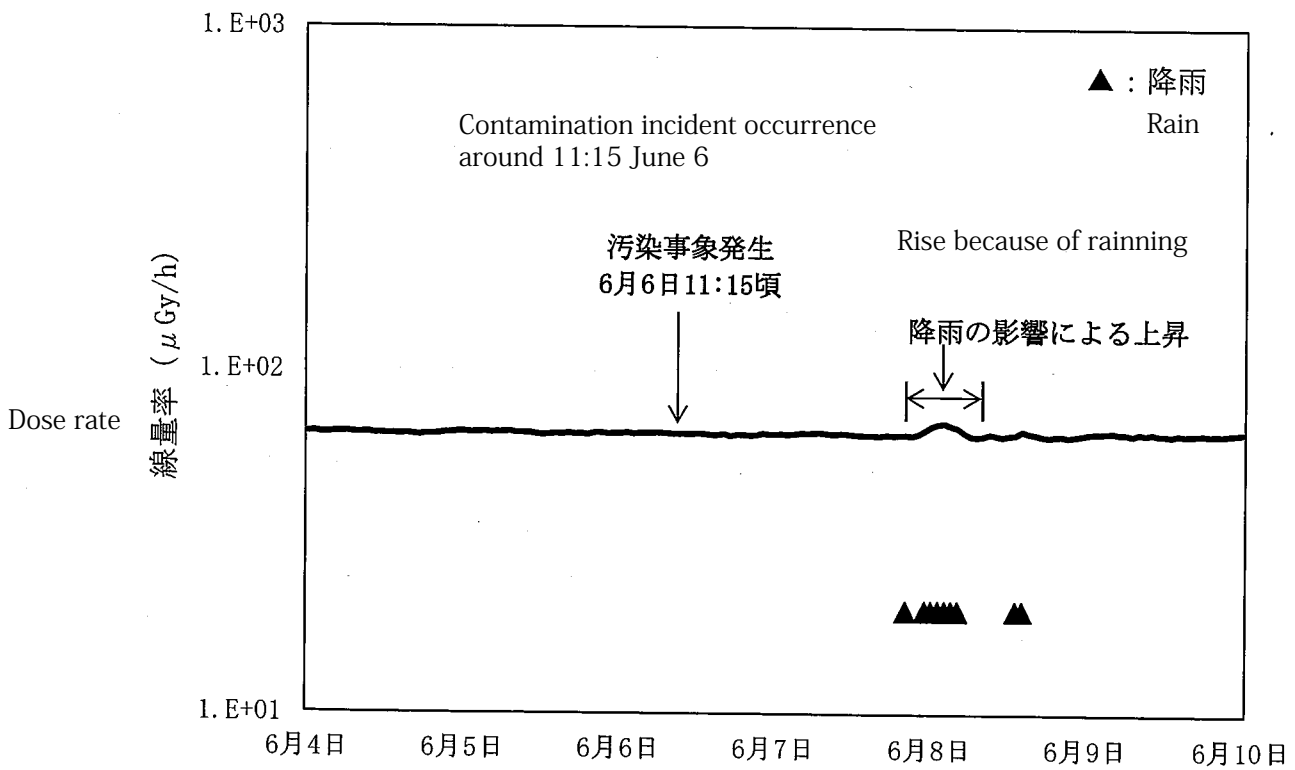
図9 モニタリングポスト (P-2) 指示値のトレンド
Fig.4.2.6 Indicated value trend of monitoring post (P-2)

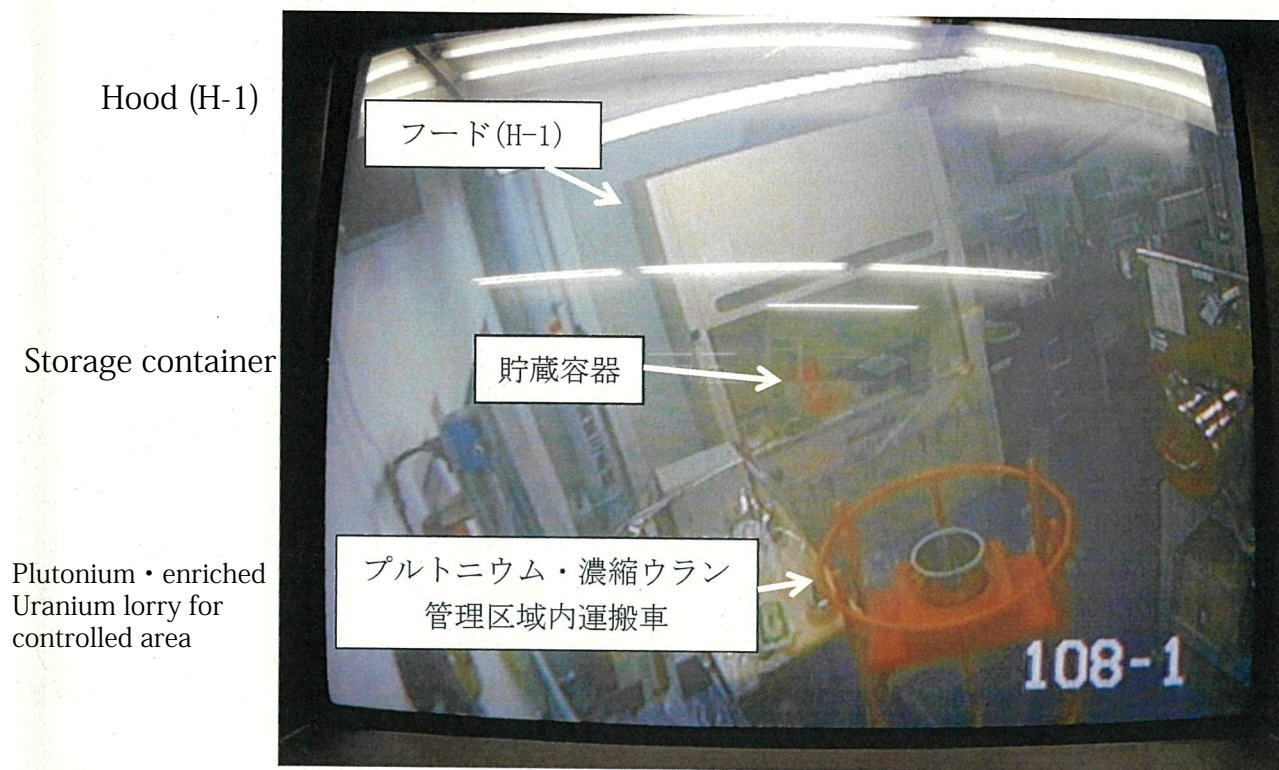
Fig. 4.2.15 Continuous monitoring of the storage container by TV camera

図 17 TV カメラによる貯蔵容器の監視

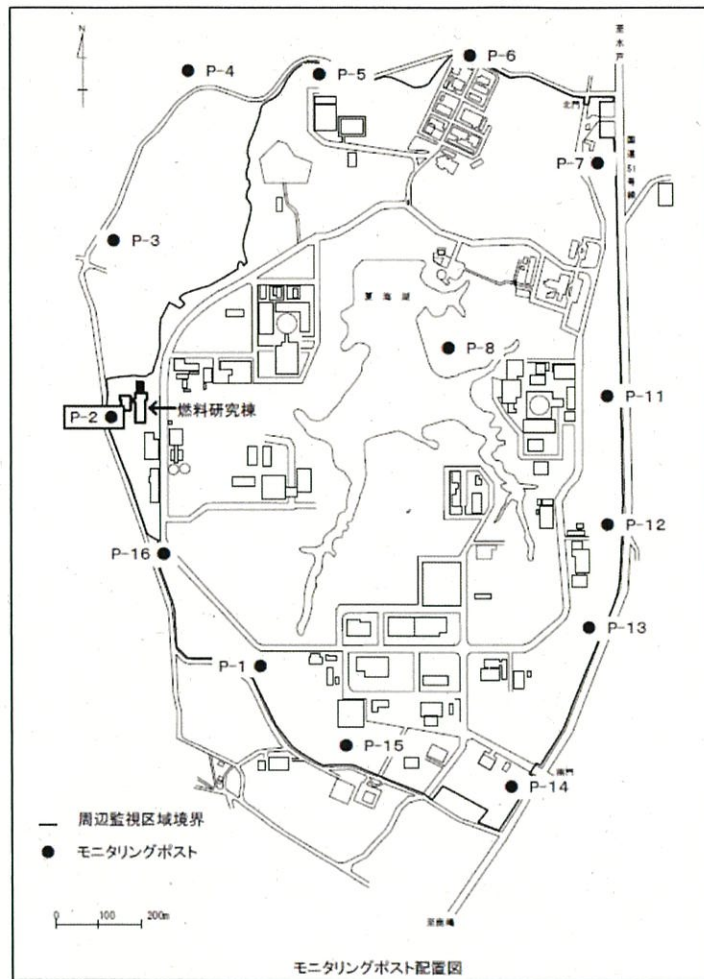
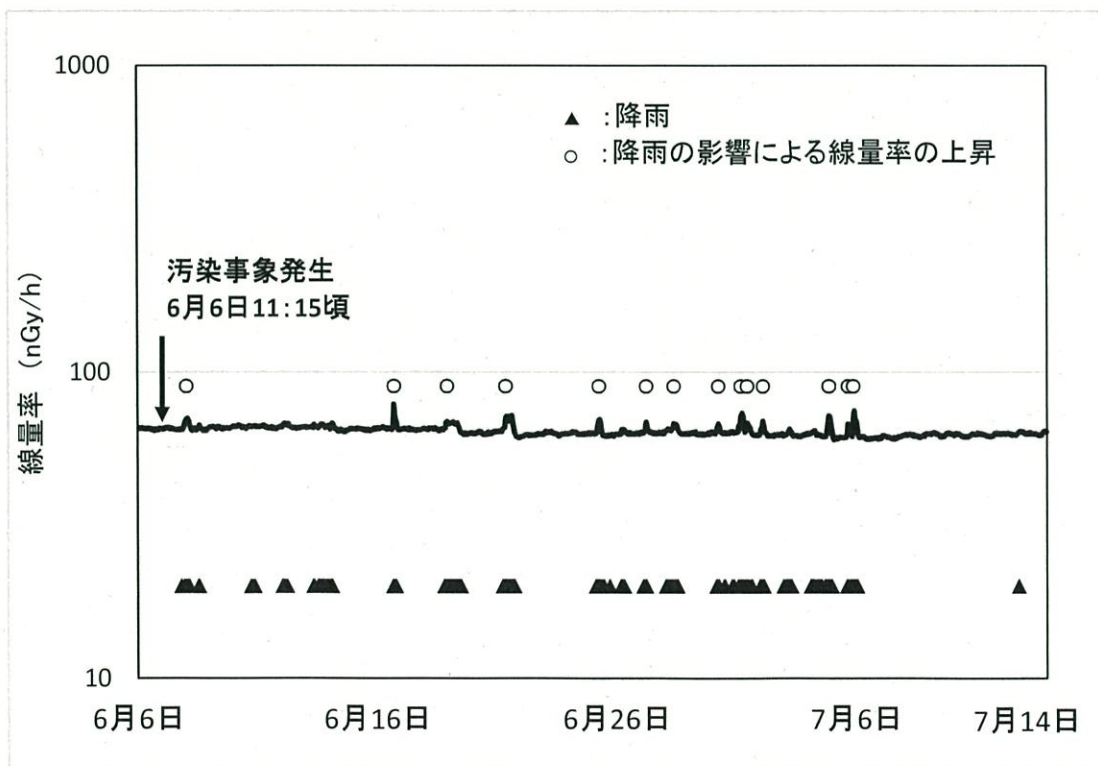
Fig. 5.1 Trend of the values indicated by the monitoring post (P-2)

図5.1 モニタリングポスト (P-2) 指示値のトレンド

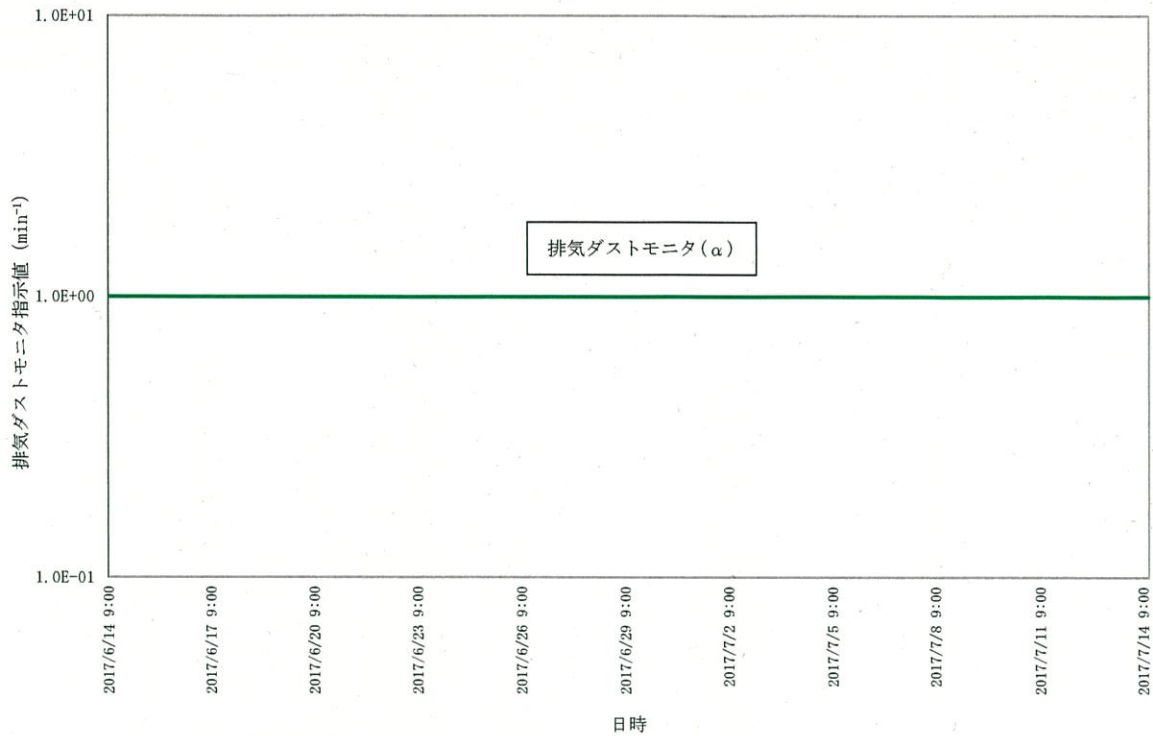
Fig. 5.2 Trend of the values indicated by the ventilation dust monitor of PFRF (H29年6月14日～7月14日)

図5.2 燃料研究棟の排気ダストモニタ指示値のトレンド

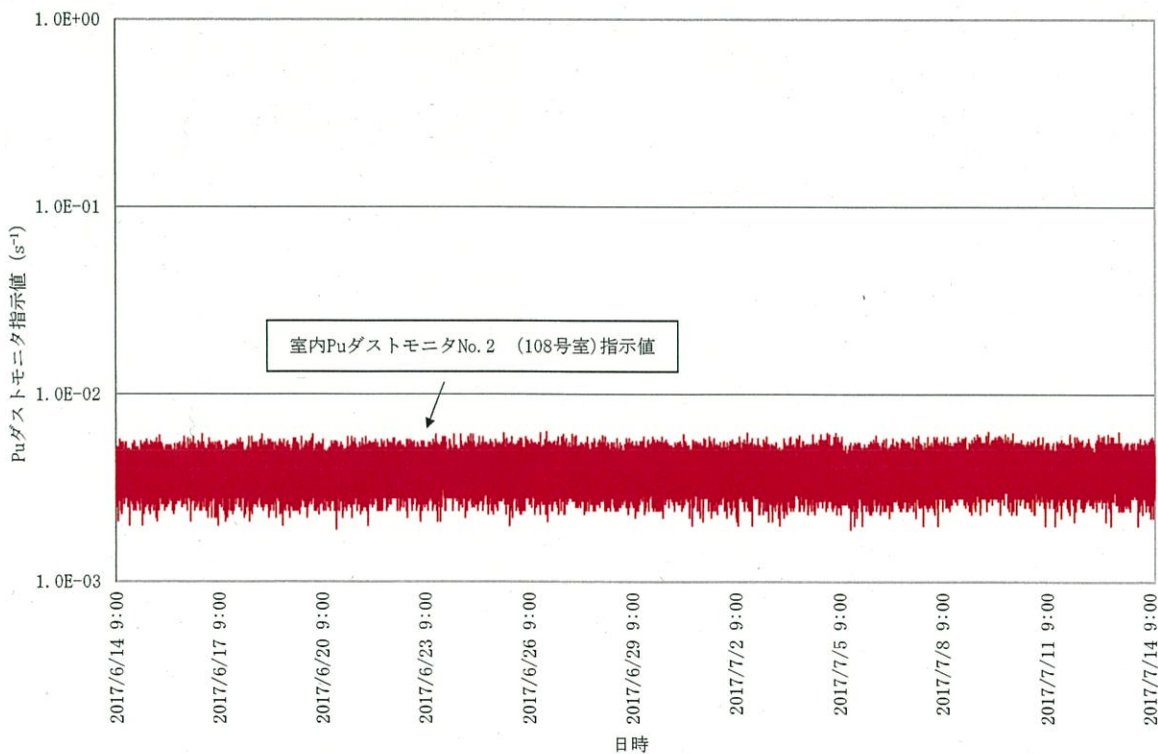
Fig. 5.3 Trend of the values indicated by the room Pu dust monitor No.2 (Room No. 108) of PFRF

図5.3 燃料研究棟の室内Puダストモニタ

No. 2 (108号室) 指示値のトレンド

(H29年6月14日～7月14日)

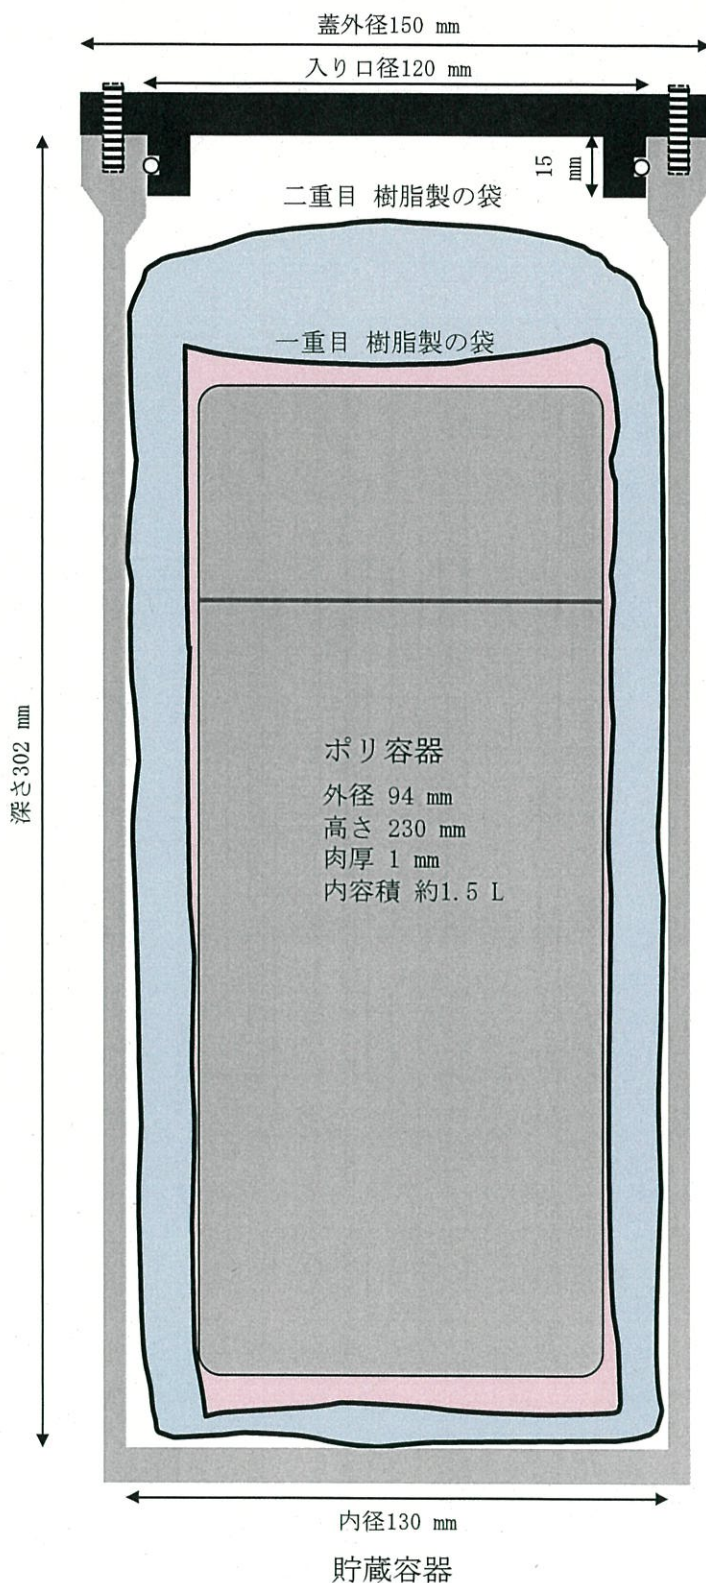
Fig. 6.4.1 Assumed image of the storage container containing nuclear fuel material

全高320×胴外径140 mm、胴体肉厚5 mm、底肉厚8 mm、蓋肉厚10 mm、内容積約3.9 L

図 6.4.1 貯蔵容器へ核燃料物質を収納した際の想定図

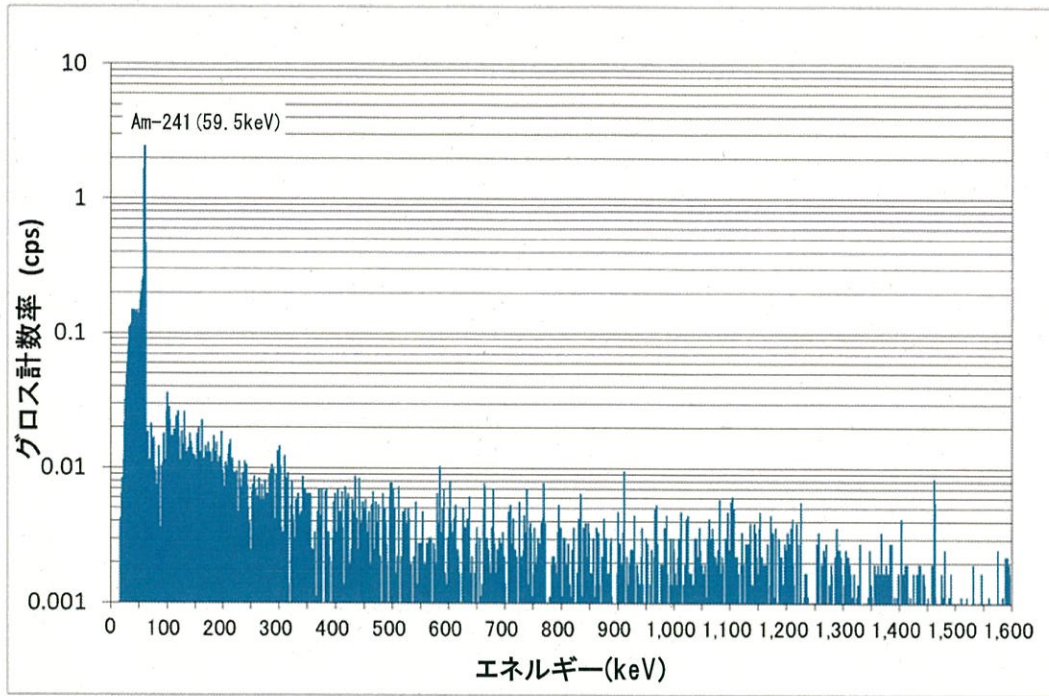
Fig. 6.5.1 Photon energy spectrum of smear sample by Ge semiconductor detector

図 6.5.1 Ge 半導体検出器によるスミヤ試料の光子エネルギースペクトル

(測定日：7月13日、採取場所：108号室 図 4.2.9 ⑧)

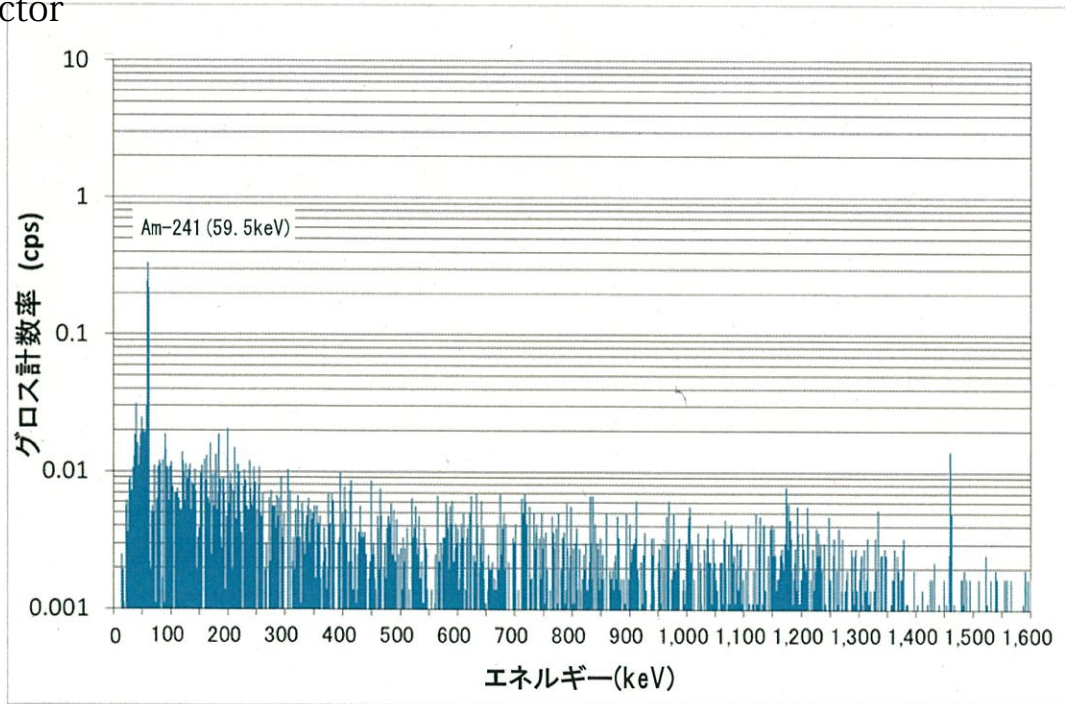
Fig. 6.5.2 Photon energy spectrum of smear sample by Ge semiconductor detector

図 6.5.2 Ge 半導体検出器によるスミヤ試料の光子エネルギースペクトル

(測定日：7月13日、採取場所：108号室 図 4.2.9 ⑭)

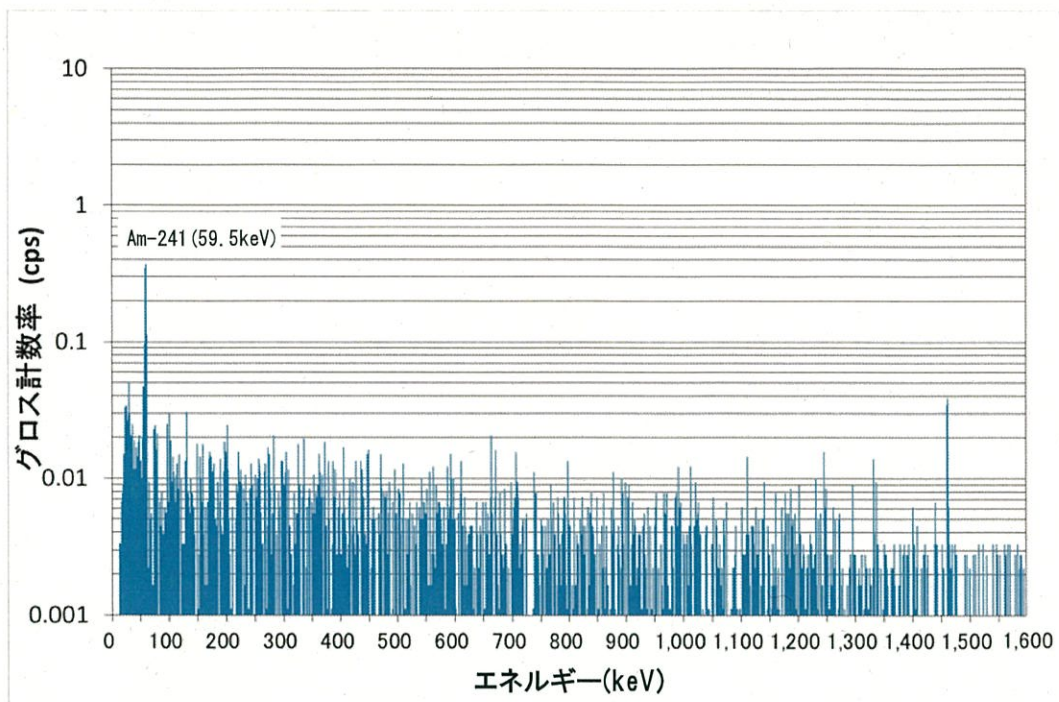
Fig. 6.5.3 Photon energy spectrum of smear sample by Ge semiconductor detector

図 6.5.3 Ge 半導体検出器によるスミヤ試料の光子エネルギースペクトル

(測定日：7月14日、採取場所：108号室 図4.2.9 ①)

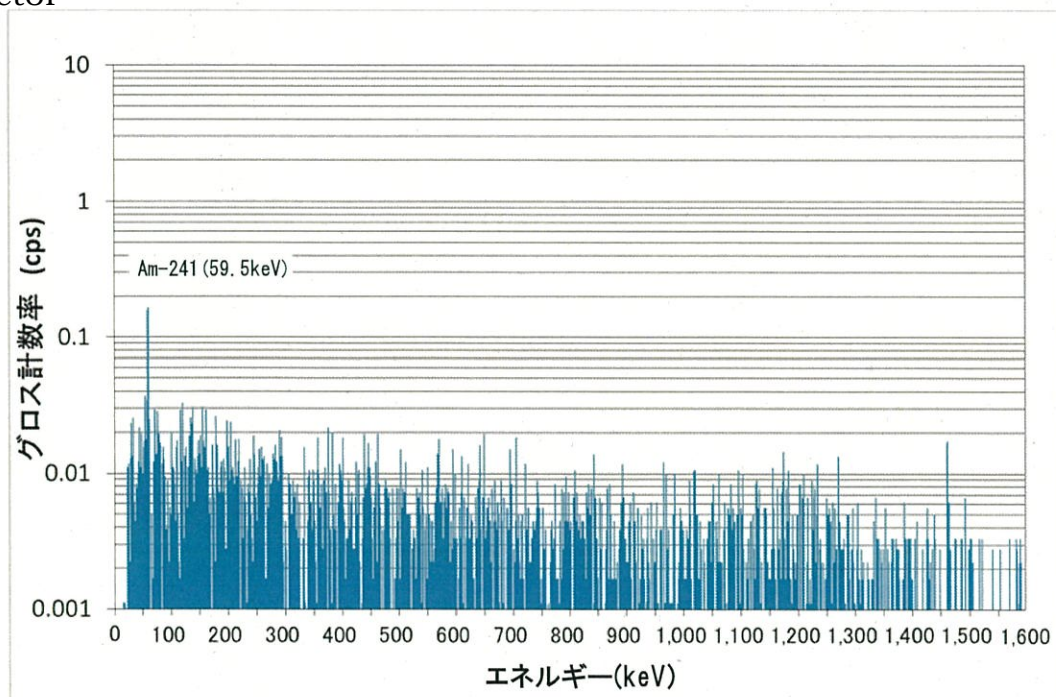
Fig. 6.5.4 Photon energy spectrum of smear sample by Ge semiconductor detector

図 6.5.4 Ge 半導体検出器によるスミヤ試料の光子エネルギースペクトル

(測定日：7月14日、採取場所：108号室 図4.2.9 ⑬)
