IAEA-TECDOC-1932

Operating Experience from Events Reported to the IAEA/NEA Fuel Incident Notification and Analysis System (FINAS)

International Atomic Energy Agency

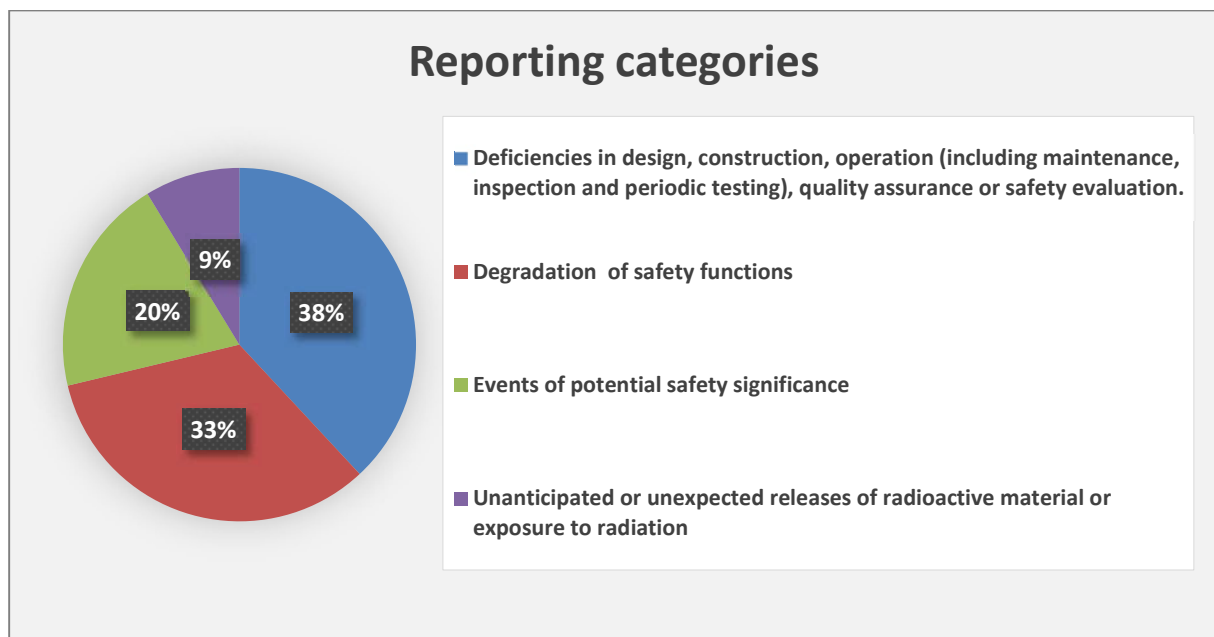
Figure 2. Distribution of the analysed events by reporting categories.

Among the events analysed, the largest number (38%) were reported in the reporting category ‘deficiencies in design, construction, operation (including maintenance, inspection and periodic testing), quality assurance or safety evaluation’, followed by ‘degradation of safety functions’ (33%). 20% of the events were reported in the category ‘events of potential safety significance’, and 9% of the events were reported in the category ‘unanticipated releases of radioactive material or exposure to radiation’. Figure 2 shows the distribution of events based on reporting categories.

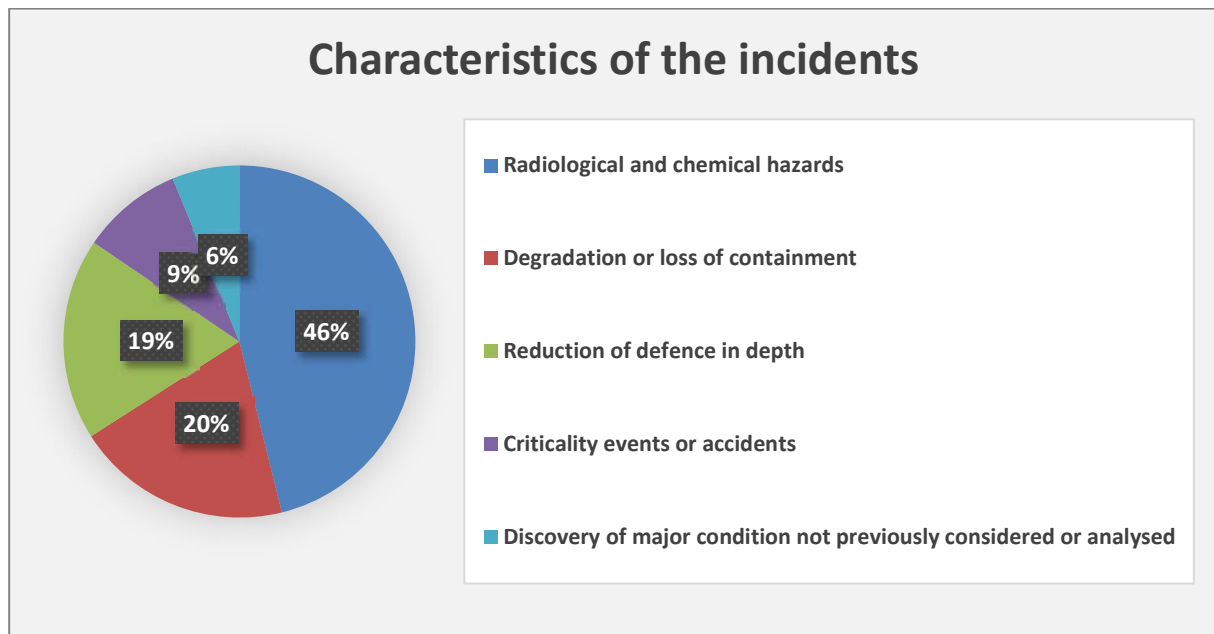
- b) The analysis of the event reports according to characteristics of the events showed that the largest number of events (46%) were characterized by ‘radiological and chemical hazards’. The radiological hazards included releases of radioactive material, degraded shielding, radiation exposure and degradation of monitoring of radioactivity. The chemical hazards involved releases of hazardous chemical material, degradation of reactivity control and degradation of monitoring of process chemistry. A total of 20% of events were characterized by ‘degradation or loss of confinement’, followed by ‘reduction of defence in depth’ (19%). Included in the latter category were events that involved loss or significant degradation of safety functions, loss of on-site or off-site power, exceeded operational limits and conditions or violation of safety procedures, false alarms and/or haphazard evacuation and risk of significant physical injury. The analysis of events resulted in a (9%) distribution of ‘criticality events or accidents’, and a (6%) distribution of ‘discovery of major condition not previously considered or analysed’. The events in the last category revealed significant failure modes and conditions that were not conceived of in the safety analyses. The safety aspects of these events varied in nature and involved conduct of operation or safety programmes (e.g. maintenance and ageing management), and bore consequences that were of potential safety significance (e.g. fires and

explosions, interruption or cut-off of electrical power supply). Figure 3 shows the distribution based on characteristics of the events.

Figure 3. Distribution of the analysed events by their safety aspects.

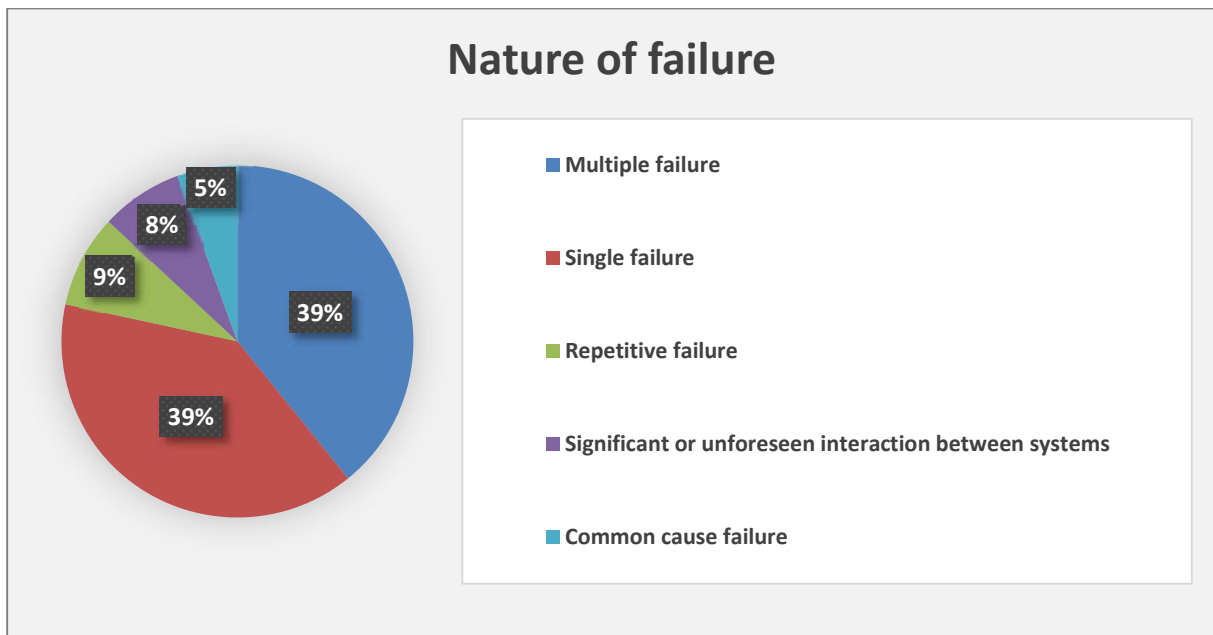
- c) The analysis of the nature of failure showed that the distributions of ‘multiple failures’ and ‘single failures’ were equal (representing 39% each). However, since most of the ‘repetitive failures’ (9%) were also ‘multiple failures’, the actual distribution of ‘multiple failures’ can be considered to be larger than that of the ‘single failure’. ‘Significant or unforeseen interaction of events’ contributed to (8%) of the distribution. The failures in these events were associated with abnormal process conditions, and failures of safety systems due to ageing, which resulted in unsafe situations such as fires, or releases of nuclear material and/or hazardous chemicals. Events reported for ‘common cause failures’ (5%) were the least frequent. This category of events includes failure of wiring in lifting equipment, fire, and loss of ability of components to perform their intended function due to ageing, as well as inadequate consideration of human factors that initiated common cause failures. Figure 4 shows the distribution of nature of failure.

Figure 4. Distribution of the analysed events by nature of failure.

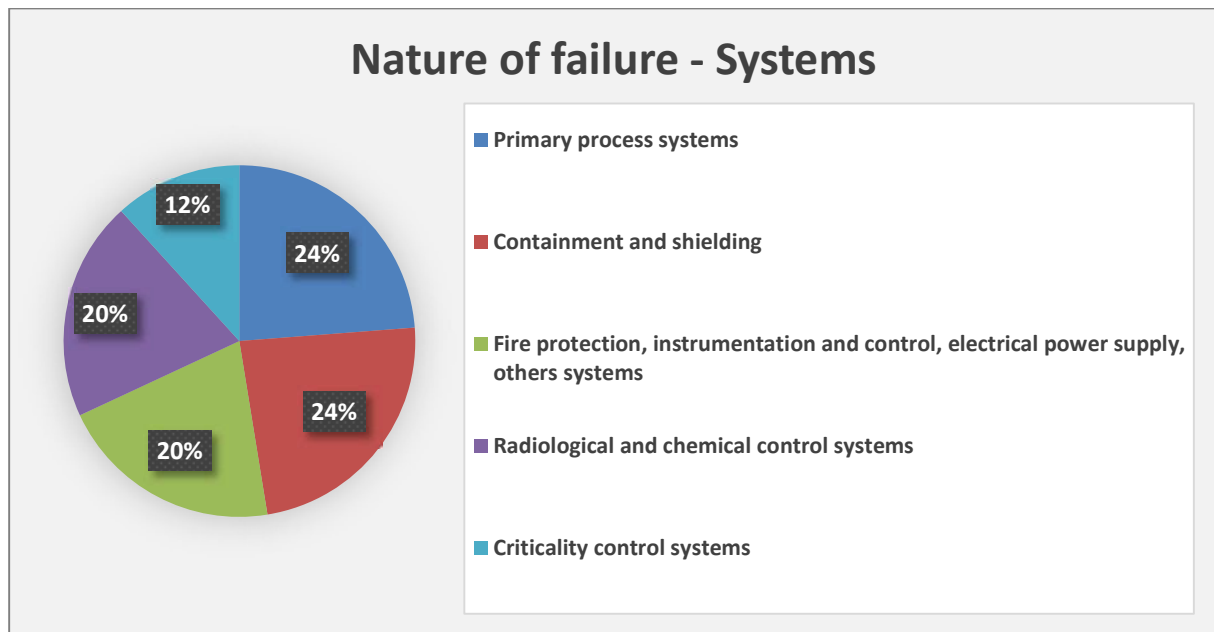
- d) The analysis of events showed that the ‘primary process systems’ (e.g. systems for handling and transport, feed and delivery, dissolving, liquid or gas extraction, calciner/fluidized furnace, separators), were the most failed or affected systems (24%) along with ‘containment and shielding’ (e.g. structures, building confinements or containments, pool liners, static and dynamic confinement or containment, ponds and pools, dry chambers). The analysis also showed that ‘fire protection, instrumentation and control, electrical power supply and other systems’ (e.g. furnace, pelletisation press, pipe bridge, filters) and ‘radiological and chemical control systems’ (e.g. reagents feed, encapsulation and vitrification equipment, incineration, compaction, radiological and chemical monitoring) were equally affected (20% each). ‘Criticality control systems’ (e.g. detector, neutron absorber, or other physical systems) were failed or affected in 12% of the analysed events. Figure 5 shows the distribution of failed or affected systems.

Figure 5. Distribution of the analysed events by failed or affected systems.

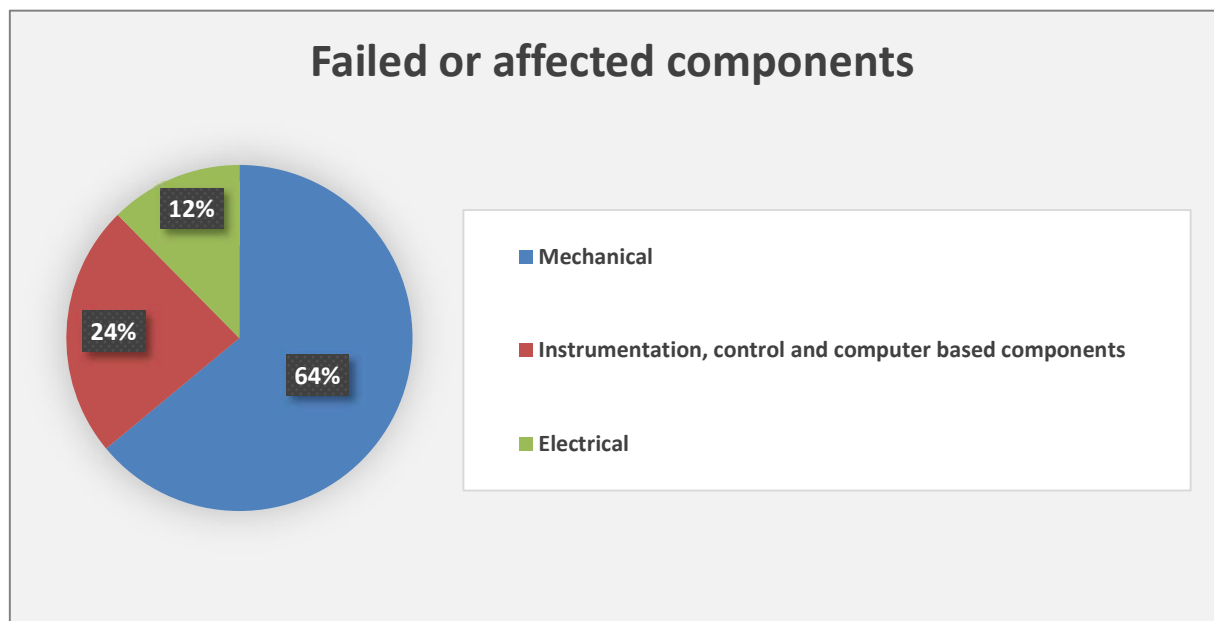
The analysis of failed or affected components showed that the distribution was 64% for ‘mechanical’, 24% for ‘instrumentation, control and computer based components’, and 12% for ‘electrical’ components. Figure 6 shows the distribution of failed or affected components.

Figure 6. Distribution of the analysed events by failed or affected components.
